SSI-9717 Snowy 2.0 Transmission Connection – Independent Environmental Audit Construction Audit 3 – Proponent Responses to Audit Findings

Snowy 2.0 Transmission Connection Project - Independent Environmental Audit Construction Audit 3

Proponent Responses

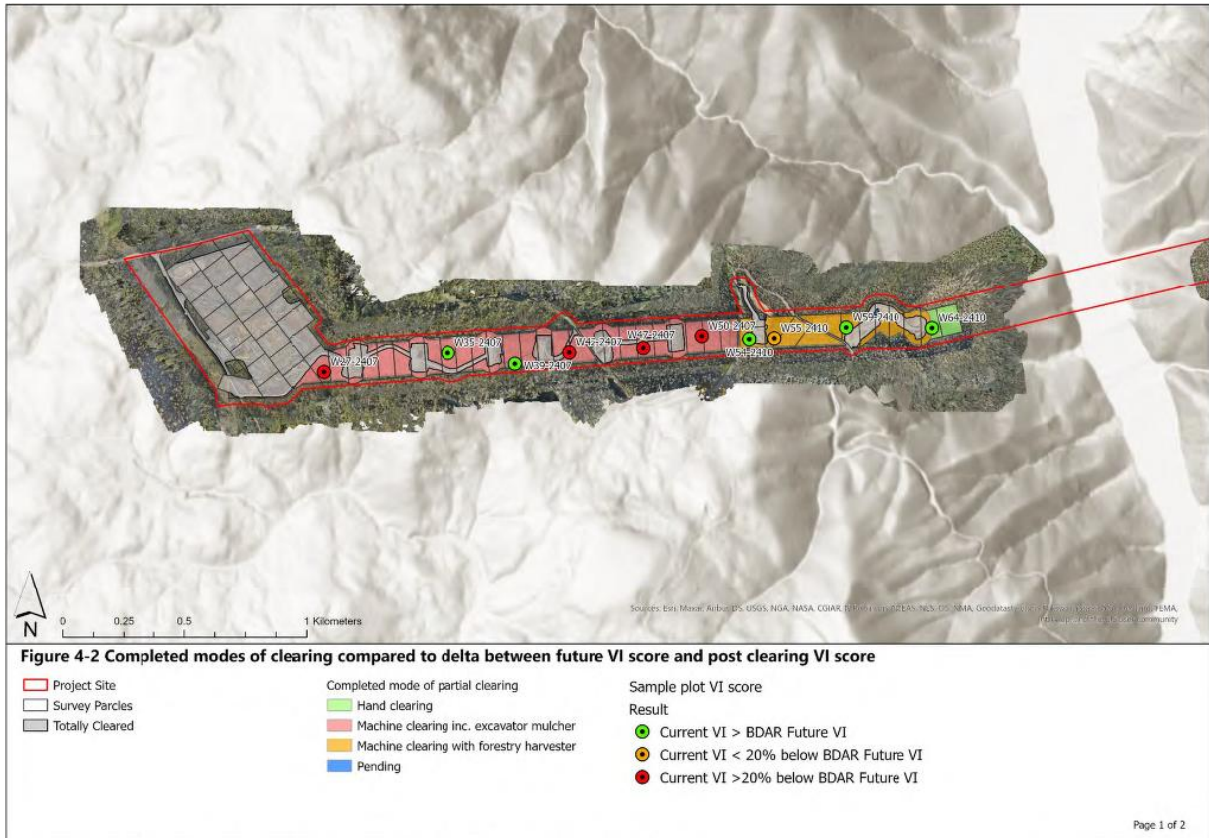
The IEA found that clearing works within the Easement Clearing Zone (ECZ) on the Project West site "west of Track 1 along the alignment to the Maragle site" (Umwelt, 2025, p. 29), shown in red in Figure 1, did not comply with the Biodiversity Management Plan [BMP] (Transgrid, 2024).

Figure 1: Area where clearing works were assumed to have been undertaken using an excavator mulcher, shown in red (Source Leneco, 2025)

Specifically, the IEA found that during vegetation clearing undertaken between February and May 2024 the use of an excavator mulcher and a forestry mulcher, rather than a forest harvester, for removal of trees over 200 mm diameter at breast height (DBH) has resulted in the extensive application of wood mulch, to depths of 200 mm and that the excessive application of mulch is likely to have resulted in significant groundcover disturbance and compromised the retention of managed shrub and groundcover vegetation.

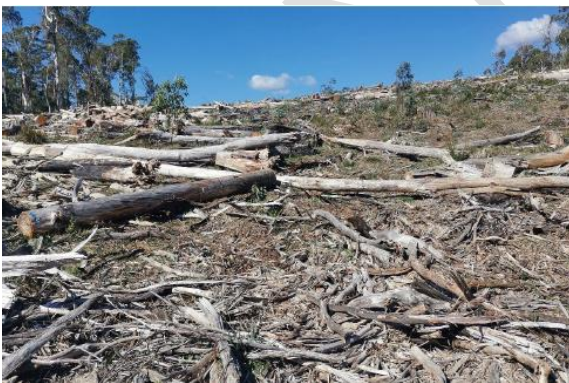
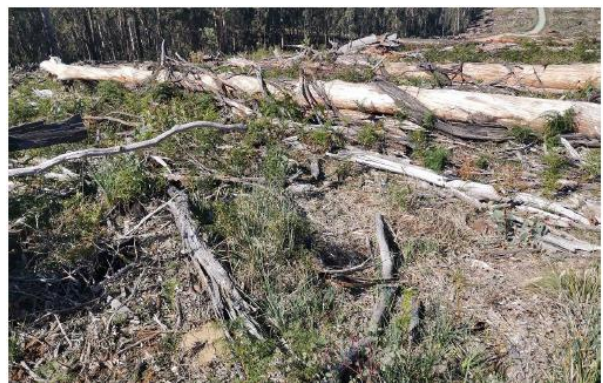
In considering whether clearing was consistent with the BDAR and the BMP, the machinery used must be considered. The IEA (Umwelt, 2025) assumes use of an excavator mulcher in these areas. It appears this assumption is based on statements in the Leneco (2025) report (see above). However, review of photographs from Umwelt (2025) indicate that a forest harvester, not an excavator mulcher, is likely to have been used, at least in some areas, with large tree trunks evident (Plate 1), consistent with use of a tree harvester and not an excavator mulcher. Rather than leaving large trunks intact on the ground an excavator mulcher would have chipped all vegetation and resulted in only mulch (i.e. no large trunks).

Plate 1: Plates 10 and 11 from Umwelt (2025) appearing to show large trunks left in situ

The use of a forestry harvester for clearing of vegetation over 200 mm DBH has been confirmed by Transgrid (Jason Snape, pers. comm. 3 July 2025). The amount of mulch observed may be a result of the volume of vegetation <200 mm DBH.
