# MONTHLY CONSTRUCTION WATER QUALITY MONITORING REPORT

July 2025

Project No.: 3200-0645

Project: Transgrid Maragle 500/330 kV Substation

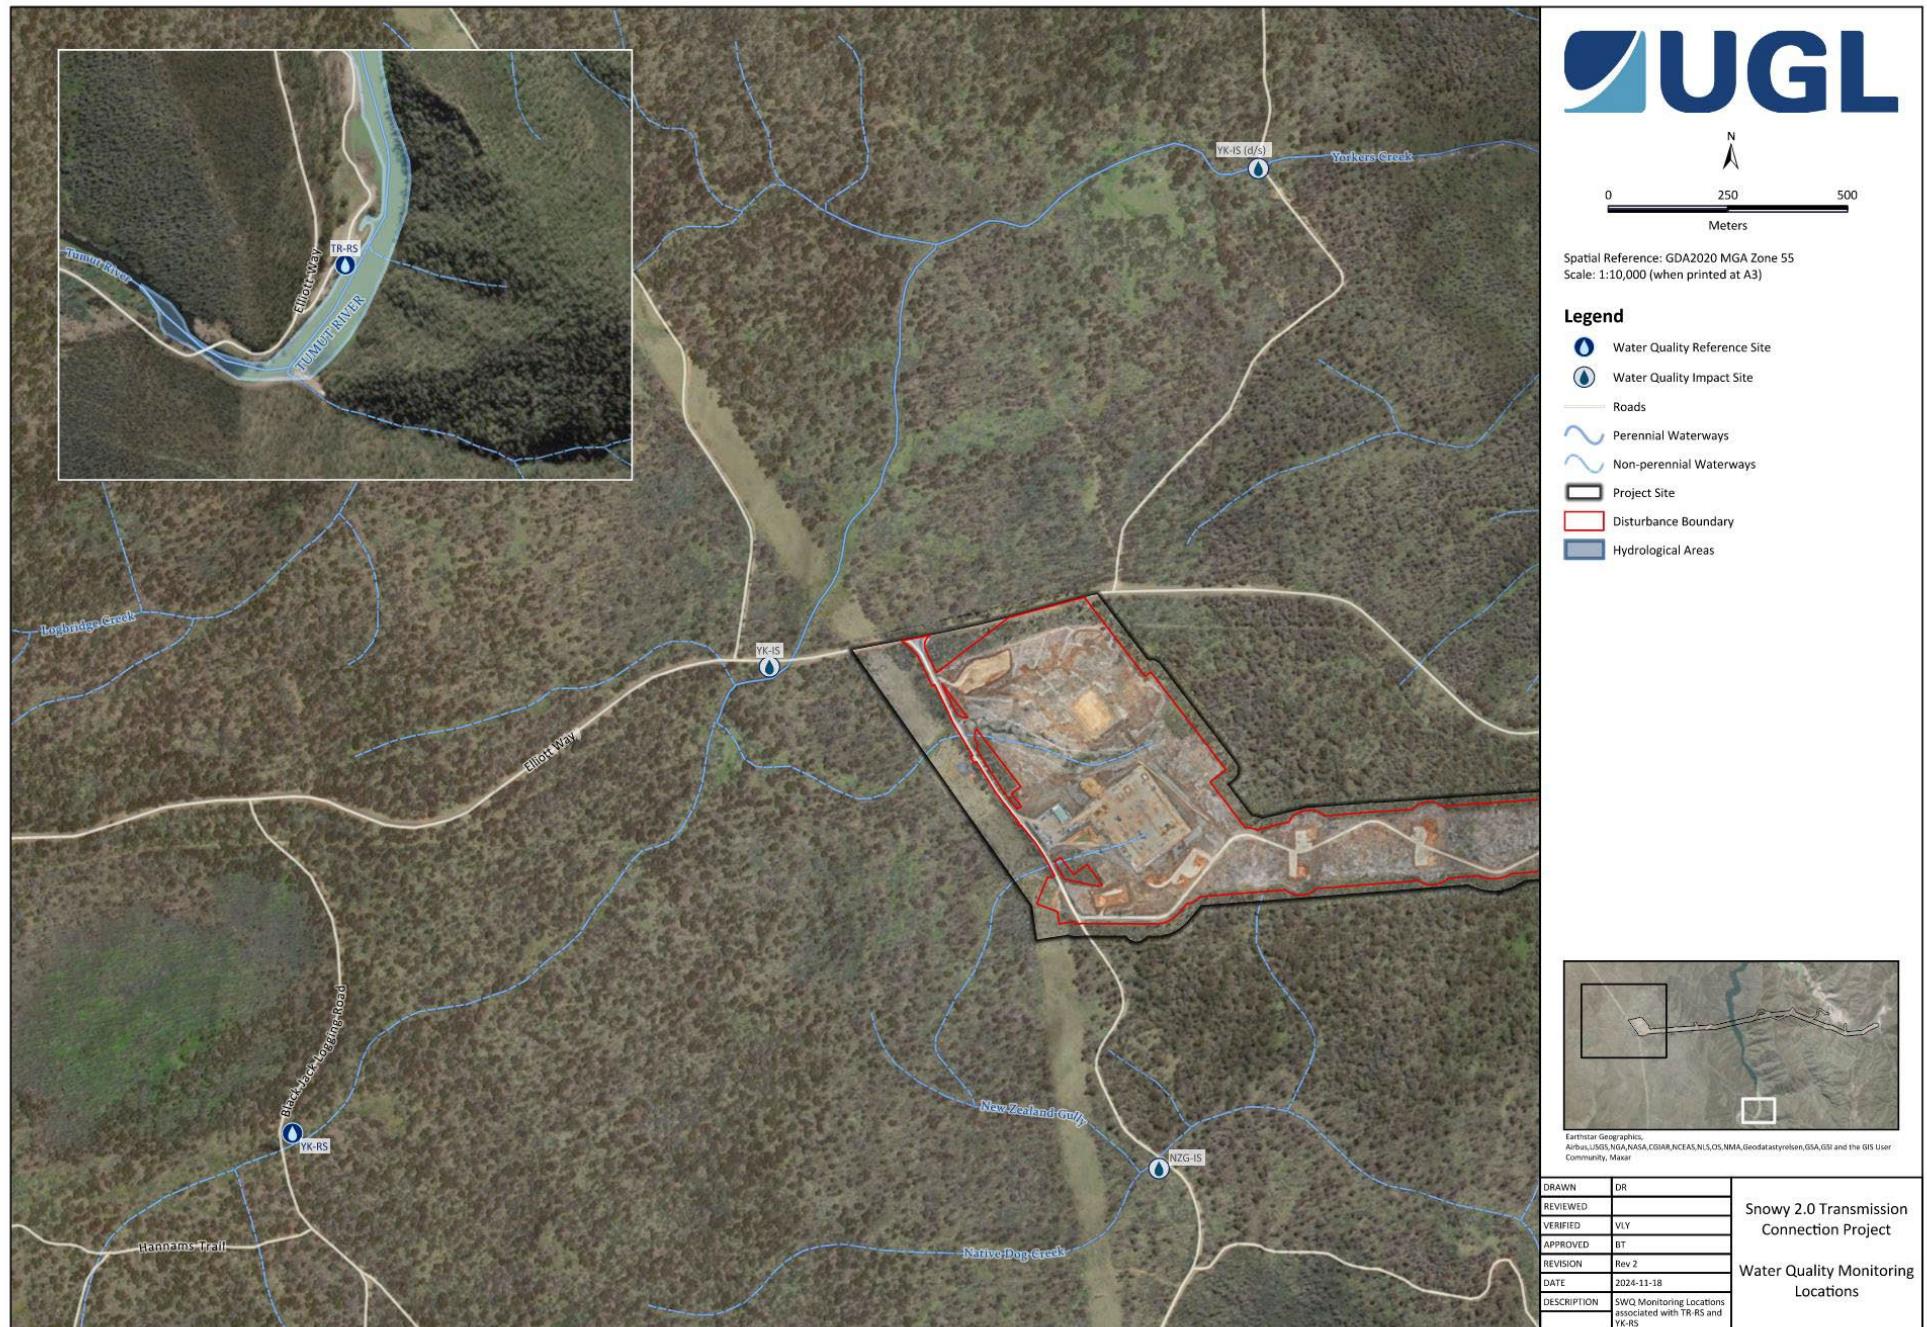
FIGURE 2 WATER QUALITY MONITORING LOCATIONS ASSOCIATED WITH REFERENCE SITE YR-RS AND TR-RS IN RELATION TO THE PROJECT

Monitoring locations are outlined in Table 1. FIGURE 2 and FIGURE 3 show the water quality monitoring locations in relation to the Project and Snowy 2.0.

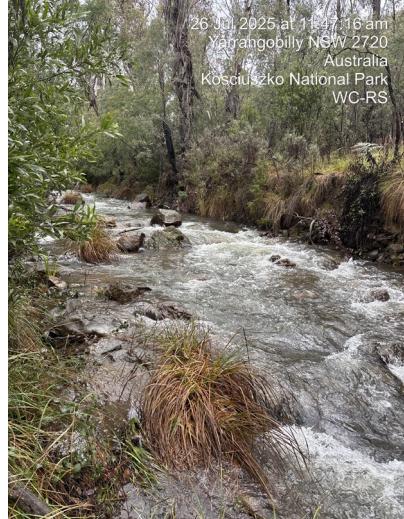
<div style="position: absolute; top: 660px; left: 760px; width: 200px; height: 100px; background-color: black; color: white; padding: 5px; font-size: 0.8em;"> 26 Jul 2025 at 11:47:16 am  Yarrangobilly NSW 2720  Australia  Kosciuszko National Park  WC-RS </div>

FIELD OBSERVATIONS		
Date	26-29 July 2025	
Weather	<p>The weather forecast for 26 July was 3 degrees Celsius (°C) with 5 percent of &lt;1 millimetres (mm) of rain. The previous 48 hours was cloudy and experienced a total of 7.2mm of rainfall across 25 to 24 July. At the time of sampling, the weather was overcast with showers.</p> <p>The weather forecast for 29 July was 2 degrees Celsius (°C) with 50 percent of &lt;1 millimetres (mm) of rain. The previous 48 hours was cloudy and experienced a total of 51mm of rainfall across 28 to 27 July. At the time of sampling, the weather was overcast.</p>	
ID	Observations	Photo
WC-RS	<ul style="list-style-type: none"> <li>High water volume with a high flow rate.</li> <li>Rocky and eroded banks, with exposed roots from a large tree.</li> <li>Presence of aquatic vegetation, including algae and moss.</li> <li>Presence of vegetative detritus within the channel.</li> <li>Water exhibiting a slight yellow tinge.</li> <li>Riparian vegetation consisted of groundcover, shrubs and trees.</li> <li>Moderate weed density, including of Blackberry (<i>Rubus fruticosus</i>).</li> </ul>

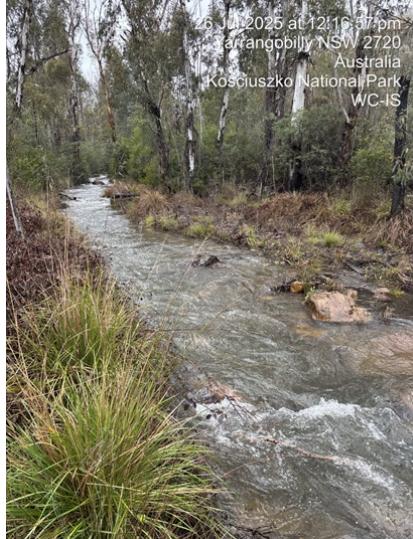
<p>6 Jul 2025 at 12:16:57 pm Yarrangobilly NSW 2720 Australia Kosciuszko National Park WC-IS</p>

<b>Date</b>	26-29 July 2025	
<b>Weather</b>	<p>The weather forecast for 26 July was 3 degrees Celsius (°C) with 5 percent of &lt;1 millimetres (mm) of rain. The previous 48 hours was cloudy and experienced a total of 7.2mm of rainfall across 25 to 24 July. At the time of sampling, the weather was overcast with showers.</p> <p>The weather forecast for 29 July was 2 degrees Celsius (°C) with 50 percent of &lt;1 millimetres (mm) of rain. The previous 48 hours was cloudy and experienced a total of 51mm of rainfall across 28 to 27 July. At the time of sampling, the weather was overcast.</p>	
<b>ID</b>	<b>Observations</b>	<b>Photo</b>
WC-IS	<ul style="list-style-type: none"> <li>High water volume with a high flow rate.</li> <li>Presence of vegetative detritus within the channel.</li> <li>Presence of aquatic invertebrates and vegetation.</li> <li>Water exhibiting a slight yellow tinge.</li> <li>Riparian vegetation comprised of trees and grasses.</li> <li>High weed density, including the presence of Blackberry (<i>Rubus fruticosus</i>)</li> <li>Rocky banks and undercut banks observed.</li> <li>Monitoring location situated adjacent to bridge and Mine Trail Road, which is frequently used by Snowy 2.0 vehicles, plant and machinery.</li> <li>Visible discharge observed from the Track 8 FGJV landslip and clean water rock drain at the time of sampling.</li> </ul>

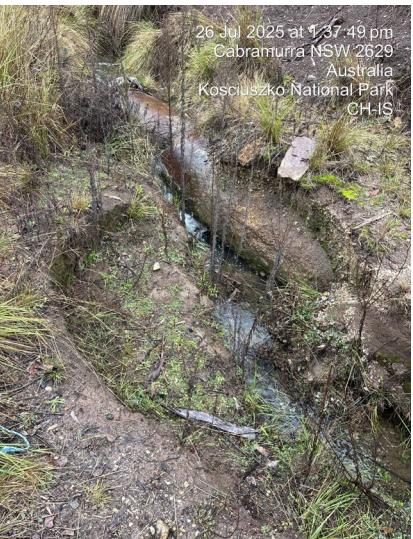
<p>26 Jul 2025 at 1:37:49 pm Cabramurra NSW 2629 Australia Kosciuszko National Park CG-IS</p>

CG-IS	<ul style="list-style-type: none"> <li>High water volume with a high flow rate.</li> <li>Presence of vegetative detritus within the channel.</li> <li>Presence of aquatic invertebrates and vegetation.</li> <li>Eroded banks and sandy bed.</li> </ul>

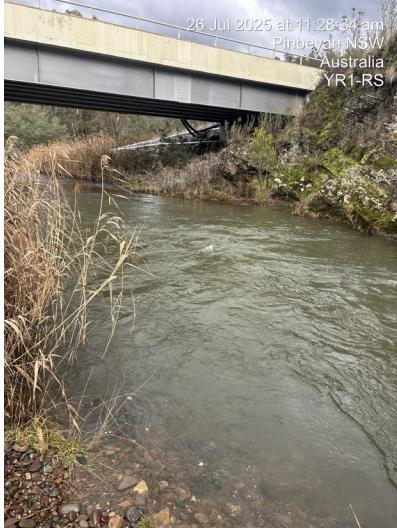
Date	26-29 July 2025	
Weather	<p>The weather forecast for 26 July was 3 degrees Celsius (°C) with 5 percent of &lt;1 millimetres (mm) of rain. The previous 48 hours was cloudy and experienced a total of 7.2mm of rainfall across 25 to 24 July. At the time of sampling, the weather was overcast with showers.</p> <p>The weather forecast for 29 July was 2 degrees Celsius (°C) with 50 percent of &lt;1 millimetres (mm) of rain. The previous 48 hours was cloudy and experienced a total of 51mm of rainfall across 28 to 27 July. At the time of sampling, the weather was overcast.</p>	
ID	Observations	Photo
YR1-IS	<ul style="list-style-type: none"> <li>Water exhibited a slight yellow tinge.</li> <li>High water volume with a high flow rate.</li> <li>Presence of vegetative detritus within the channel.</li> <li>White foam observed accumulating on debris at the water surface.</li> <li>Moderate weed density, including the presence of thistle (<i>Cirsium sp.</i>) and Blackberry (<i>Rubus fruticosus</i>)</li> <li>Riparian vegetation consisted of groundcover, shrubs and trees</li> <li>Rocky banks with sections of exposed soil higher along the bank profile.</li> <li>Presence of aquatic vegetation, including algae.</li> <li>FGJV observed pumping water from their sediment basin at the time of sampling.</li> </ul>

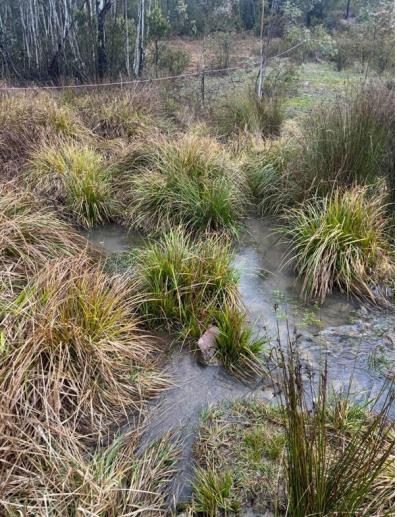
LHG-IS	<ul style="list-style-type: none"> <li>Monitoring location is situated adjacent to Mine Trail Road, which is frequently used by Snowy 2.0 vehicles, plant and machinery.</li> <li>Moderate level with moderate flow rate.</li> <li>Rocky bed with no defined banks.</li> <li>Water exhibiting a Brown-milky tinge.</li> <li>Overgrown vegetation dominated by groundcover species.</li> <li>Presence of silt and grass seed husks on the streambed.</li> <li>Presence of aquatic vegetation, including algae</li> </ul>

- » Vegetation cover along the riparian zone can influence the stability of the banks and groundwater which in turn may influence the waterways
  - » Sheen from organic decomposition observed on the surface of the water at LHG-IS and YK-RS may impact WQ parameters

- » Presence of algae (not overgrown) and aquatic vegetation in waterways indicate the SWQ is sufficient to support aquatic ecosystems
- » LHG-IS has consistently recorded exceedances across multiple parameters. This could be influenced by the shallow depth of the water and the high silt deposits observed in the bed

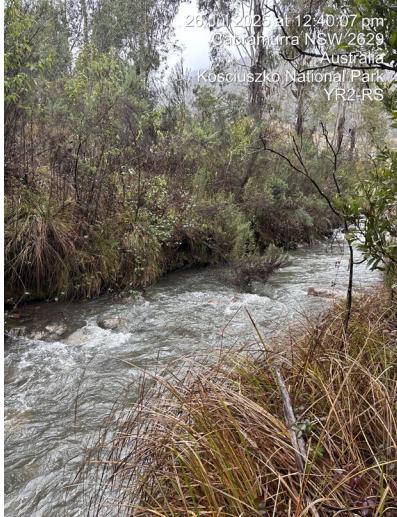
Date	26-29 July 2025	
Weather	<p>The weather forecast for 26 July was 3 degrees Celsius (°C) with 5 percent of &lt;1 millimetres (mm) of rain. The previous 48 hours was cloudy and experienced a total of 7.2mm of rainfall across 25 to 24 July. At the time of sampling, the weather was overcast with showers.</p> <p>The weather forecast for 29 July was 2 degrees Celsius (°C) with 50 percent of &lt;1 millimetres (mm) of rain. The previous 48 hours was cloudy and experienced a total of 51mm of rainfall across 28 to 27 July. At the time of sampling, the weather was overcast.</p>	
ID	Observations	Photo
YR2-IS	<ul style="list-style-type: none"> <li>Presence of aquatic invertebrates.</li> <li>Rocky bed and banks.</li> <li>High volume with a high flow rate.</li> <li>Riparian vegetation dominated by groundcover species.</li> <li>Moderate weed density, including Blackberry (<i>Rubus fruticosus</i>)</li> <li>Presence of vegetative detritus within the channel.</li> <li>Monitoring location is situated adjacent to bridge and electrical transmission tower positioned atop a rocky cliff, near the Snowy 2.0 laydown area.</li> </ul>

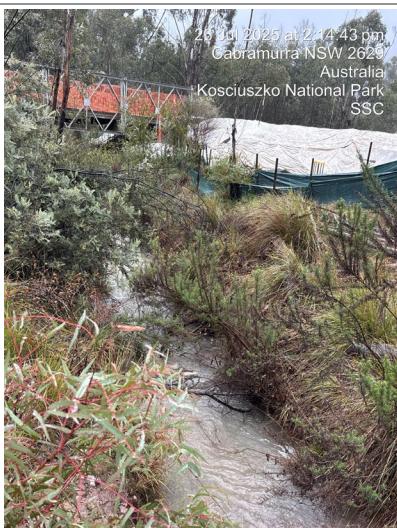
SSC-IS	<ul style="list-style-type: none"> <li>High water volume with a high flow rate.</li> <li>White foam accumulating on debris at water's surface.</li> <li>Turbid water exhibited milky-brown tinge.</li> <li>Presence of overhanging vegetation adjacent to bank.</li> <li>Monitoring location situated under SSC construction bridge.</li> </ul>

- » TP (mg/L) levels were generally consistent with previous sampling periods, with only marginal exceedances recorded.
- » Three dissolved metal analytes were recorded in exceedance across various sampling locations. The following analytes were in exceedance, Al, Fe and Mn. It is noted that SSC-IS (0.31mg/L) is 155 times the SSGV.

- » Six total metal analytes (total Al, Cr, Cu, Pb, Zn and Fe) were identified in exceedance across various sampling locations during July 2025. It is noted that SSC-IS (0.002mg/L) was 200 times above the respective total Cr DGV during the July 2025 sampling period.

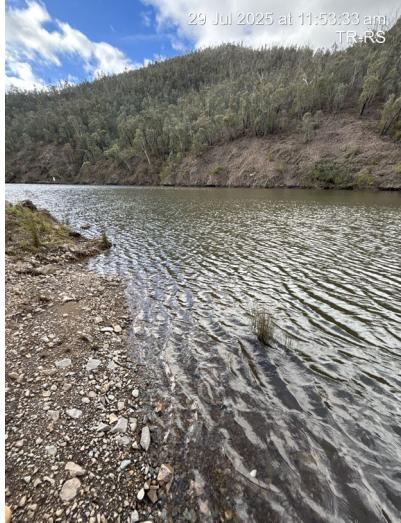
<b>Date</b>	26-29 July 2025	
<b>Weather</b>	<p>The weather forecast for 26 July was 3 degrees Celsius (°C) with 5 percent of &lt;1 millimetres (mm) of rain. The previous 48 hours was cloudy and experienced a total of 7.2mm of rainfall across 25 to 24 July. At the time of sampling, the weather was overcast with showers.</p> <p>The weather forecast for 29 July was 2 degrees Celsius (°C) with 50 percent of &lt;1 millimetres (mm) of rain. The previous 48 hours was cloudy and experienced a total of 51mm of rainfall across 28 to 27 July. At the time of sampling, the weather was overcast.</p>	
<b>ID</b>	<b>Observations</b>	<b>Photo</b>
TR-RS	<ul style="list-style-type: none"> <li>Stream banks composed of rocky substrate with a sandy bed.</li> <li>Monitoring location situated adjacent to publicly accessible O'Hares Campground and Talbingo Reservoir ancillary infrastructure.</li> <li>Presence of aquatic invertebrates and vegetation observed.</li> <li>Water was clear with moderate volume and a moderate flow rate.</li> <li>Presence of vegetative detritus identified within the channel.</li> <li>Riparian vegetation comprised a mix of groundcover species and trees.</li> <li>Evidence of recent landslips noted along the banks.</li> </ul>

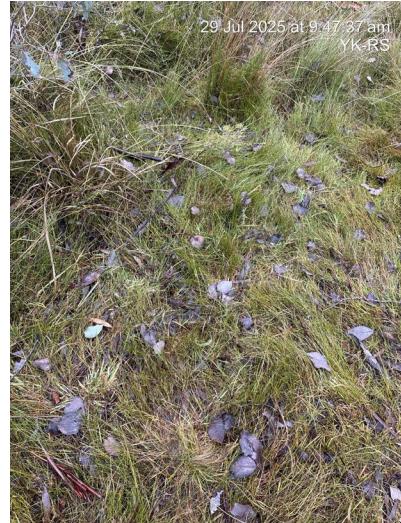
YK-RS	<ul style="list-style-type: none"> <li>No flow; dry at the time of sampling.</li> </ul>

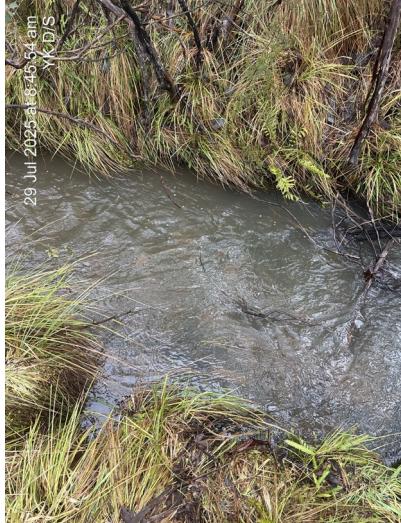
<b>Date</b>	26-29 July 2025	
<b>Weather</b>	<p>The weather forecast for 26 July was 3 degrees Celsius (°C) with 5 percent of &lt;1 millimetres (mm) of rain. The previous 48 hours was cloudy and experienced a total of 7.2mm of rainfall across 25 to 24 July. At the time of sampling, the weather was overcast with showers.</p> <p>The weather forecast for 29 July was 2 degrees Celsius (°C) with 50 percent of &lt;1 millimetres (mm) of rain. The previous 48 hours was cloudy and experienced a total of 51mm of rainfall across 28 to 27 July. At the time of sampling, the weather was overcast.</p>	
<b>ID</b>	<b>Observations</b> <ul style="list-style-type: none"> <li>Presence of aquatic vegetation.</li> <li>Water exhibited a yellow to brown tinge.</li> <li>Vegetative detritus observed within the water channel.</li> <li>Riparian vegetation comprised of groundcover species and trees.</li> <li>Low weed density observed, including Blackberry (<i>Rubus fruticosus</i>).</li> <li>High water volume with a high flow rate.</li> <li>Undermined banks and rocky and sandy bed containing mica.</li> <li>Monitoring location situated adjacent to publicly accessible 4WD track.</li> </ul>	<b>Photo</b>

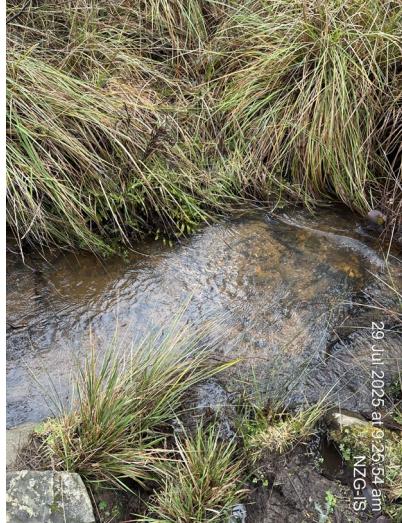
<b>Date</b>	26-29 July 2025	
<b>Weather</b>	<p>The weather forecast for 26 July was 3 degrees Celsius (°C) with 5 percent of &lt;1 millimetres (mm) of rain. The previous 48 hours was cloudy and experienced a total of 7.2mm of rainfall across 25 to 24 July. At the time of sampling, the weather was overcast with showers.</p> <p>The weather forecast for 29 July was 2 degrees Celsius (°C) with 50 percent of &lt;1 millimetres (mm) of rain. The previous 48 hours was cloudy and experienced a total of 51mm of rainfall across 28 to 27 July. At the time of sampling, the weather was overcast.</p>	
<b>ID</b>	<b>Observations</b>	
NZG-IS	<ul style="list-style-type: none"> <li>Presence of aquatic vegetation within the channel.</li> <li>Organic detritus observed throughout the channel.</li> <li>Overhanging vegetation present along the banks.</li> <li>Clear water exhibited a slight yellow tinge.</li> <li>High weed density observed, including Blackberry (<i>Rubus fruticosus</i>).</li> <li>Monitoring location situated adjacent to publicly accessible 4WD track.</li> <li>High water volume with a high flow rate.</li> <li>Banks exhibited signs of erosion and undercutting, with a pebbly-bed composition.</li> <li>Riparian vegetation comprised groundcover species and trees.</li> </ul>

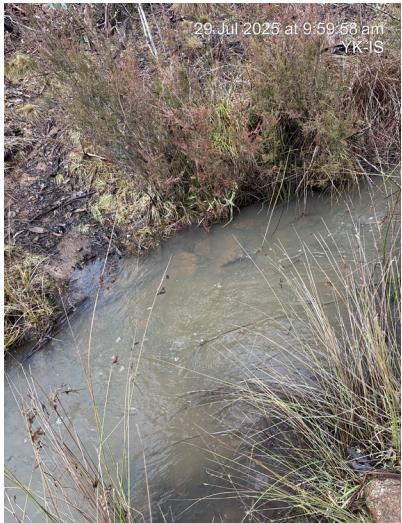
YK-IS	<ul style="list-style-type: none"> <li>Water was turbid and cloudy, exhibiting a slight yellow tinge.</li> <li>High presence of aquatic vegetation.</li> <li>High water volume with a high flow rate.</li> <li>Banks exhibited signs of erosion, with bed material containing visible mica.</li> <li>Overhanging vegetation present along the banks.</li> <li>Presence of vegetative detritus located within the water channel.</li> <li>Riparian vegetation comprised groundcover species, shrubs and trees.</li> <li>Low weed density recorded.</li> <li>Monitoring location situated adjacent to Elliott Way, leading towards culvert.</li> </ul>

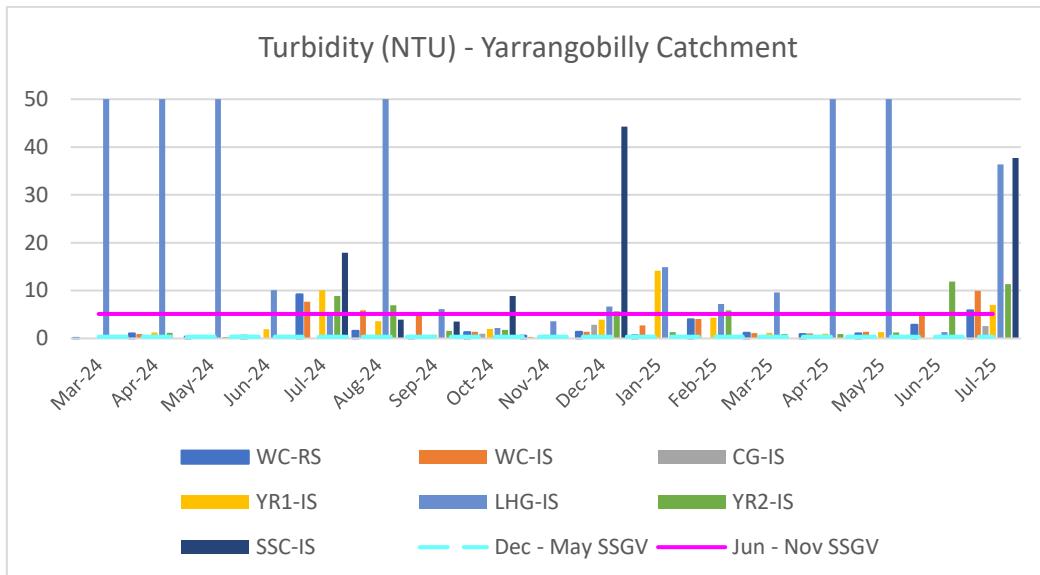
FIGURE 19: TURBIDITY FOR YARRANGOBILLY RIVER CATCHMENT

In July 2025, Turbidity (NTU) levels in the Yarrangobilly River Catchment increased across most sites, with several exceeding the June — November SSGV (5 NTU), refer to FIGURE 19. The Talbingo Reservoir also recorded a significant rise in turbidity from June 2025 to July 2025, as shown in FIGURE 20. Yorkers Creek Catchment, turbidity levels exceeded June — November SSGV expressed in FIGURE 21.

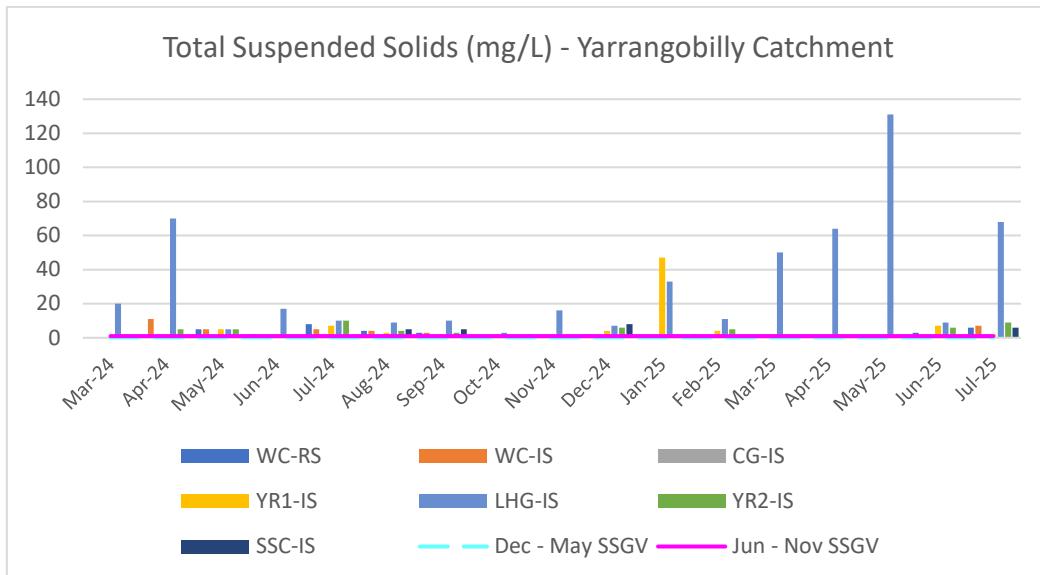
FIGURE 22: TSS FOR YARRANGOBILLY RIVER CATCHMENT

In July 2025, TSS (mg/L) levels within the Yarrangobilly River Catchment generally decreased compared to values recorded in June 2025 (FIGURE 22). Talbingo Reservoir values increased from June 2025 (1mg/L) to July 2025 (5mg/L) significantly higher than the June — November SSGV (FIGURE 23). In the Yorkers Creek Catchment, YK-IS and NZG-IS remained above the June — November SSGV (FIGURE 24).

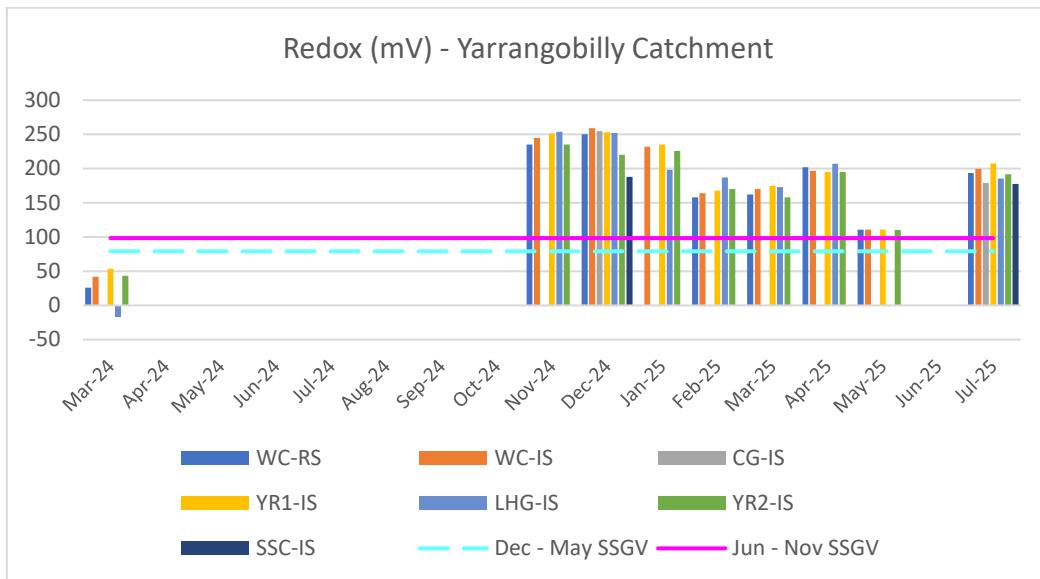
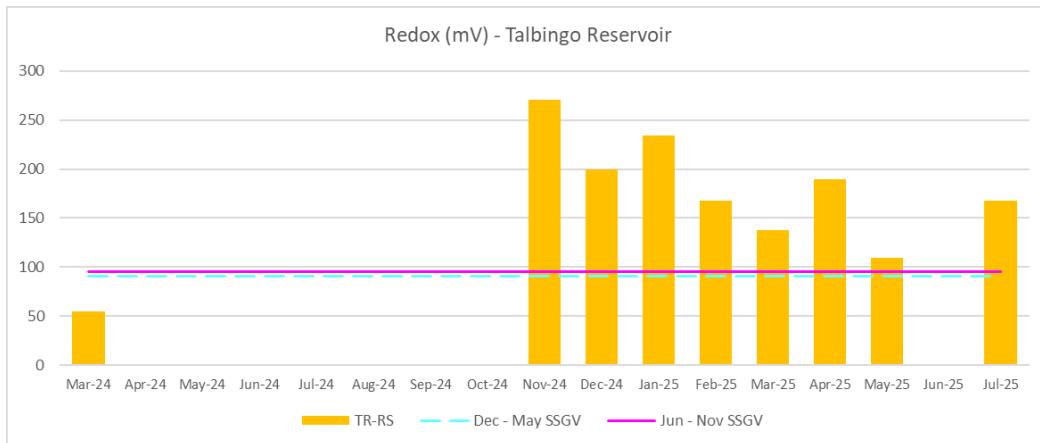
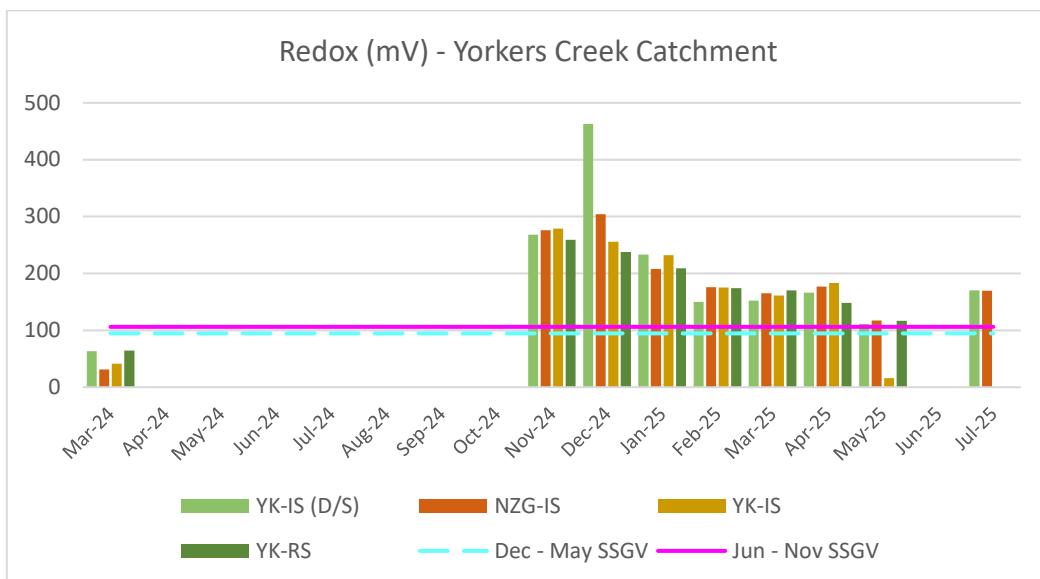
Redox (mV) levels in July 2025 were above the June — November SSGV across all three catchments (refer to FIGUREs 28 — 30). While the results indicate exceedance, the recorded values were considerably lower than earlier peaks observed between November 2024 and February 2025.

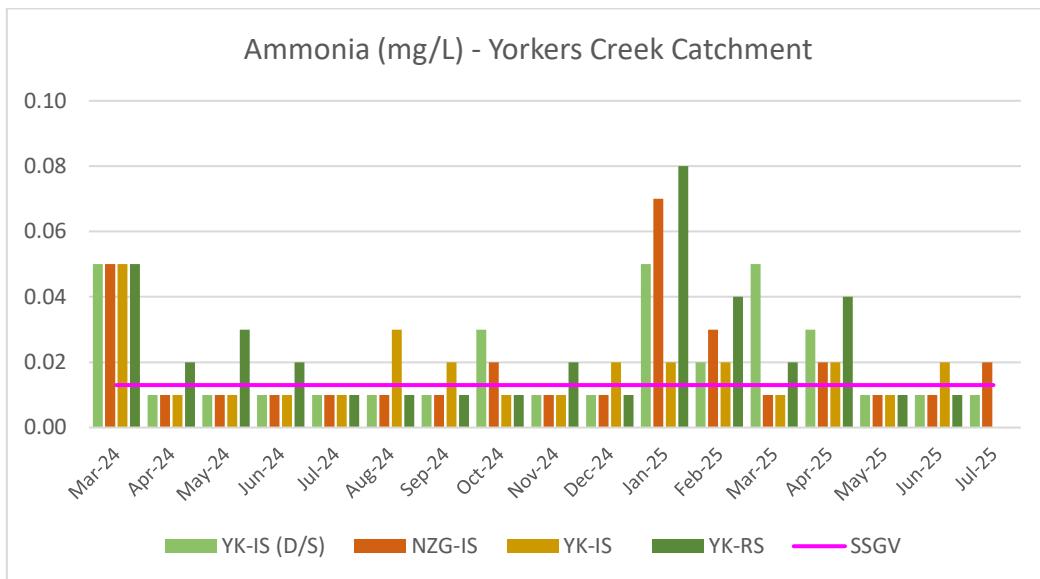
FIGURE 36: AMMONIA FOR YORKERS CREEK CATCHMENT

Ammonia (mg/L) levels between June 2025 and July 2025 showed notable variation across the three catchments. In Yarrangobilly Catchment, concentrations increased across various sampling sites, with substantial exceedances of the SSGV at WC-IS, YR2-IS and SSC-IS, compared to June 2025 levels (refer to FIGURE 34). In contrast, Talbingo Reservoir recorded a reduction in Ammonia (mg/L) levels compared to June 2025 (see FIGURE 35). The Yorkers Creek Catchment remained similar to values identified in June 2025 with isolated exceedance at NZG-IS in July 2025 (refer to FIGURE 36).

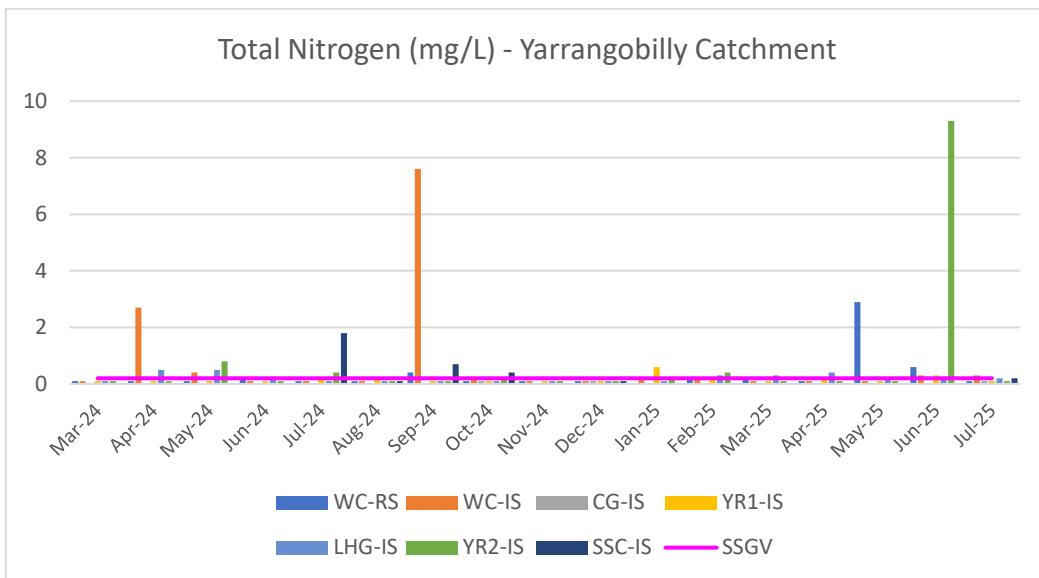
FIGURE 46: TN FOR YARRANGOBILLY RIVER CATCHMENT

TN (mg/L) values consistently remained below the SSGV across all catchments (FIGURE 46-48) with the exception of WC-IS marginally exceeding the SSGV with a result of 0.3mg/L (FIGURE 46)

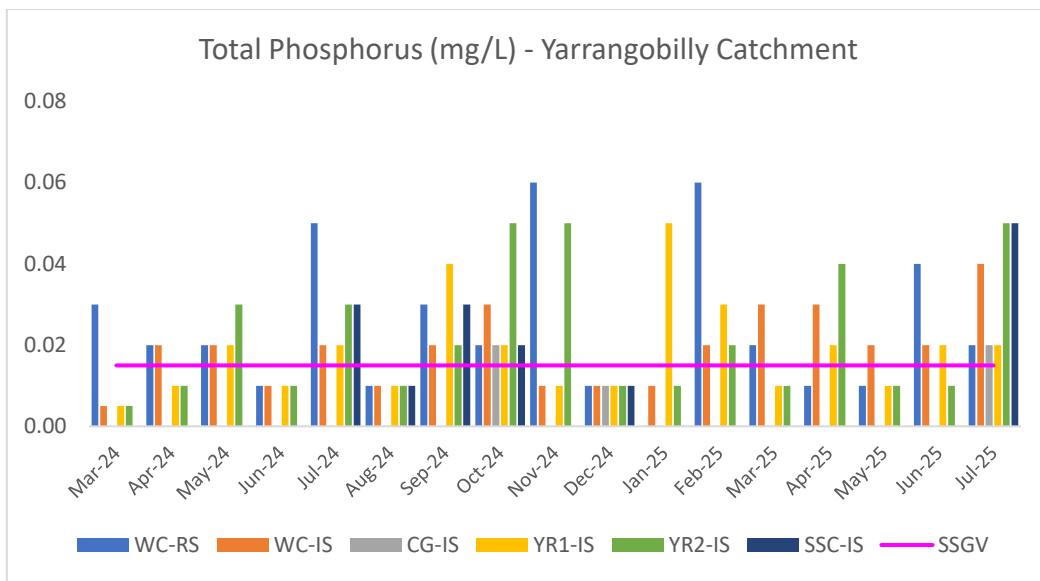
FIGURE 49: TP FOR YARRANGOBILLY RIVER CATCHMENT

TP (mg/L) levels fluctuated from June 2025 across each catchment. A marginal increase of TP was identified at each of the Yarrangobilly Catchment sampling sites, with exceedance identified against the SSGV (FIGURE 49). A reduction in TP between June 2025 and July 2025 was noted at the Talbingo Reservoir although continued exceedance of SSGV values was exhibited (FIGURE 50). Reduction in TP was observed at the Yorkers Creek Catchment sampling sites although continued exceedance of the SSGV was apparent (FIGURE 51).

The sudden peak in total phosphorus identified at LHG-IS in May 2025 was likely a result of laboratory error and has been removed from the graph.
