**Subject: Snowy 2.0 - Transmission Connection - Construction Independent Environmental Audit #3**

**SNOWY 2.0 TRANSMISSION  
CONNECTION PROJECT**

**FINAL**

July 2025

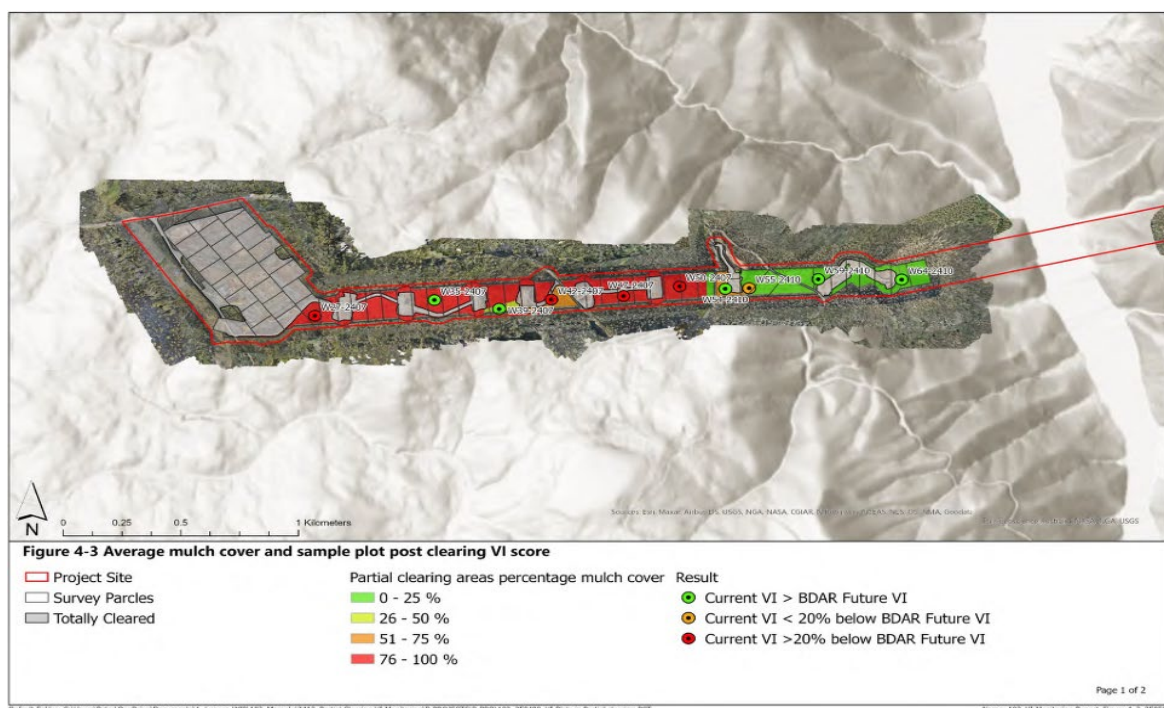
**Figure 1** Average mulch cover and sample plot post clearing VI score (LENECO, 2025)

Within the Easement Clearing Zone (ECZ) on the Project West between the Maragle Switch Yard and Track 1 over an area of approximately 1.5km of the easement, significant groundcover disturbance was observed (refer to **Plate 8**, **Plate 9**, **Plate 10**, **Plate 11**, **Plate 12**, **Plate 13**, **Plate 14**, **Plate 15**, **Plate 16**, **Plate 17** and **Plate 18** in **Appendix 5**). Specifically, the retention of managed shrub and groundcover vegetation appeared to be compromised due to the use of extensive application of woodchip mulch, particularly between the western extent of the Project Area, west from Track 1. This excessive generation and application of mulch is considered to be attributed to failure to adhere to the BMP clearing requirements, which required an excavator mulcher to be utilised for clearing of trees with a diameter under 200 mm. After the site inspection, a Post-clearing Vegetation Integrity Monitoring Report (LENECO April 2025) was provided. The report identified that from February to May 2024, clearing in the ECZ was undertaken using an excavator-mounted mulcher, with Transgrid noting that a forestry mulcher was also utilised for a period in March 2024 however after March was no longer used due to challenges with steeper/undulating terrain. As observed during the audit site inspection the use of these clearing methods has resulted in excessive woodchip mulch and increased ground disturbance, especially in the taller forest areas in Project Area West. The LENECO Report also identified this and mapped an area of approximately 1.5km between Maragle Switch Yard and Track 1 where mulch cover was confirmed to range from 76% to 100% (refer to **Figure 1**). The use of the forestry mulcher on the Project West site did not comply with the BMP's requirement to use a excavator mulcher. The forestry mulcher is not considered a similar machine to an excavator mulcher due to differences in design, mobility, and application. Forestry mulchers are self-propelled, purpose-built machines designed primarily for clearing on-ground vegetation, shrubs, and small trees over large areas, whereas excavator mulchers are attachments fitted to excavators, offering greater flexibility for selective clearing, especially in partial clearing zones.

This non-compliance has likely led to increased disturbance and impacts to shrubs and ground cover vegetation and resulted in excessive woodchip cover that has smothered shrub and groundcover vegetation that was required to be retained. Furthermore, the application of mulch at such depth has likely elevated ground temperatures, potentially degrading the soil seedbank. It is important to note that spreading mulch is not considered a form of rehabilitation and, in this case, may have had the opposite effect by impeding vegetation recovery. The extent of the impacts observed from this have the potential to have resulted in environmental harm (as defined under the Infrastructure Approval).

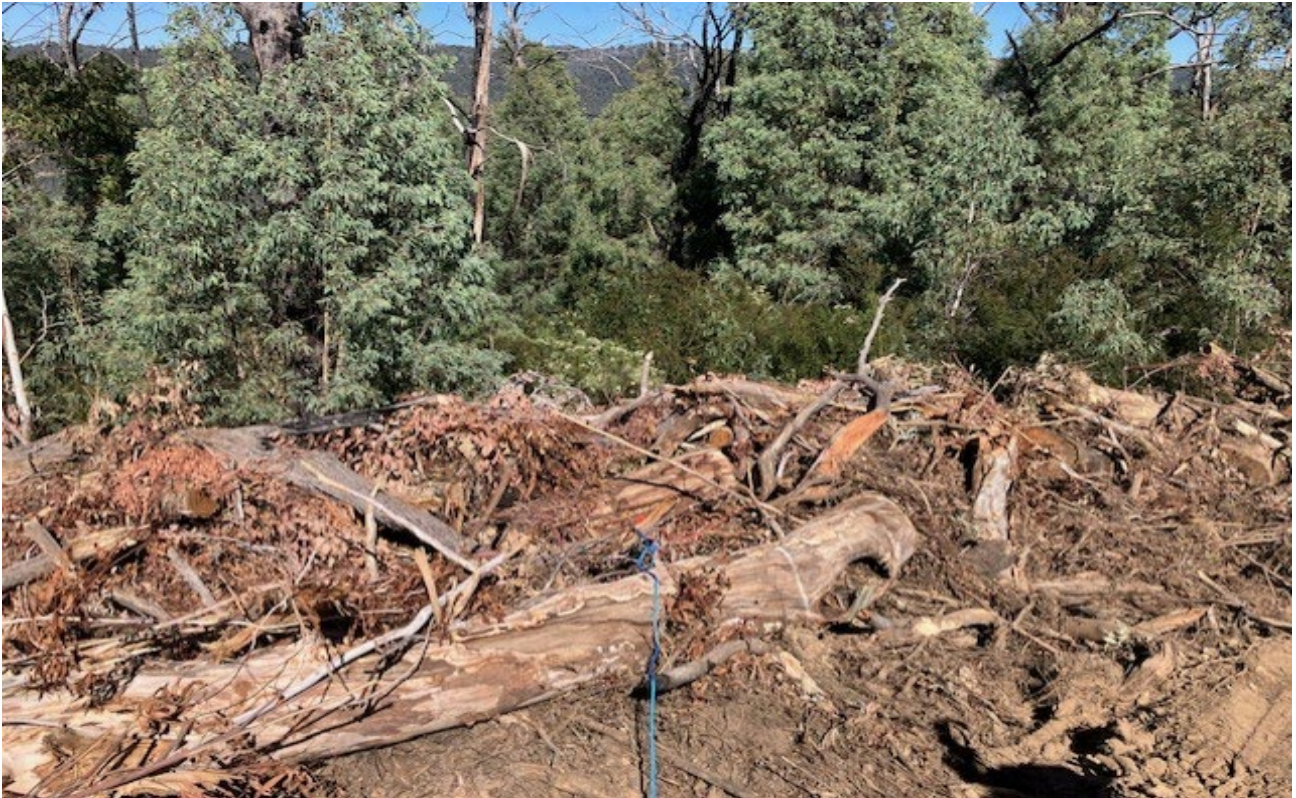
**Plate 1: Example 1 - Clearing observed extending beyond delineated area along Track 5C (Inspection Date: 13/03/2025).**

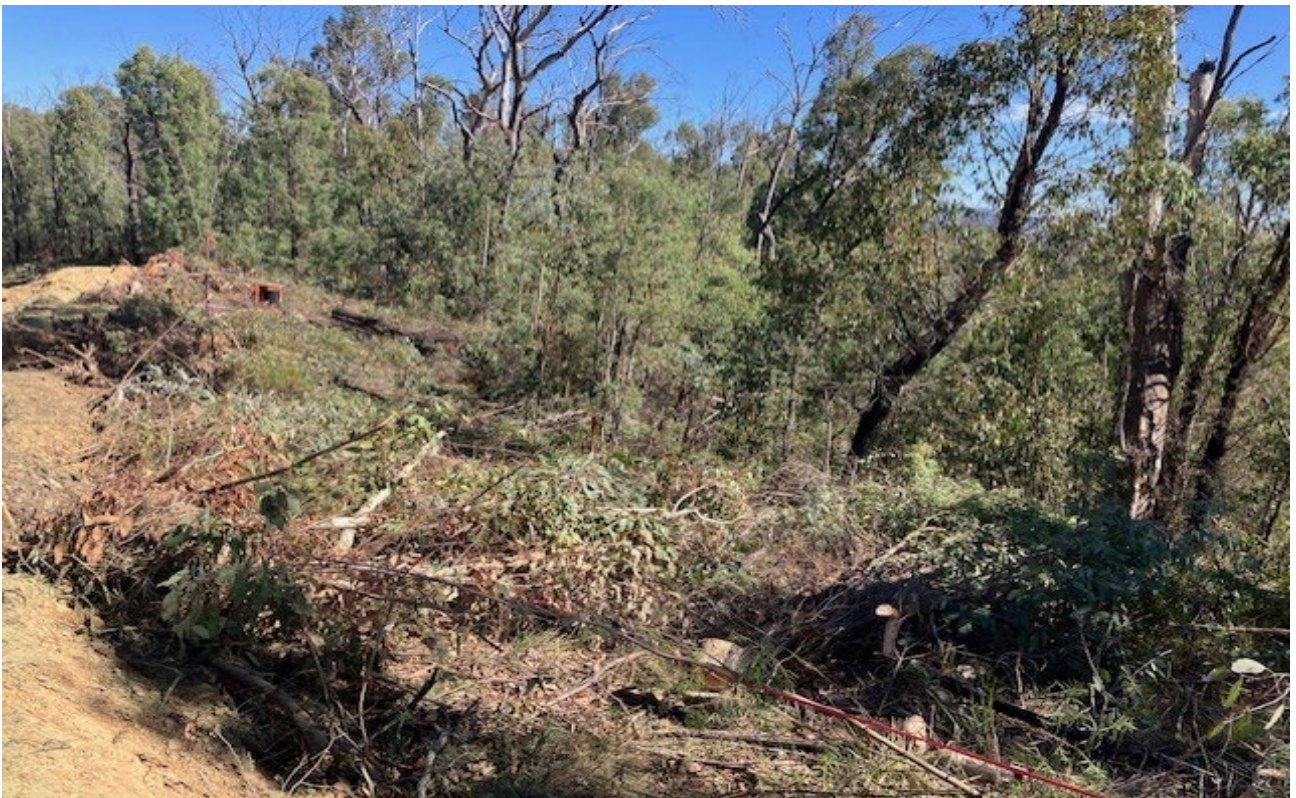
**Plate 2: Example 2 - Clearing observed extending beyond delineated area along Track 5C (Inspection Date: 12/03/2025).**

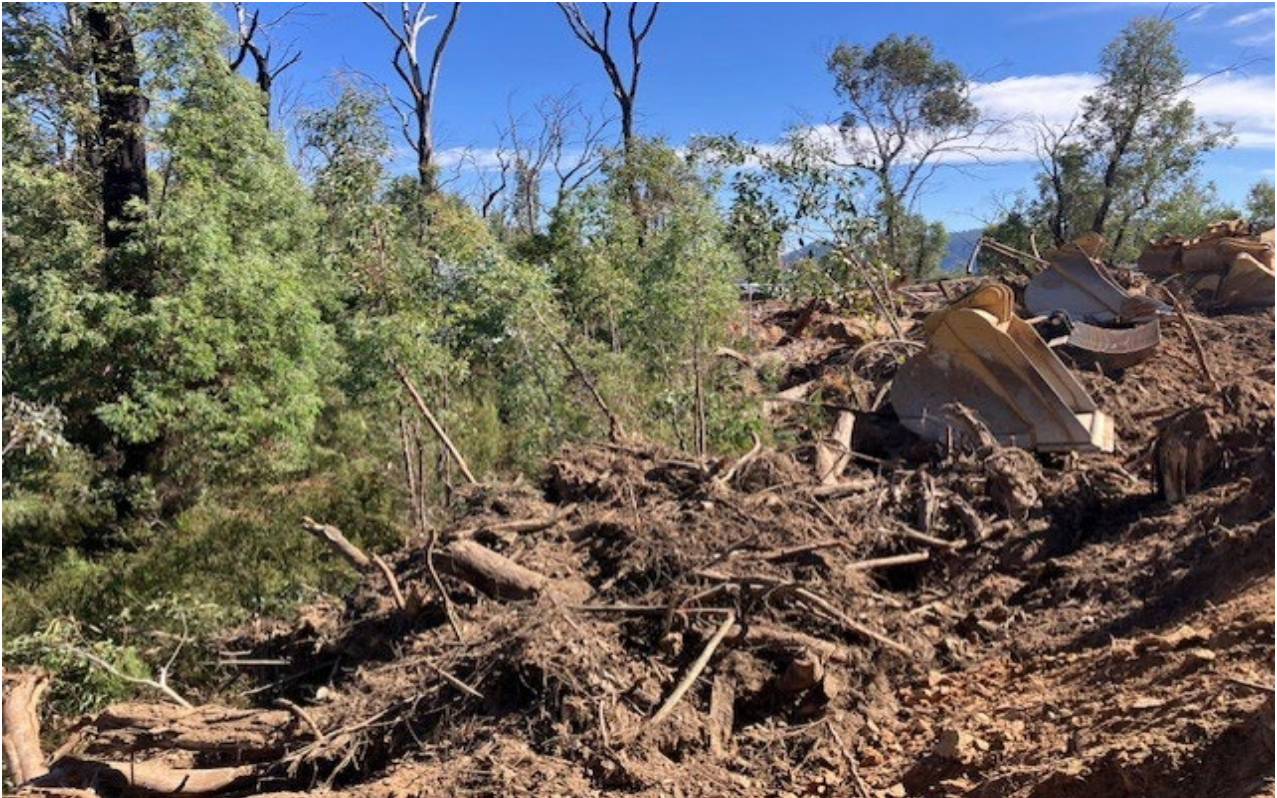
**Plate 3: Example 3 - Clearing observed extending beyond delineated area along Track 5C (Inspection Date: 12/03/2025).**

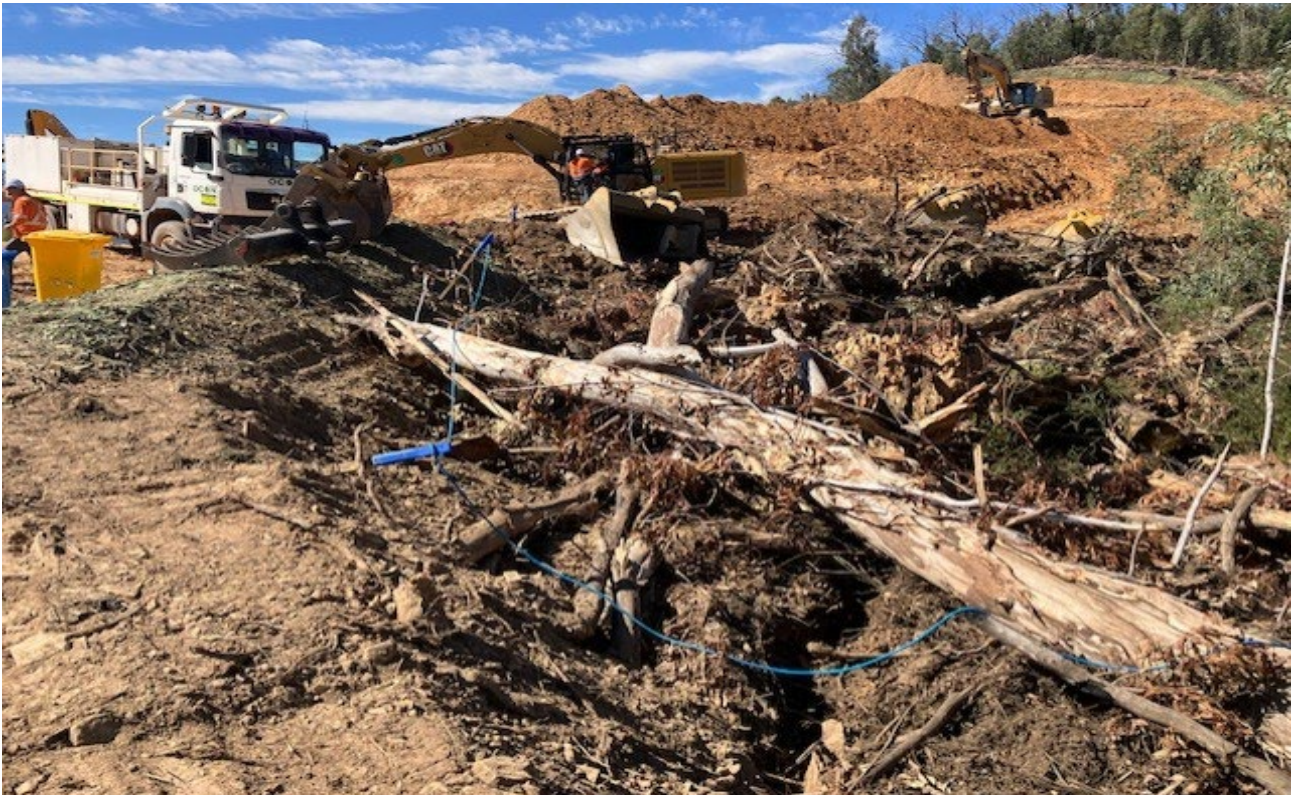
**Plate 4: Blue ropes in place of red ropes was identified along Track 5C (Inspection Date: 12/03/2025).**

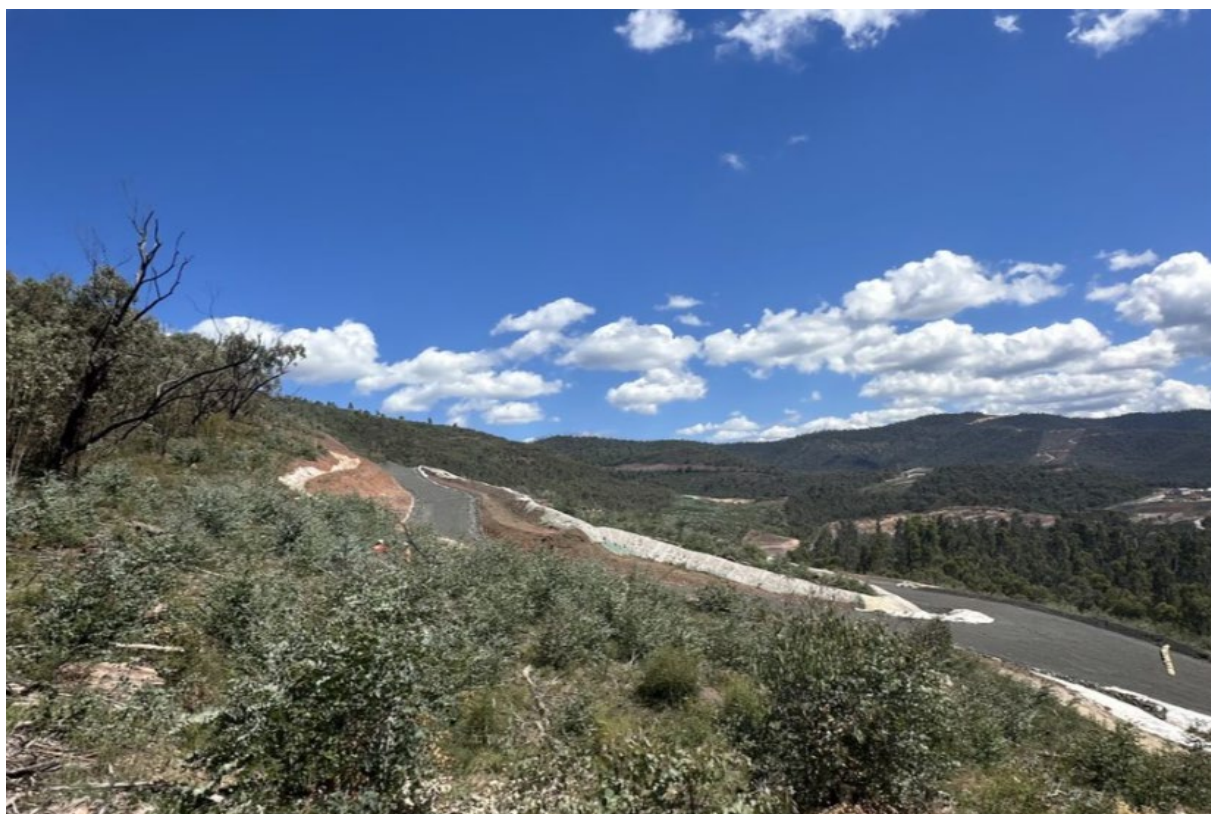
Partial clearing, which is intended to minimise ecological disturbance by preserving ground cover and understorey vegetation, showed mixed implementation across the Project Area. In Project East, hand-cleared areas generally retained native ground cover and an appropriate density of shrubs, aligning with the intended outcomes of the BDAR and BMP (refer to **Plate 5**, **Plate 6** and **Plate 7** in **Appendix 5**).

**Plate 5: Overview of partial clearing area located in Track 8 (Inspection Dated: 12/03/2025).**

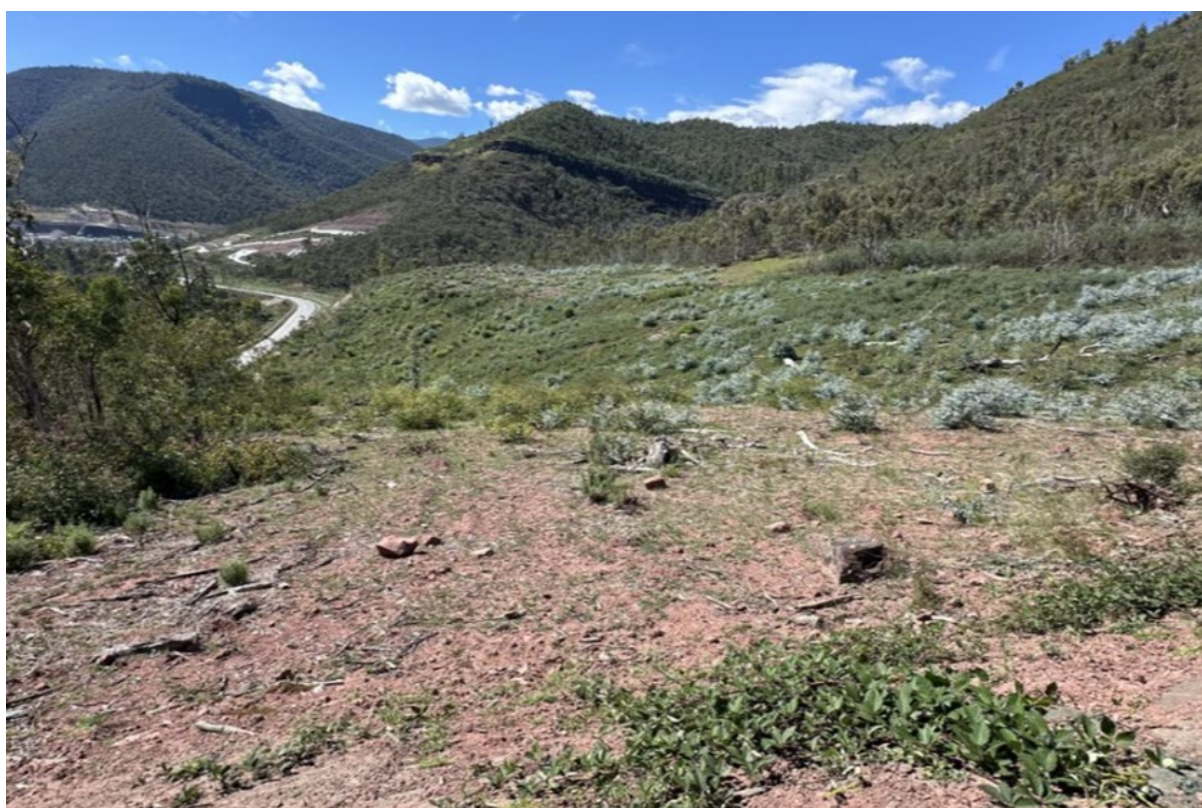
**Plate 6: Comparison of total and partial clearing areas. Partial clearing areas showing persistent groundcover vegetation located within Track 7 (Inspection Date: 12/03/2025).**

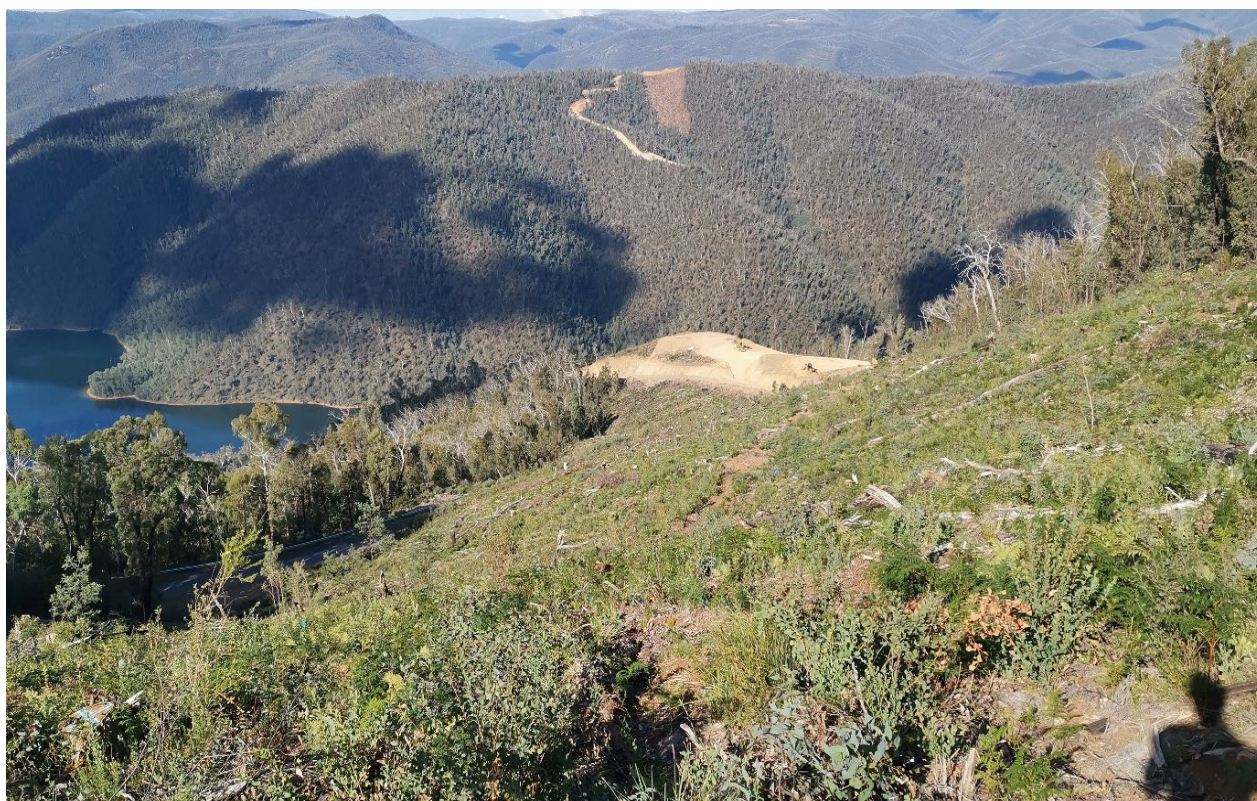
**Plate 7: Track 1 Partial Clearing Zone – Low density of coarse woody mulch observed. Steeper slope has limited mulcher access to the area. Fewer large trees present in the original PCT (Inspection Date: 12/03/2025).**

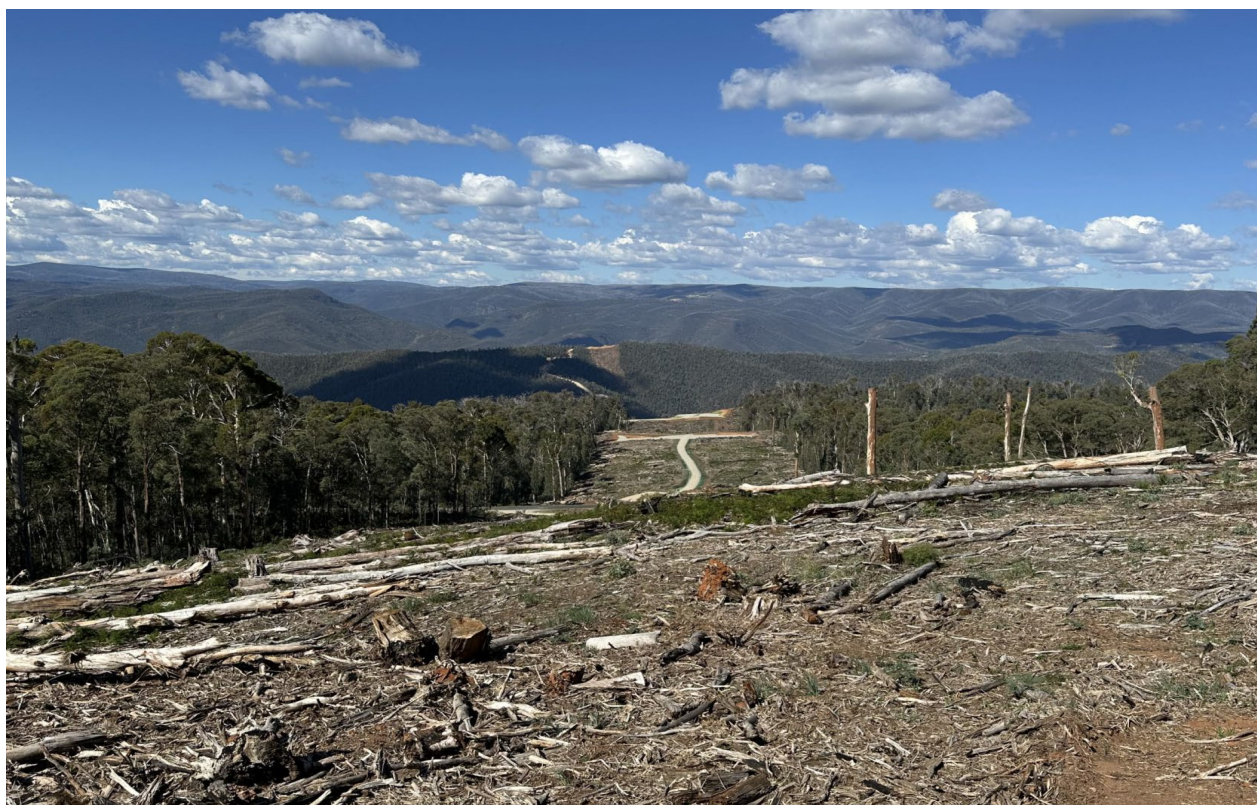
**Plate 8: Areas of partial clearing located within Track 9 (Inspection Date: 12/03/2025).**

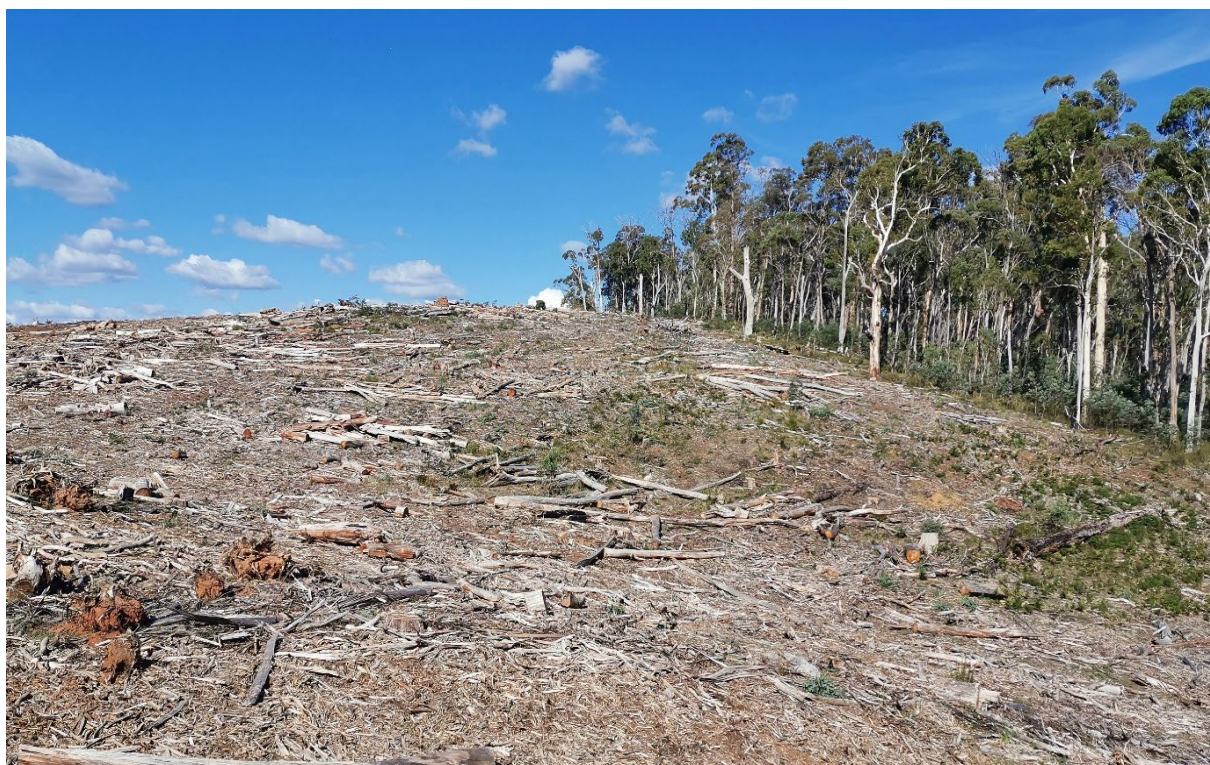
**Plate 9: Track 9 displays reduced mulch cover and depth compared to adjacent patches, with noticeably better ground cover retention in some areas. Signs of compaction and horse activity are also evident (Inspection Date: 12/03/2025).**

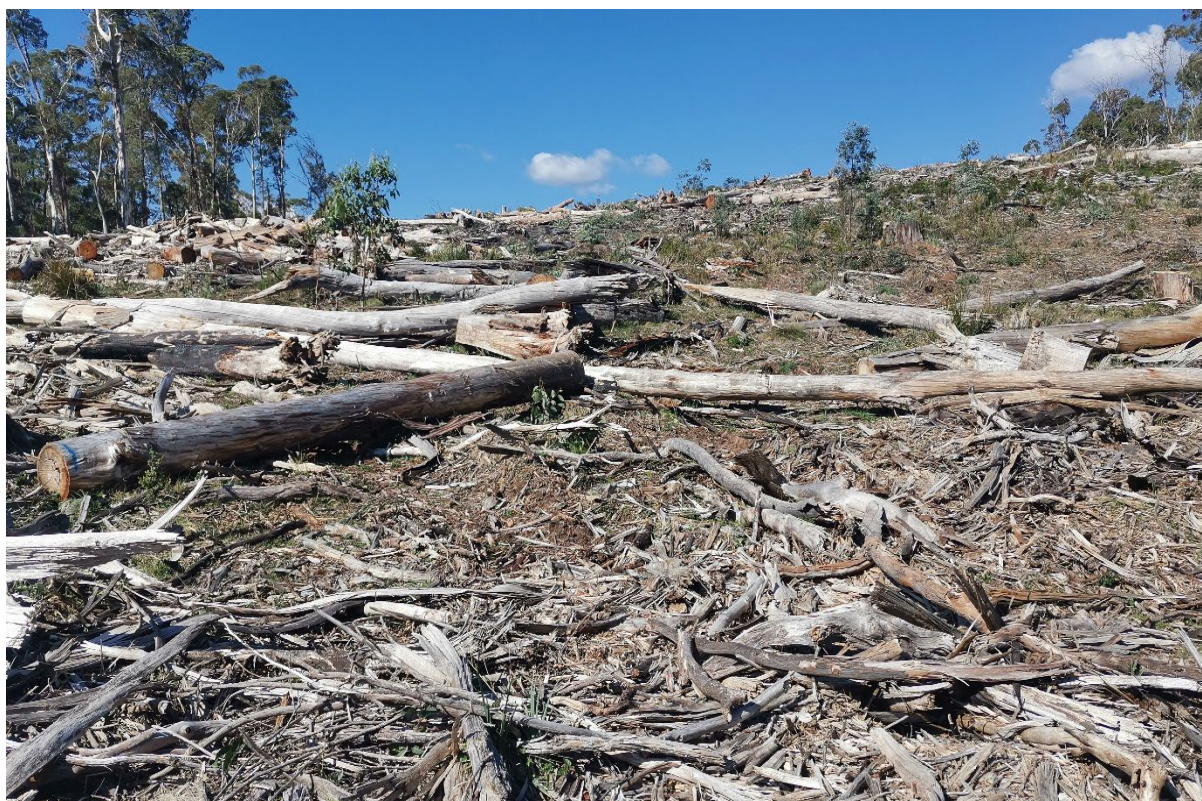
**Plate 10: Track 9 Pad 20 shows mulch depth up to 200 mm, with up to 90% cover in some areas. Blackberry presence noted (Inspection Date: 12/03/2025).**

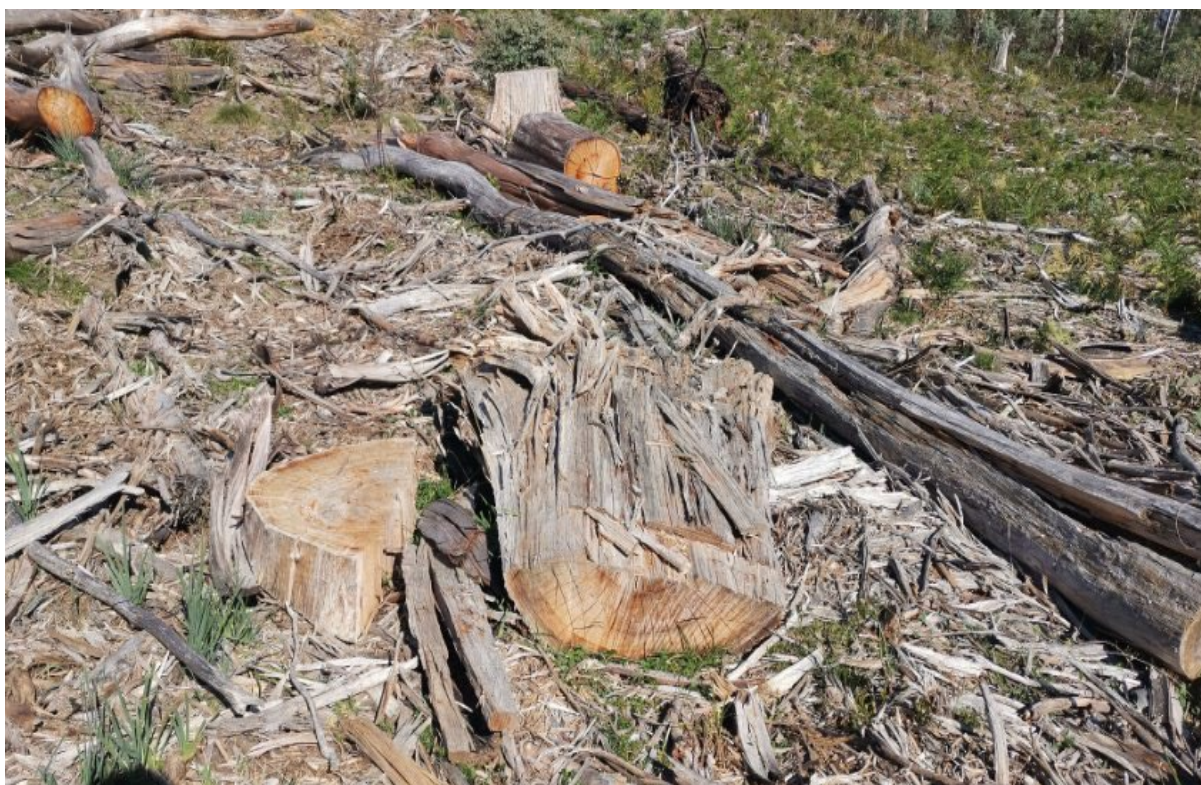
**Plate 11: Track 9 Pad 20 shows mulch depth up to 200 mm, with up to 90% cover in some areas. (Inspection Date: 12/03/2025).**

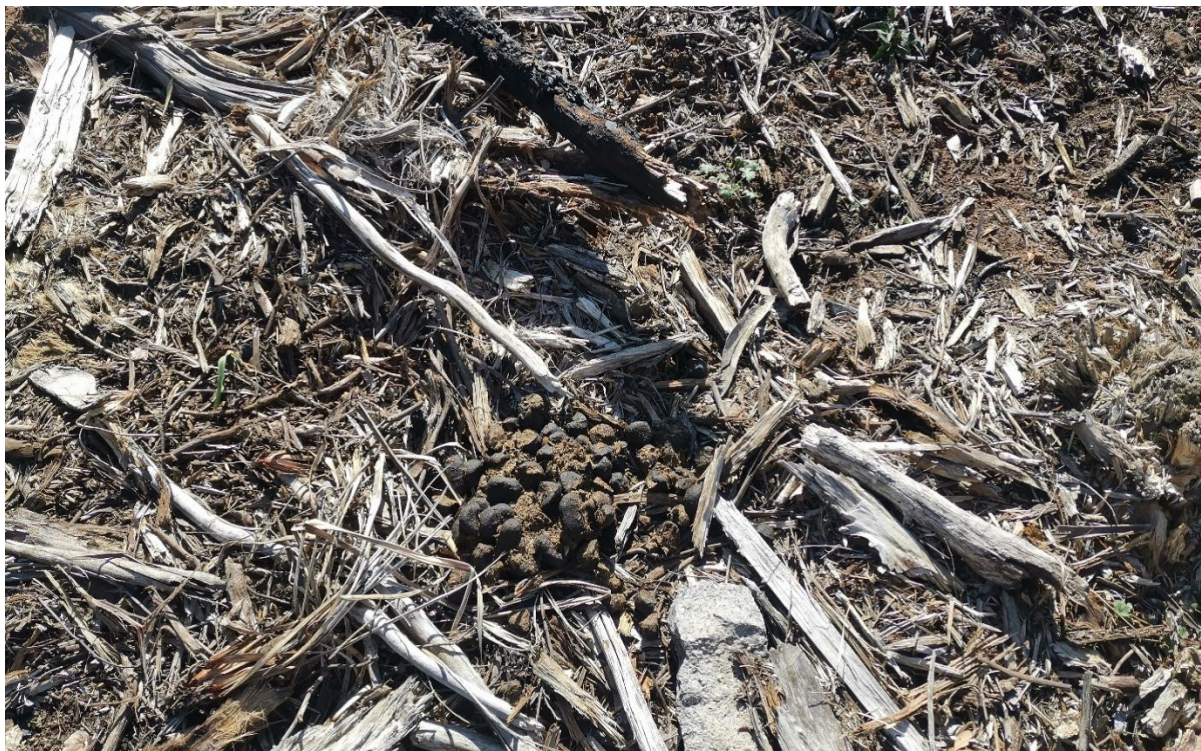
**Plate 12: Partial clearing zones observed on Track 9 Pad 18. Mulch cover decreases with distance from the tower pad. No shrub cover present; some ground cover regeneration observed. Large mulch debris covers approximately 40%, with variable depth (Inspection Date: 12/03/2025).**

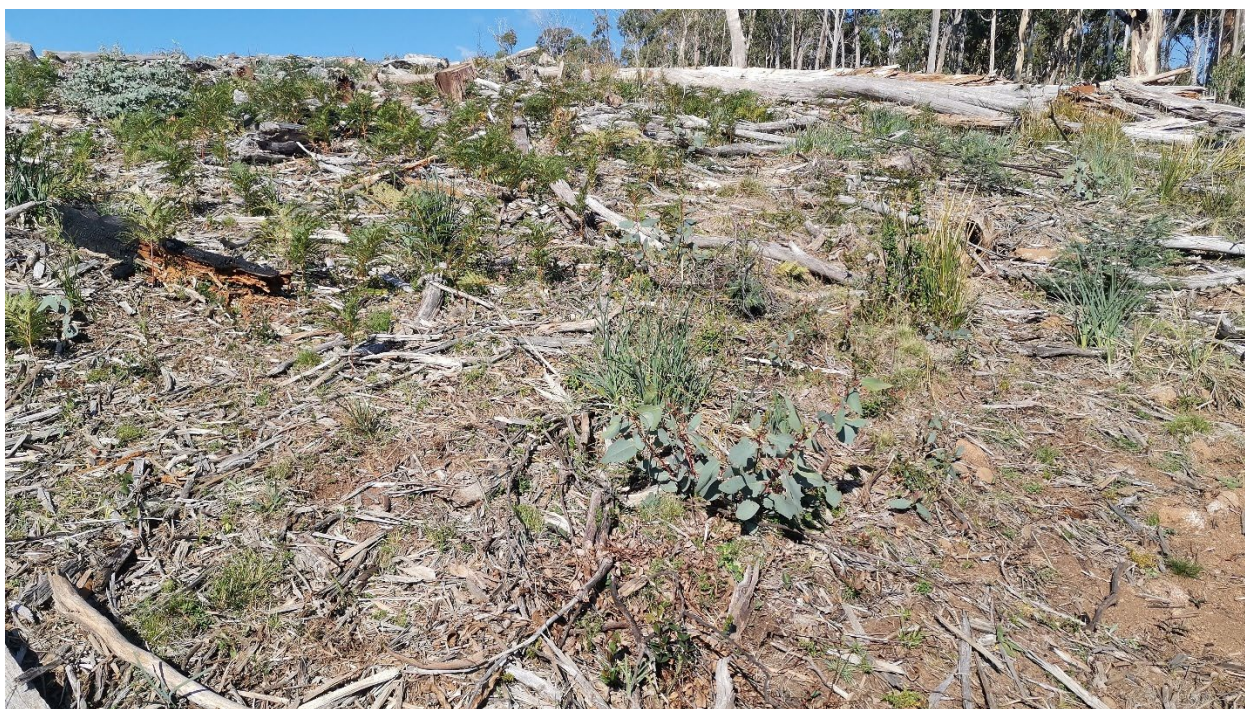
**Plate 13: Some partial clearing zones observed on Track 9 indicate less mulch cover and depth compared to adjoining patches, some regeneration of ground covers, compaction evident, horse activity evident (Inspection Date: 12/03/2025).**

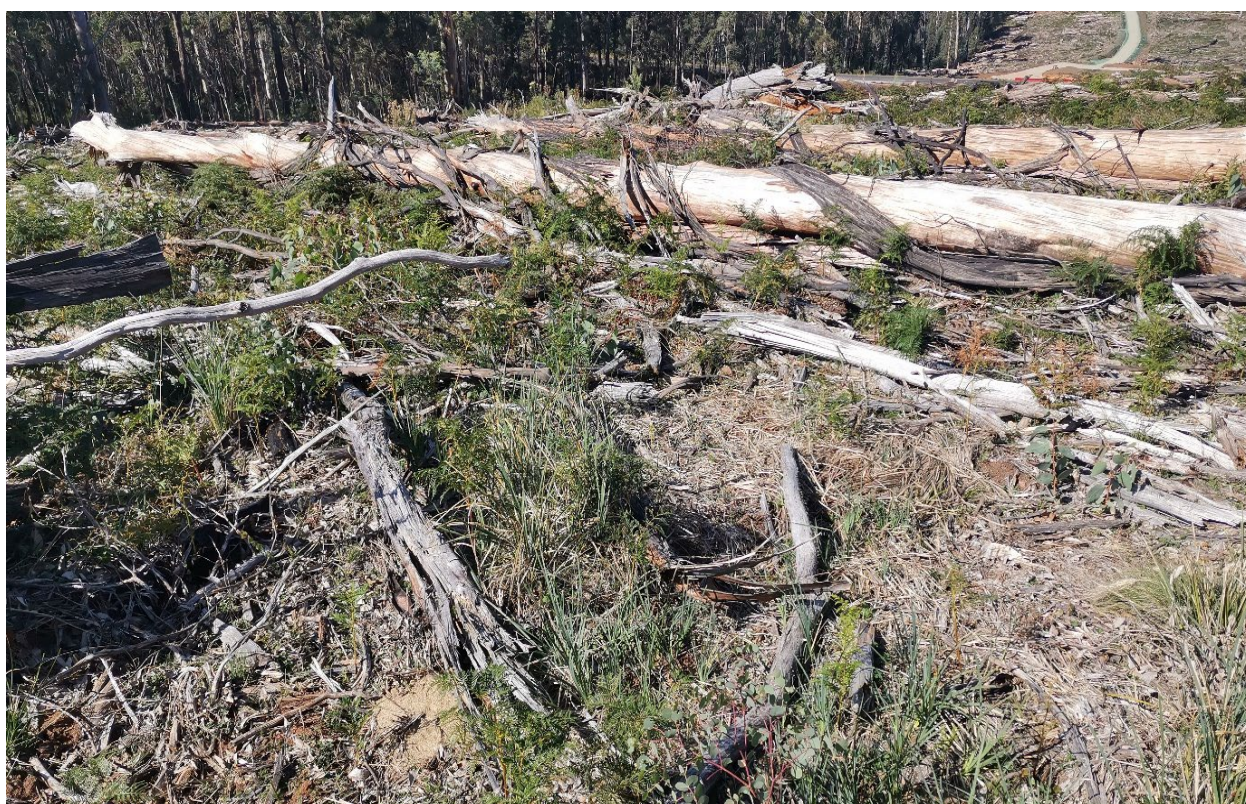
**Plate 14: Partial clearing zones observed on Track 9 Pad 18. Mulch cover decreases with distance from the tower pad. No shrub cover present; some ground cover regeneration observed. Large mulch debris covers approximately 40%, with variable depth (Inspection Date: 12/03/2025).**

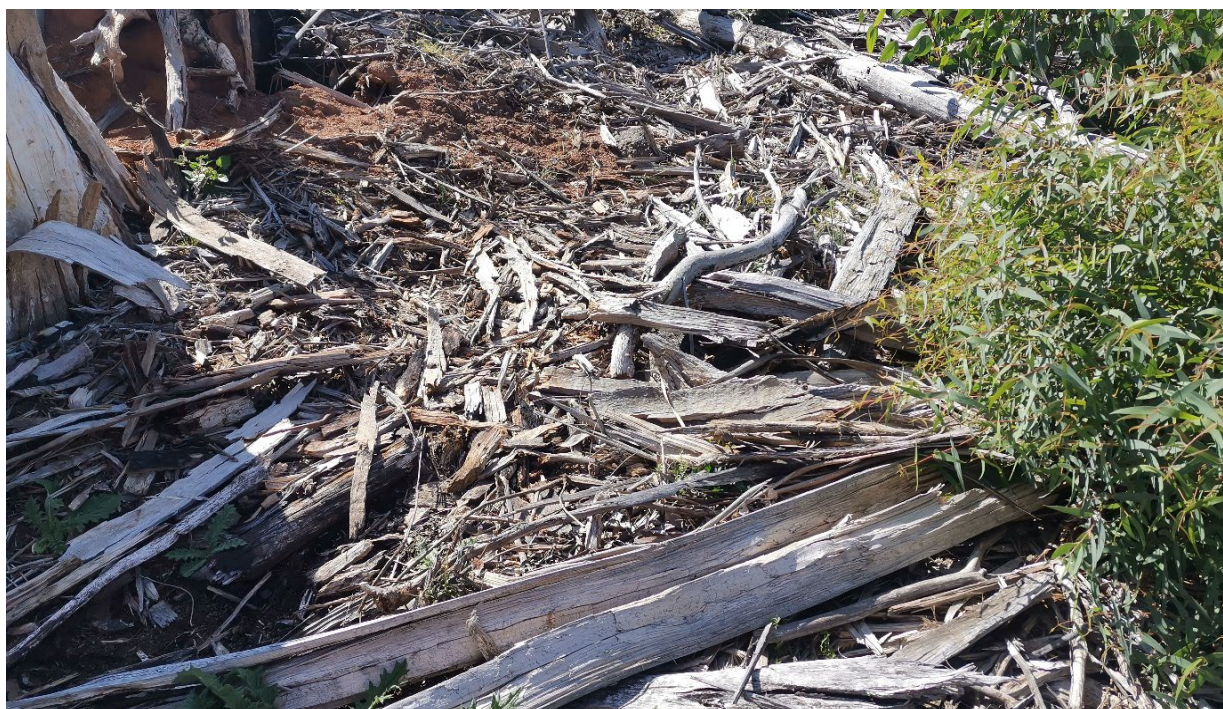
**Plate 15: Track 9 Pad 18 – Mulch cover decreases with distance from the tower pad. No shrub cover present; some ground cover regeneration observed. Large mulch debris covers approximately 40%, with varying depth (Inspection Date: 12/03/2025).**

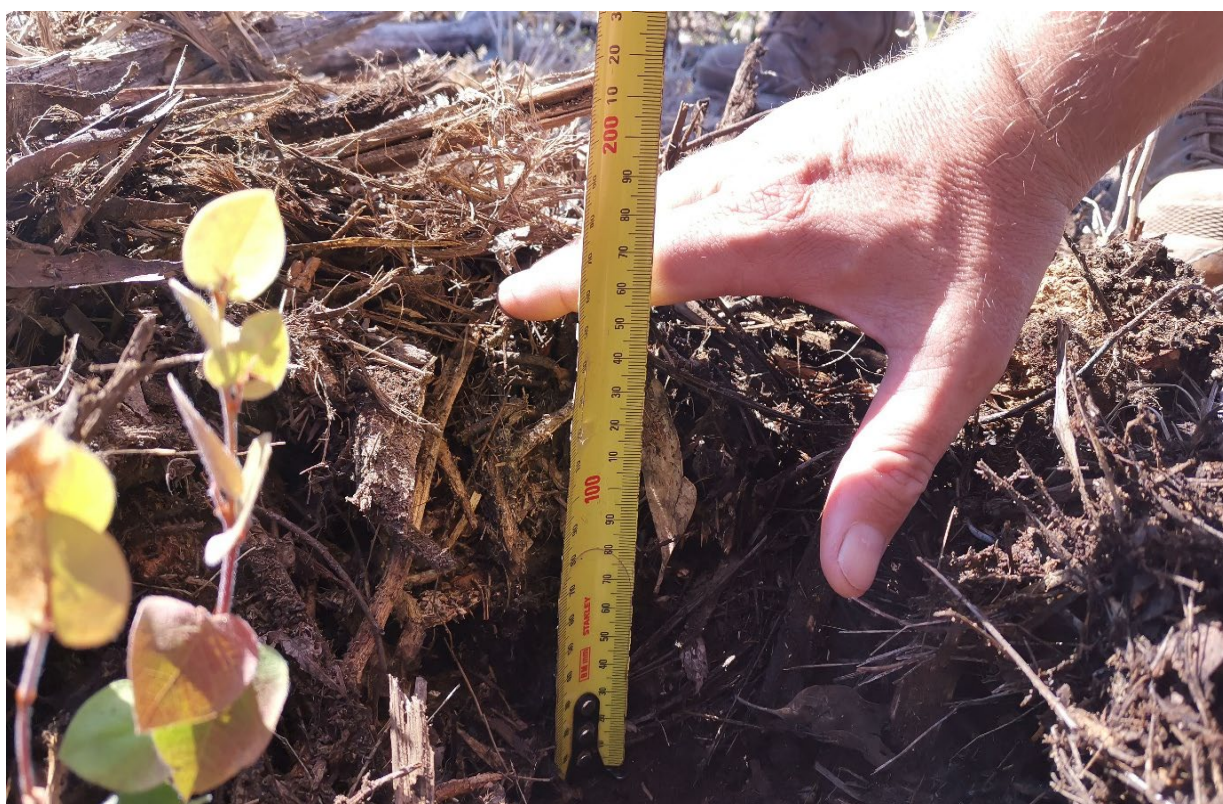
**Plate 16: Track 9 shows a patch with reduced mulch cover and depth compared to adjoining areas. Ground cover retention is notably better, with evidence of compaction and horse activity (Inspection Date: 12/03/2025).**

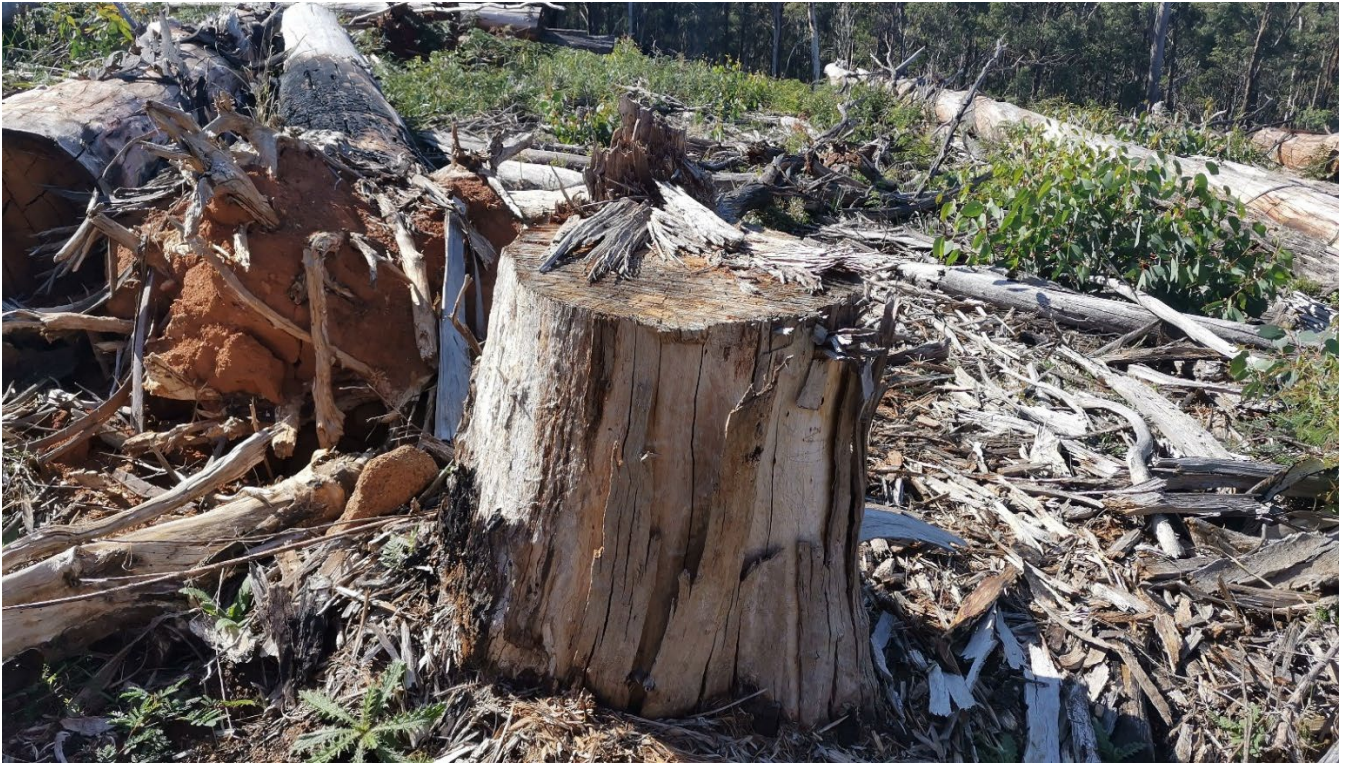
**Plate 17: Partial clearing zones observed on Track 9 Pad 18. Mulch cover decreases with distance from the tower pad. No shrub cover present; some ground cover regeneration observed. Large mulch debris covers approximately 40%, with variable depth (Inspection Date: 12/03/2025).**

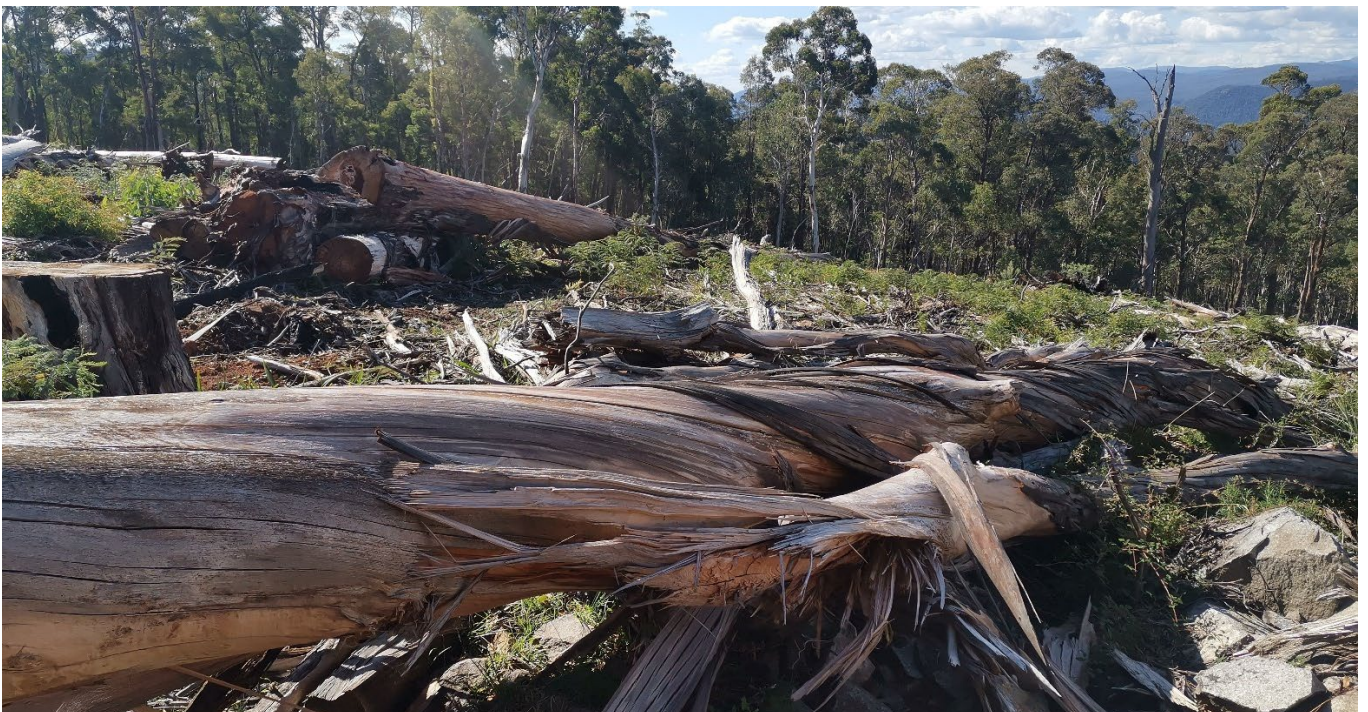
**Plate 18: Partial clearing zones observed on Track 9 Pad 18. Mulch cover decreases with distance from the tower pad. No shrub cover present; some ground cover regeneration observed. Large mulch debris covers approximately 40%, with variable depth (Inspection Date: 12/03/2025).**

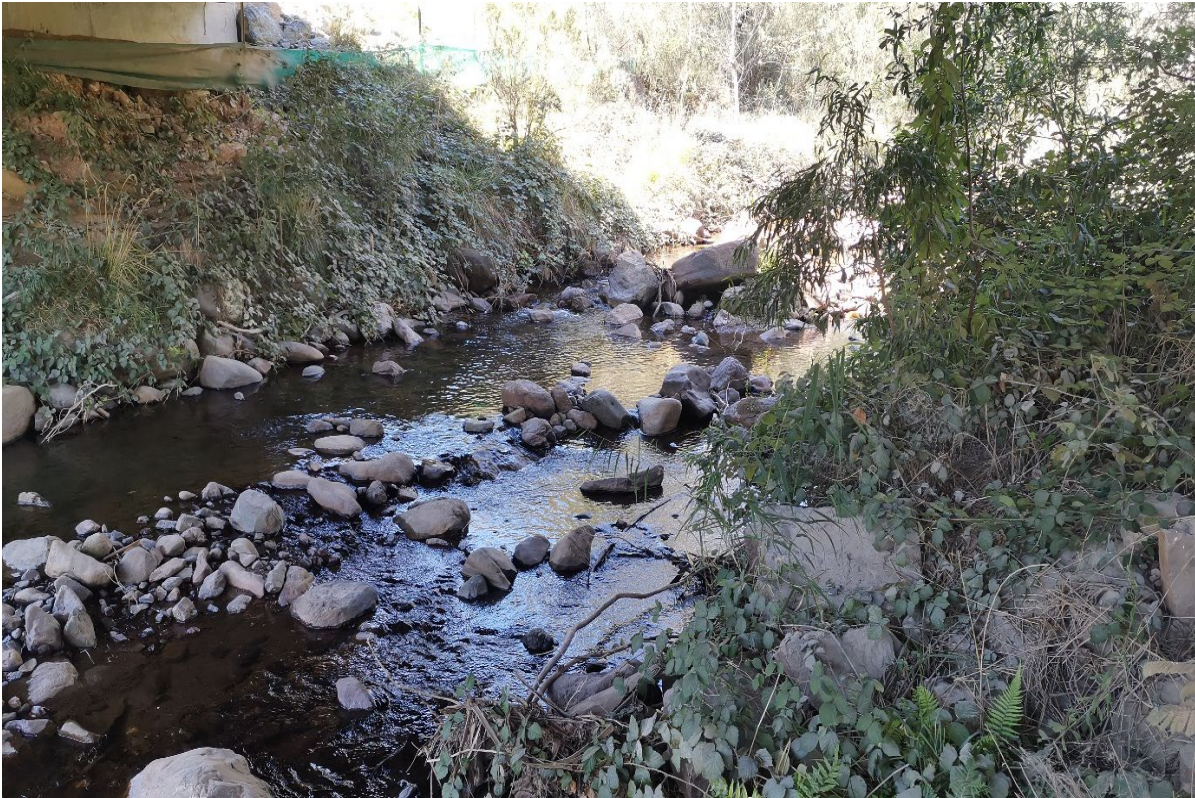
**Plate 19: Wallaces Creek – Booroolong Frog Habitat (Inspection Date: 12/03/2025).**

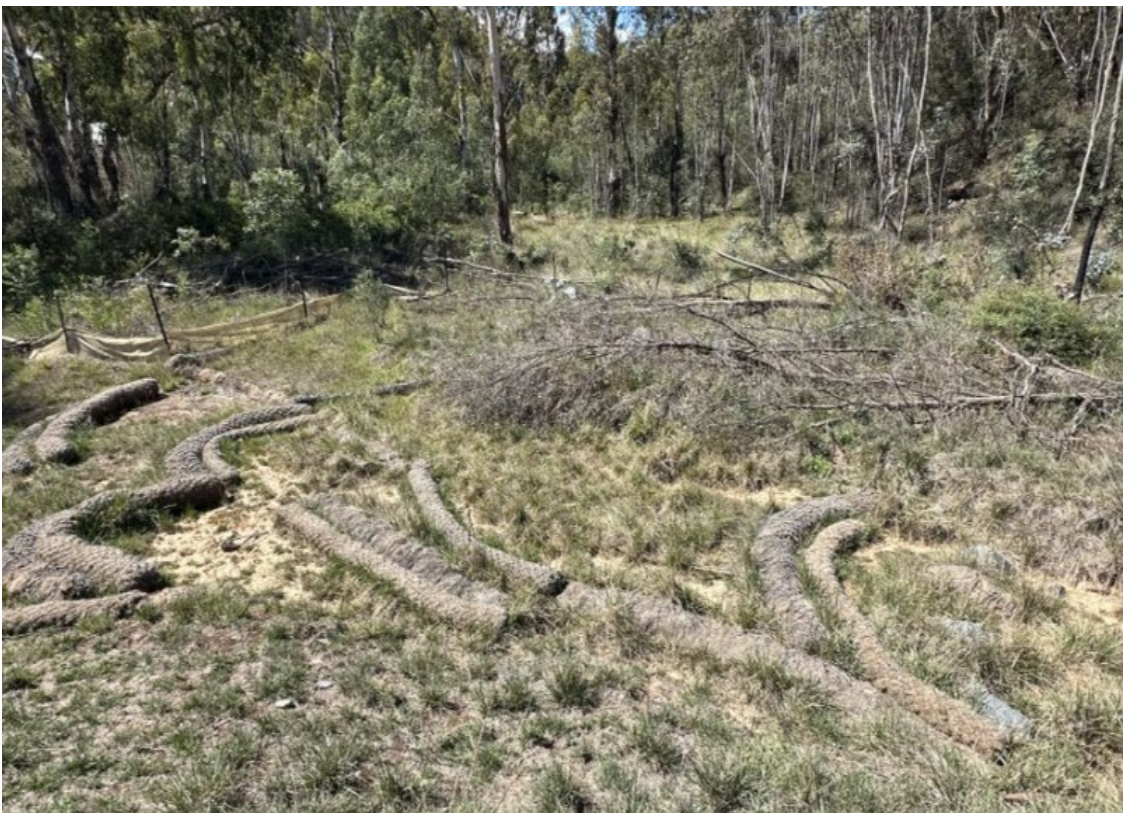
**Plate 20: Erosion and sediment controls leading into Wallaces Creek (Inspection Date: 12/03/2025).**

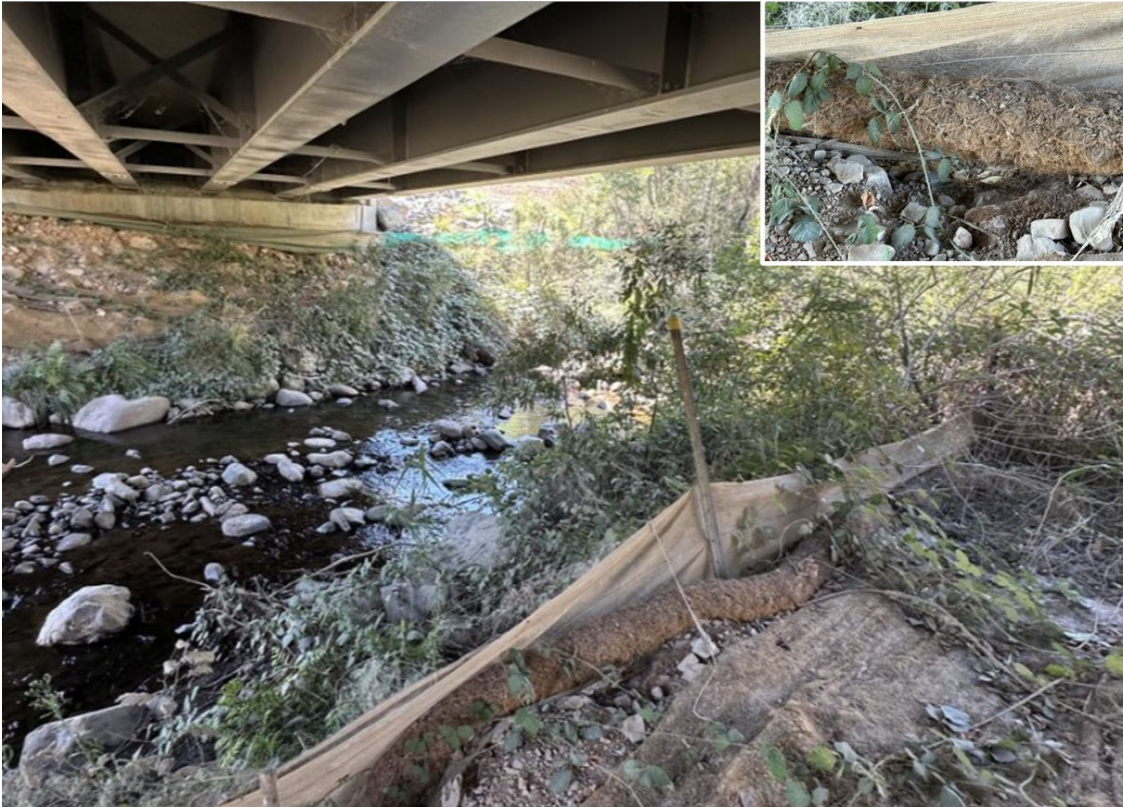
**Plate 21: Erosion and sediment controls located on edge of Wallace Creek. Sediment fences were observed not embedded (Inspection Date: 12/03/2025).**
