**Subject: Snowy 2.0 - Transmission Connection - Construction Independent Environmental Audit #3**

**SNOWY 2.0 TRANSMISSION  
CONNECTION PROJECT**

**FINAL**

July 2025

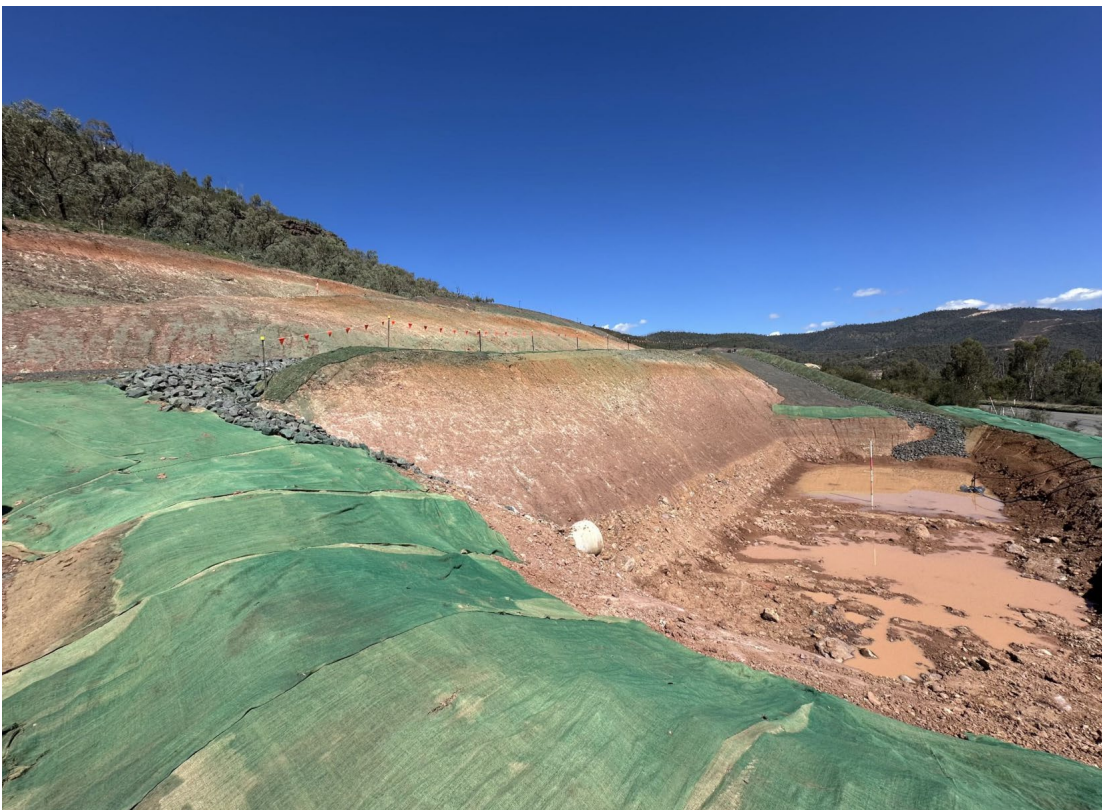
**Plate 22: Sediment basin located near the base of Track 8 (Inspection Date: 12/03/2025).**

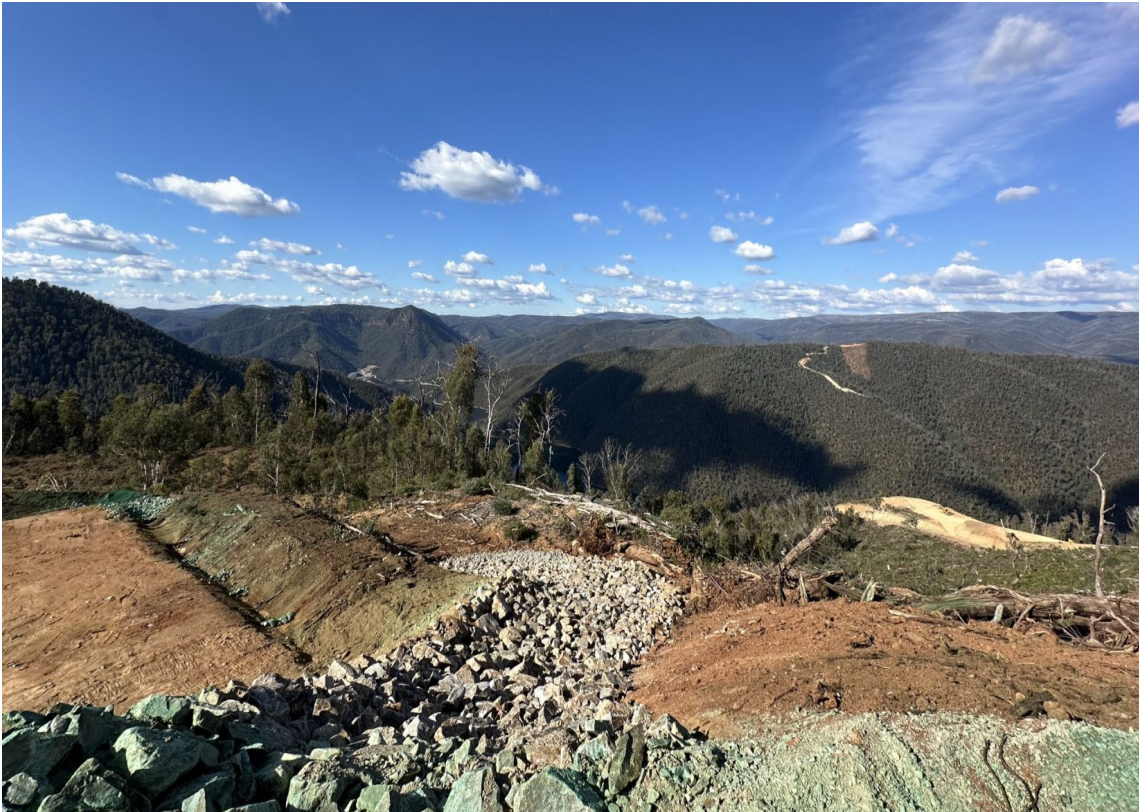
**Plate 23: Rock drains located along the western alignment (Inspection Date: 12/03/2025).**

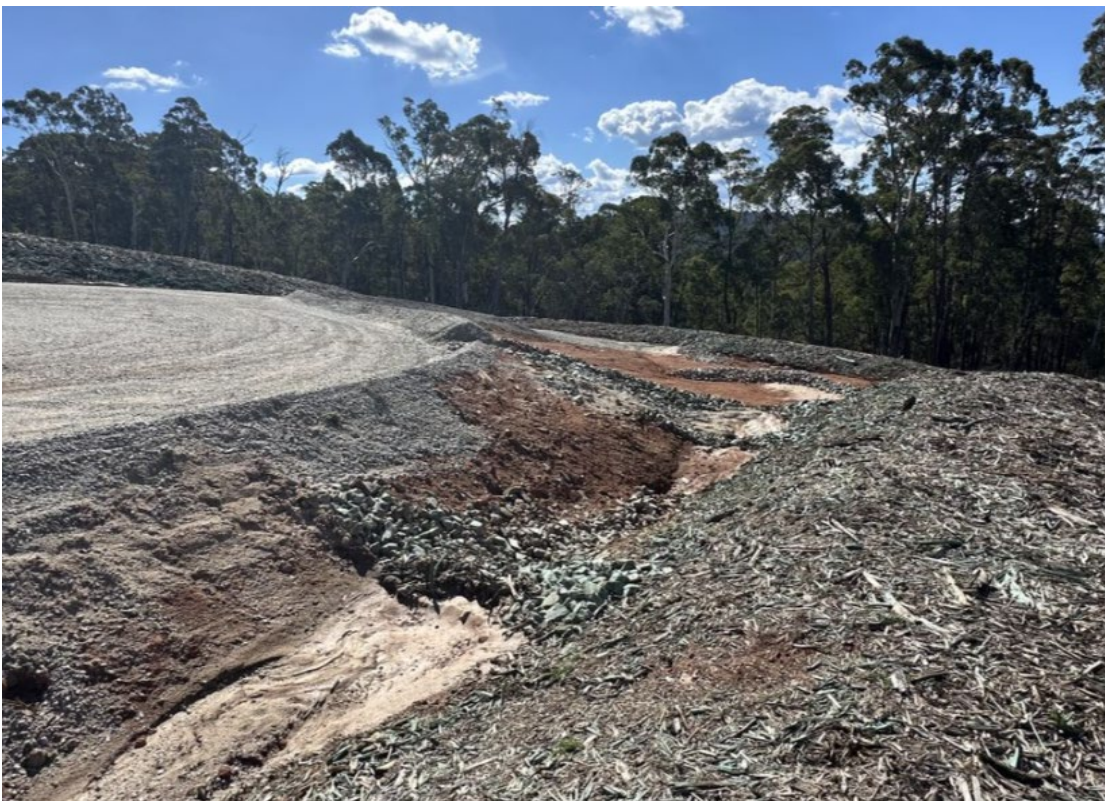
**Plate 24: Rock drains located along the western alignment (Inspection Date: 12/03/2025).**

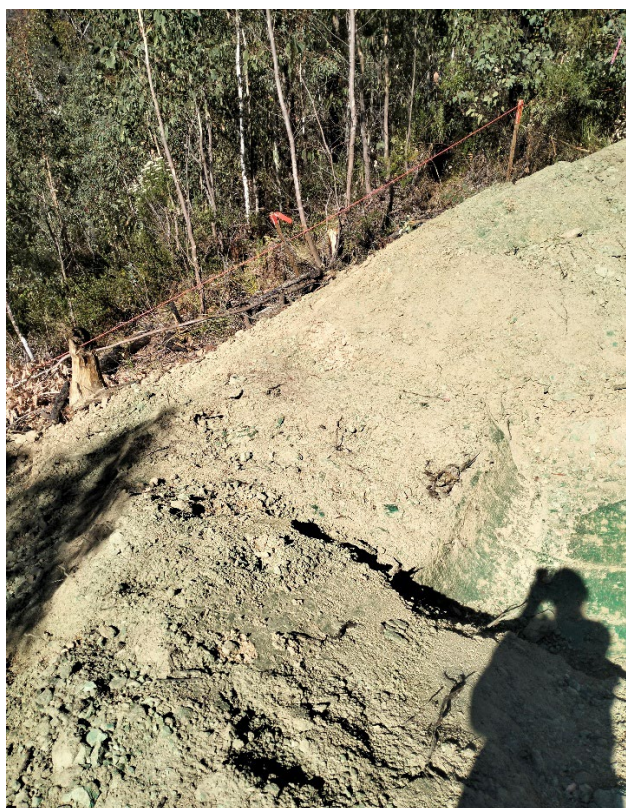
**Plate 26: Track 4 Sediment trap, evidence of soil binder present however outlet is unlined (Inspection Date: 12/03/2025).**

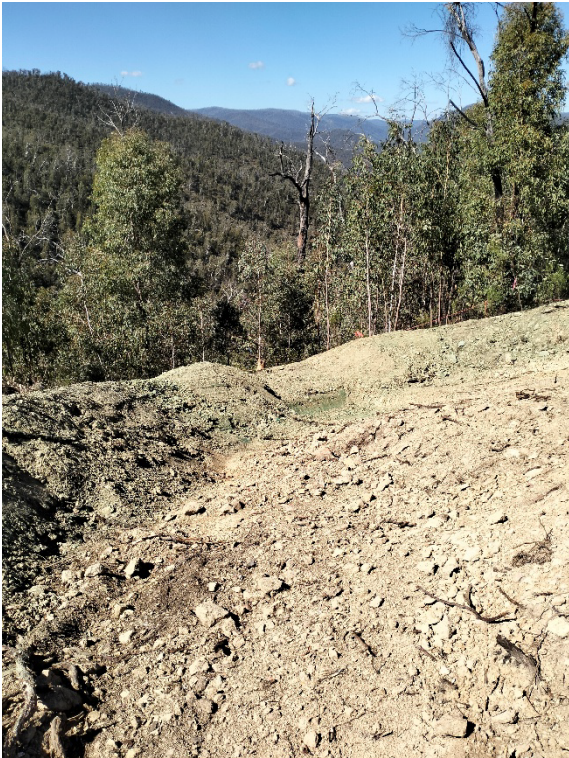
**Plate 27: Track 4 Sediment trap, evidence of soil binder present however outlet is unlined (Inspection Date: 12/03/2025).**

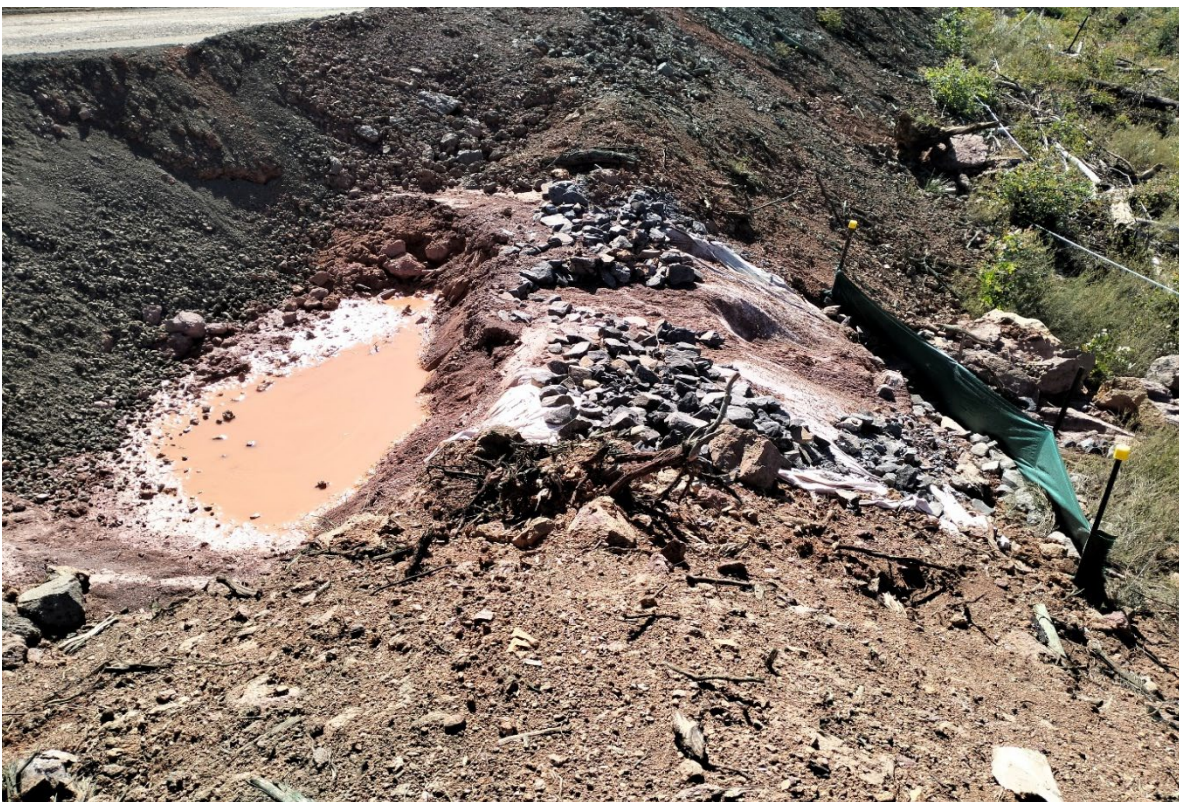
**Plate 28: Track 5 Sediment Trap with evidence of sediment overflow in outlet (Inspection Date: 12/03/2025).**

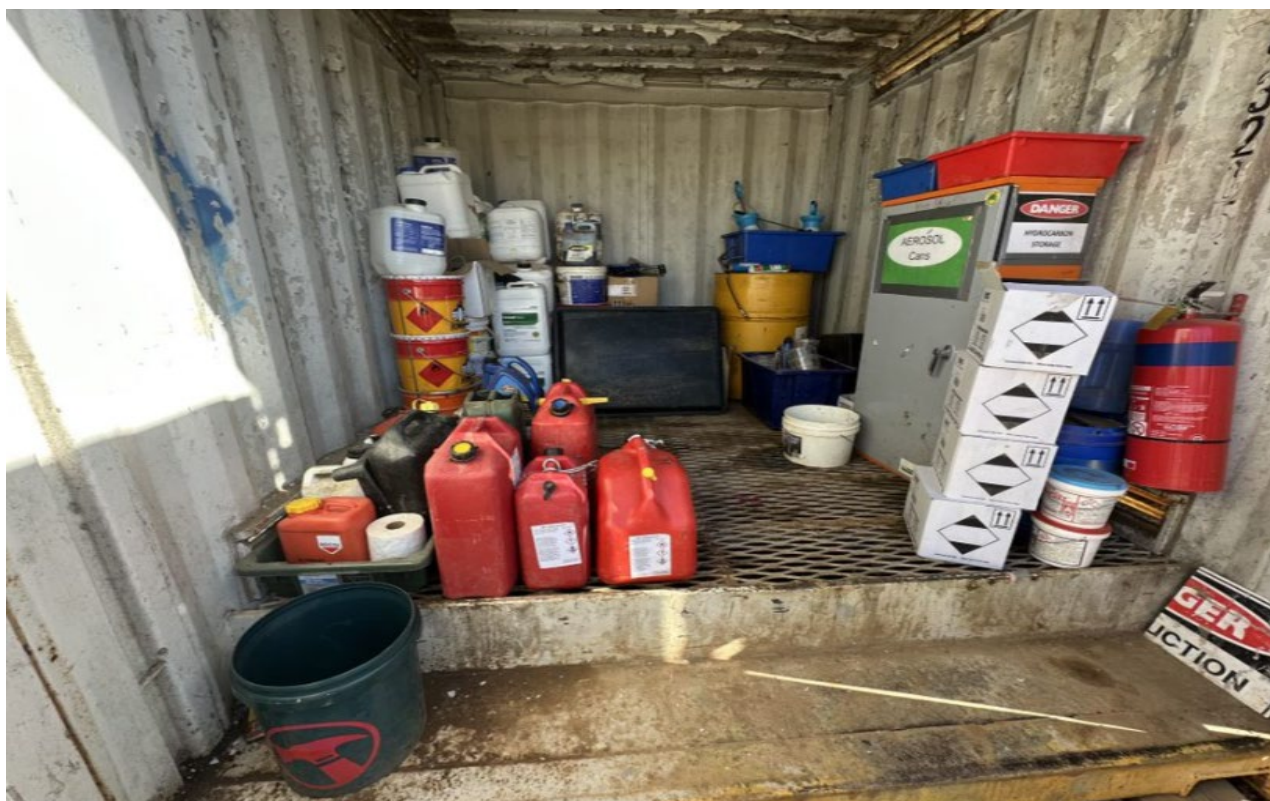
**Plate 29: Interior view of the bunded chemical storage area at the Maragle Project Construction Compound (Inspection Date: 13/03/2025).**

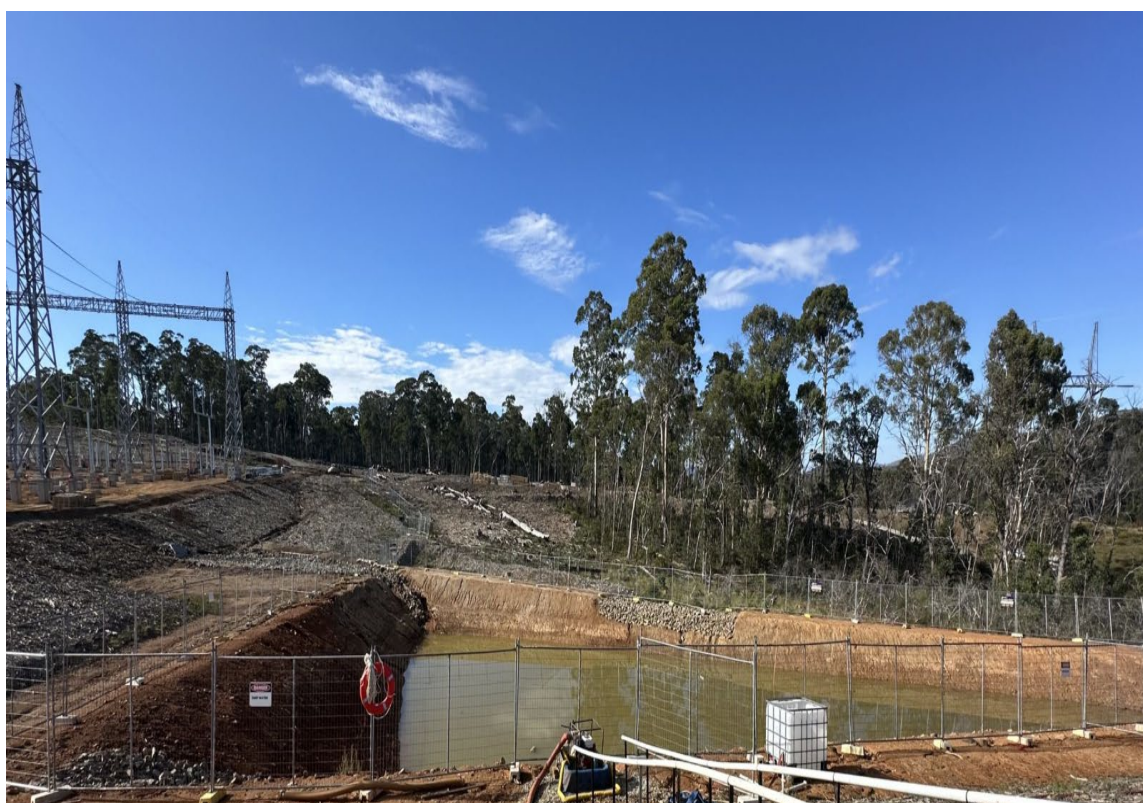
**Plate 30: Sediment basin at the Maragle Project Construction Compound (Inspection Date: 12/03/2025).**

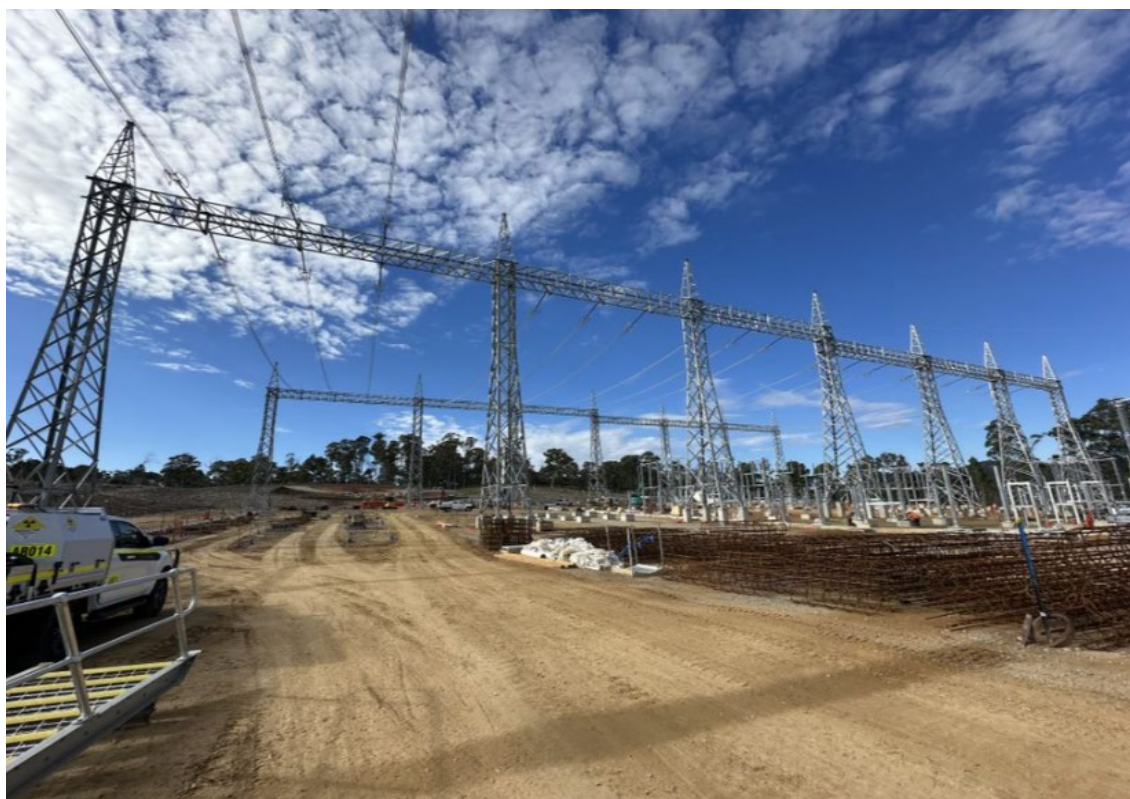
**Plate 31: Overview of multiple gantries constructed at the Maragle Substation Project Area (Inspection Date: 13/03/2025).**

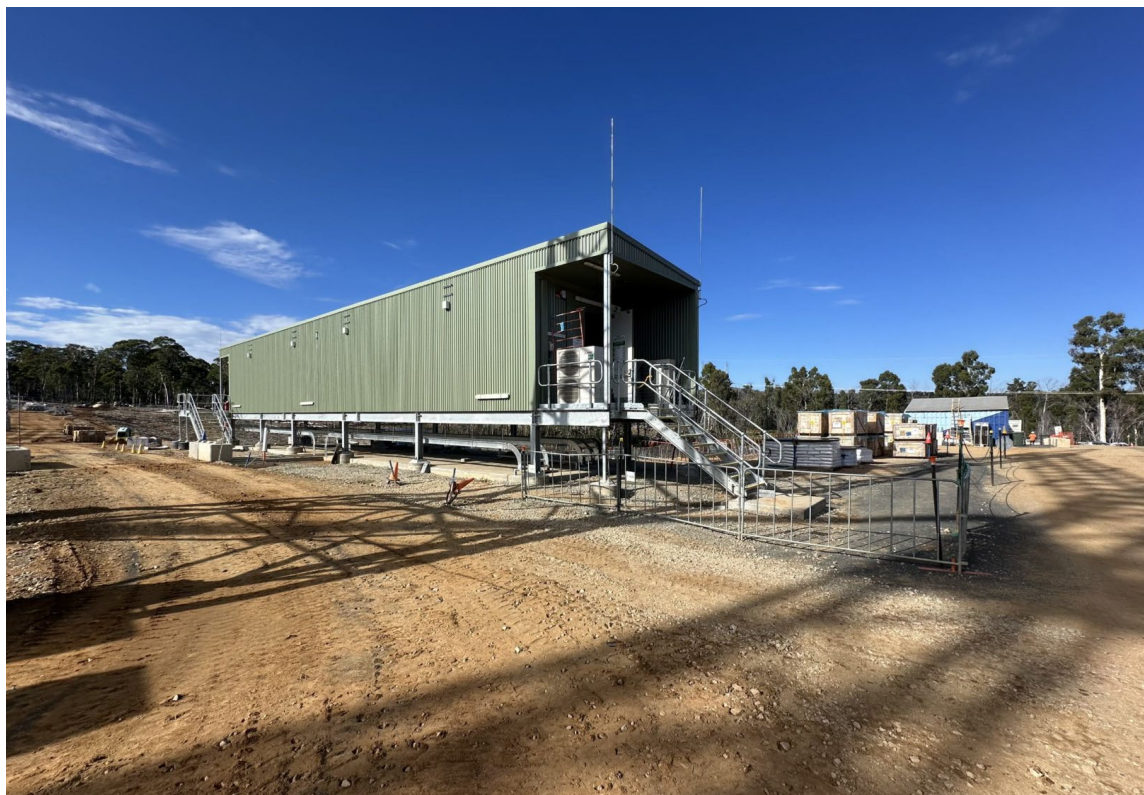
**Plate 32: Ongoing installation of the auxiliary building at the Maragle Substation Project Area (Inspection Date: 13/03/2025).**

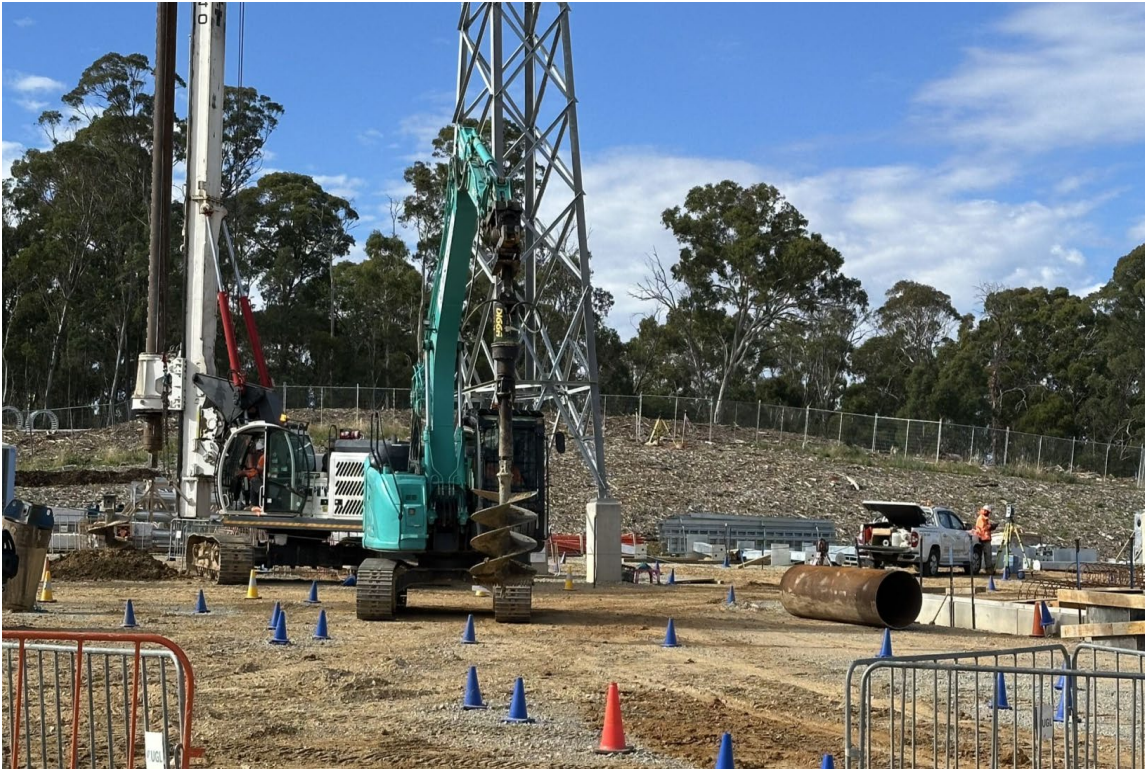
**Plate 33: Construction plant observed was in good condition, appearing to be well maintained and operated in a safe and efficient manner located within Maragle Substation Project Area (Inspection Date: 13/03/2025).**

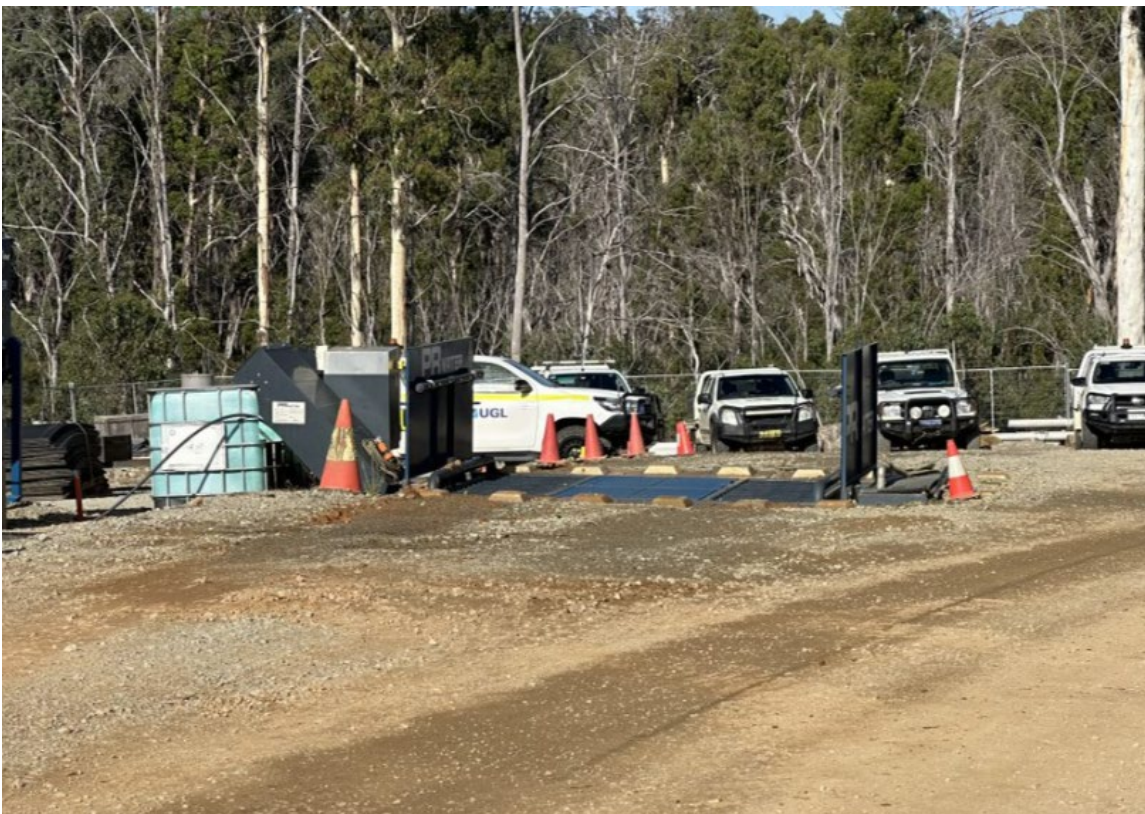
**Plate 34: Wheel washing station located within the Maragle Project Construction Compound (Inspection Date: 13/03/2025).**

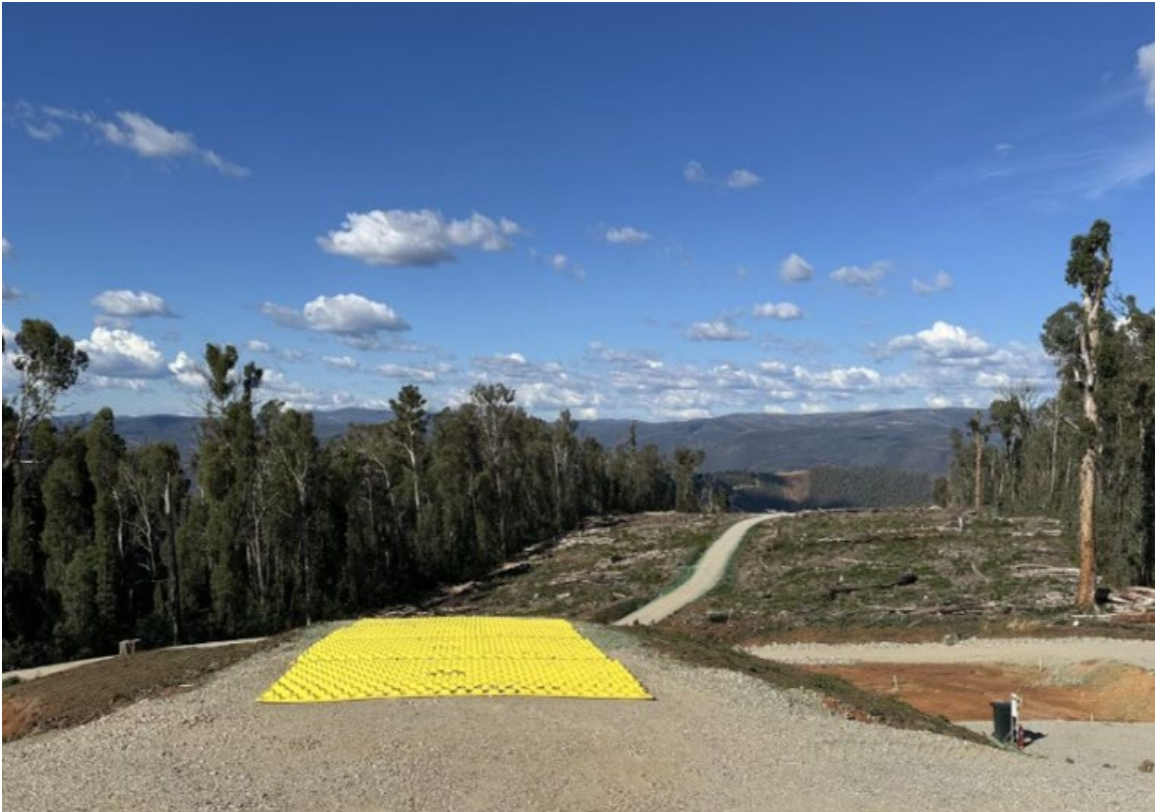
**Plate 35: Rumble girds installed at the entrance and exit of Track 10 (Inspection Date: 12/03/2025).**

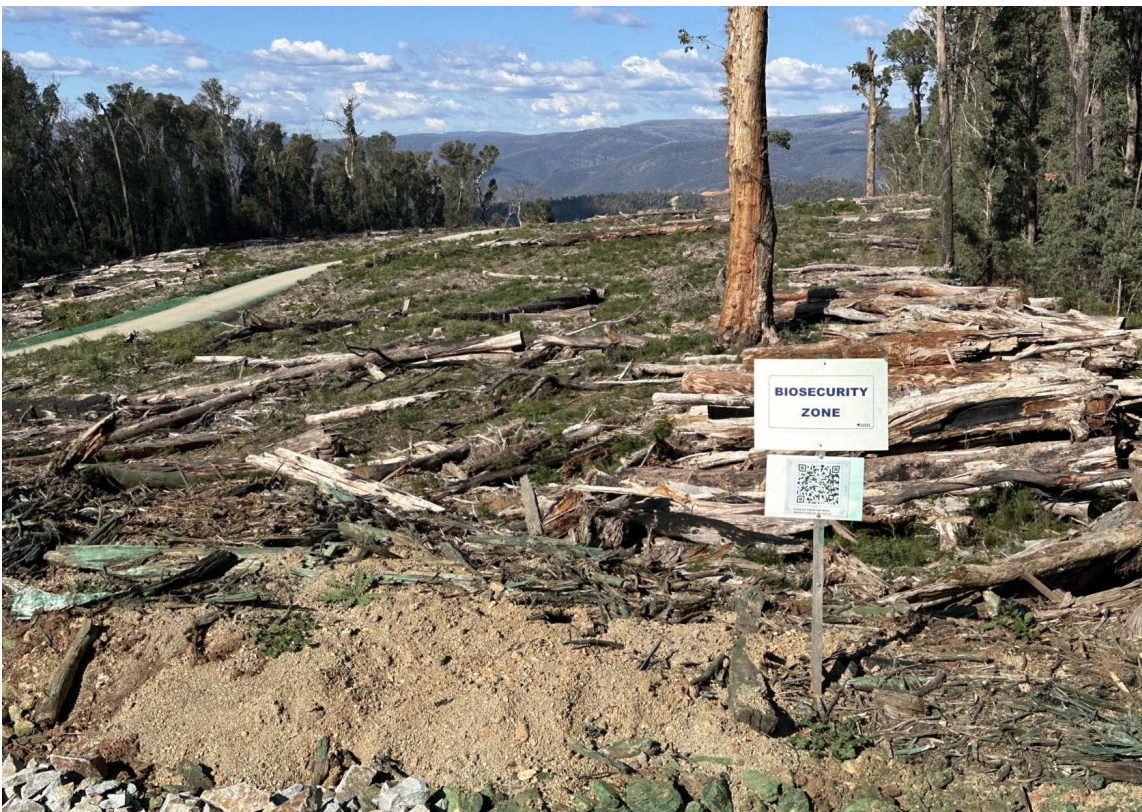
**Plate 36: Signposted Biosecurity Zones with QR codes observed in Track 10 (Inspection Date: 13/03/2025).**

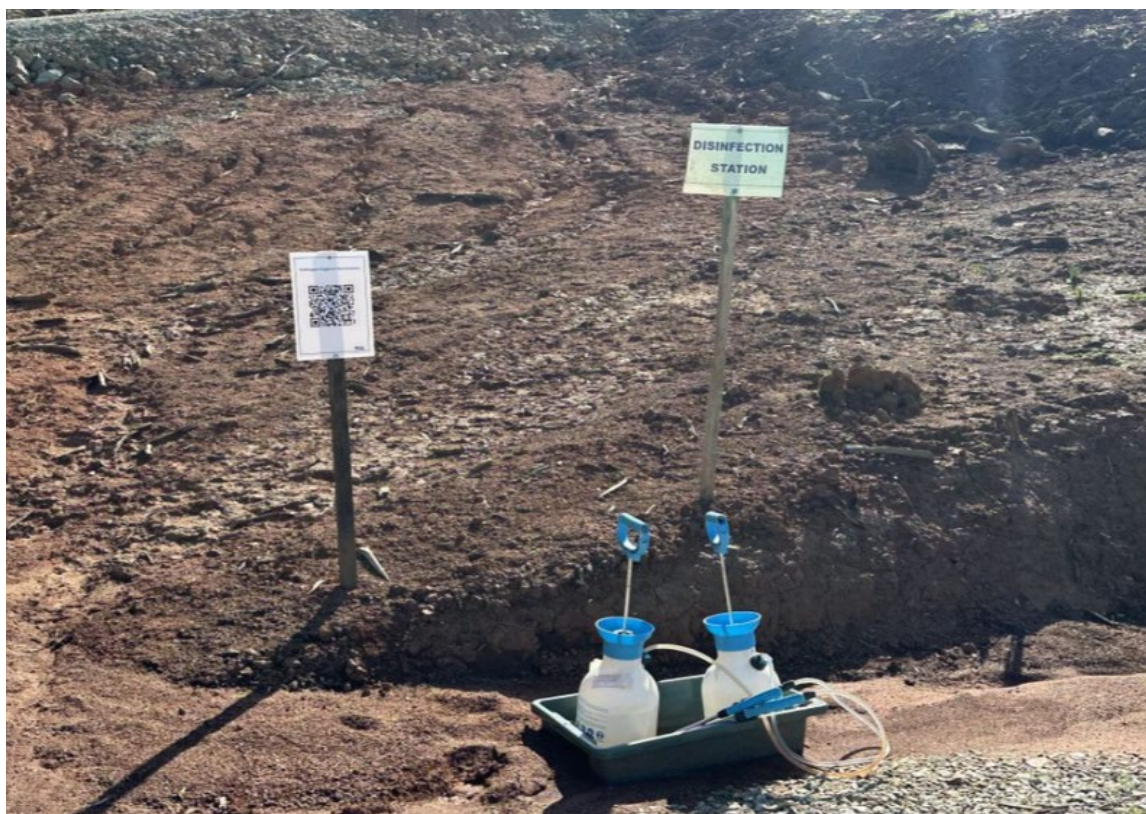
**Plate 37: Disinfection stations with accompanying QR codes observed in Track 10 (Inspection Date: 12/03/2025).**

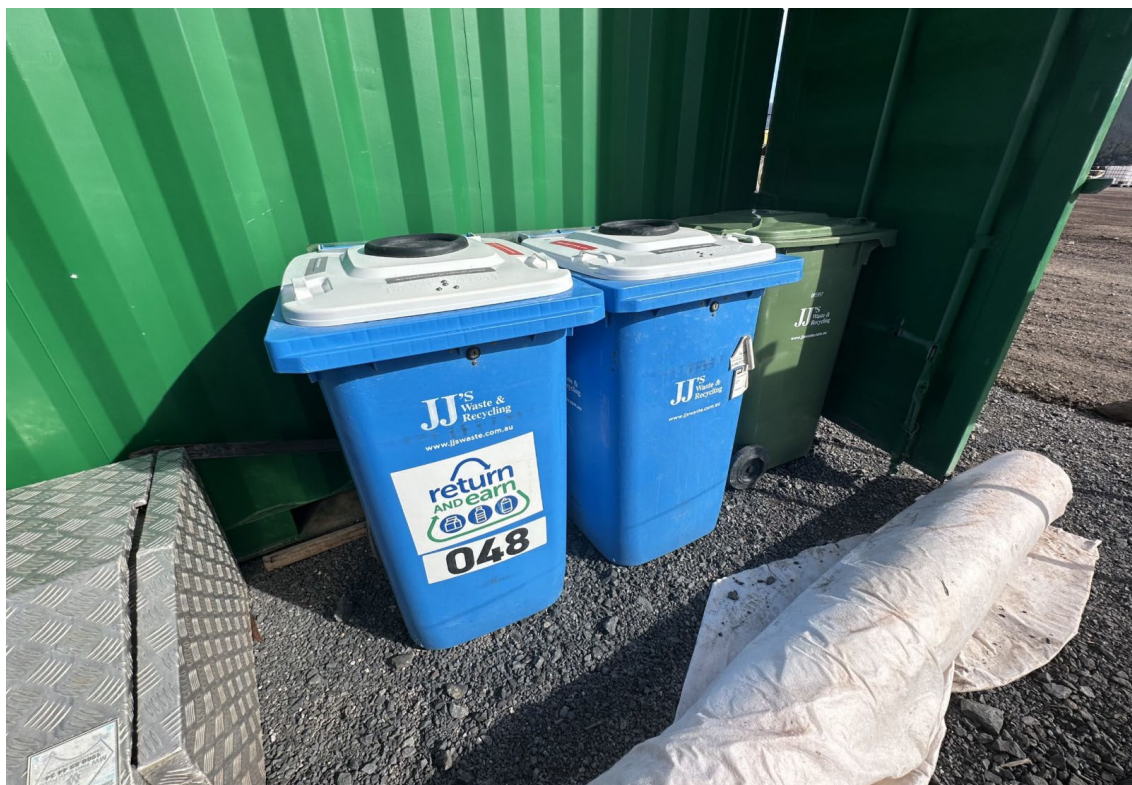
**Plate 38: Waste segregated into designated waste bins located within Lobs Hole Project Compound (Inspection Date: 12/03/2025).**

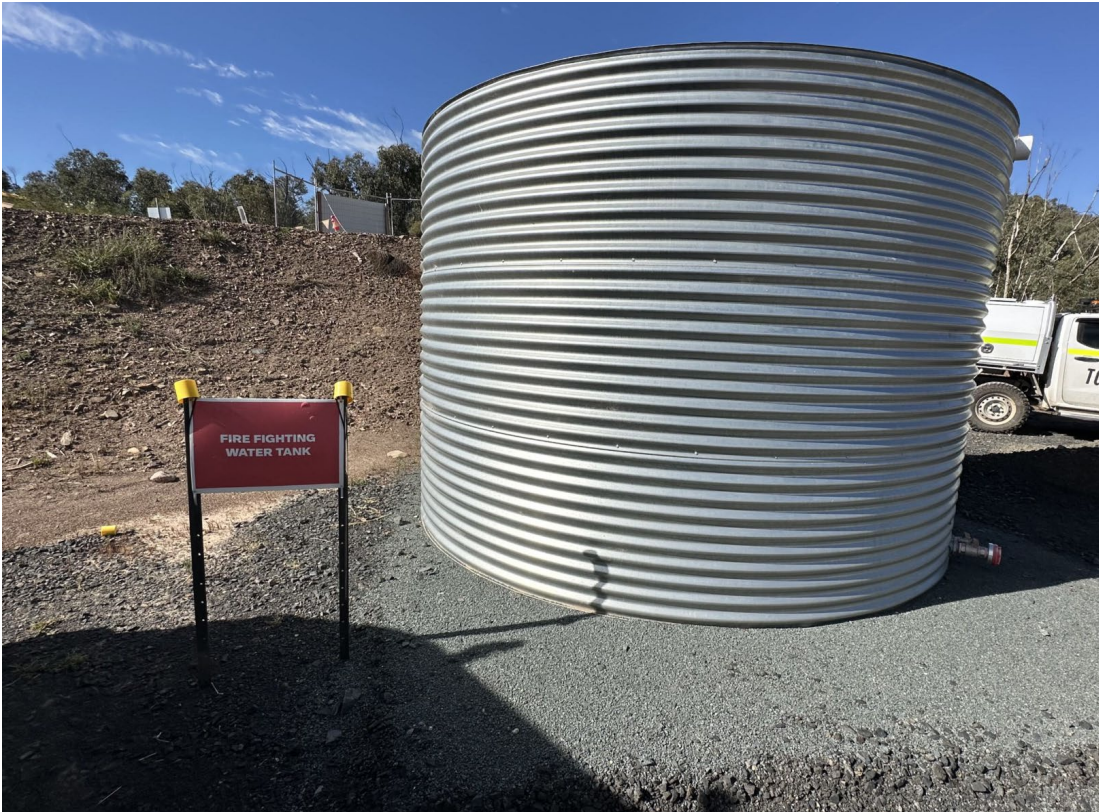
**Plate 39: Water supply tank at Lobs Hole Project Compound full and signposted (Inspection Date: 12/03/2025).**

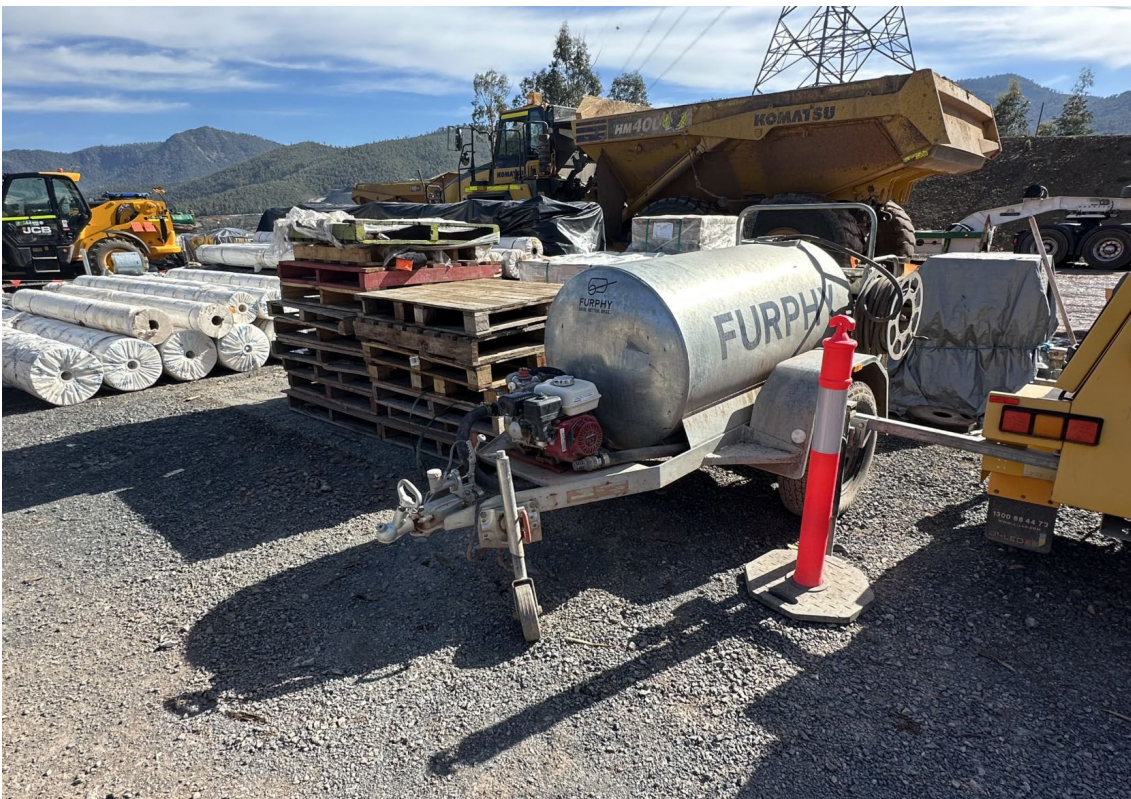
**Plate 40: Firefighting equipment located within Lobs Hole Project Compound (Inspection Date: 12/03/2025).**

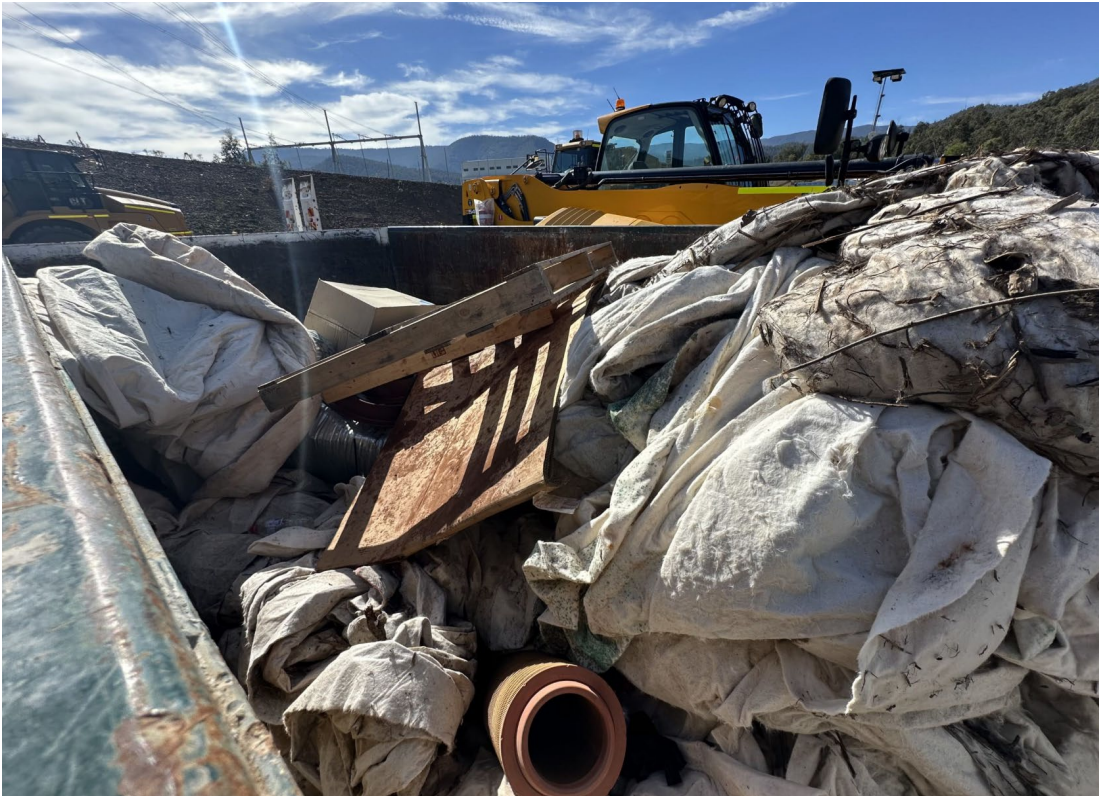
**Plate 41: General skip bin located at Lobs Hole Project Compound (Inspection Date 12/03/2025).**

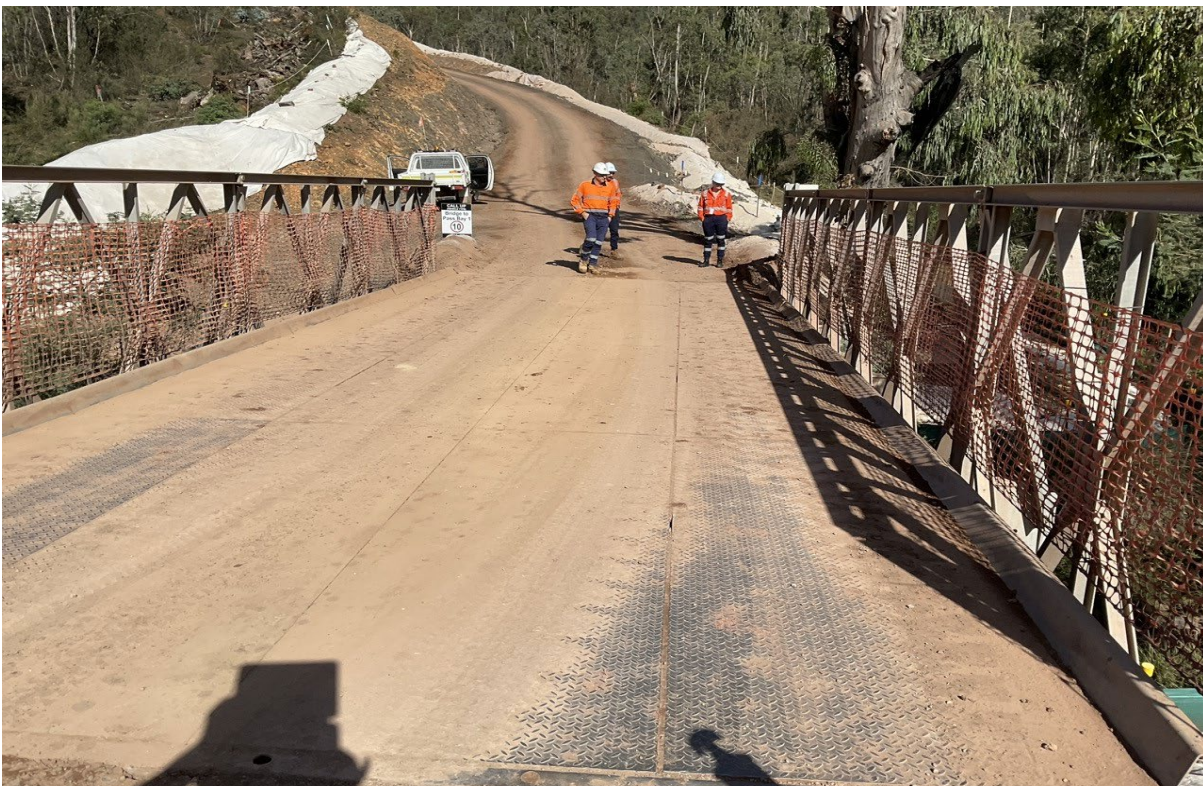
**Plate 42: Dust observed on deck of Sheep Station Creek Bridge (Inspection Date 12/03/2025).**

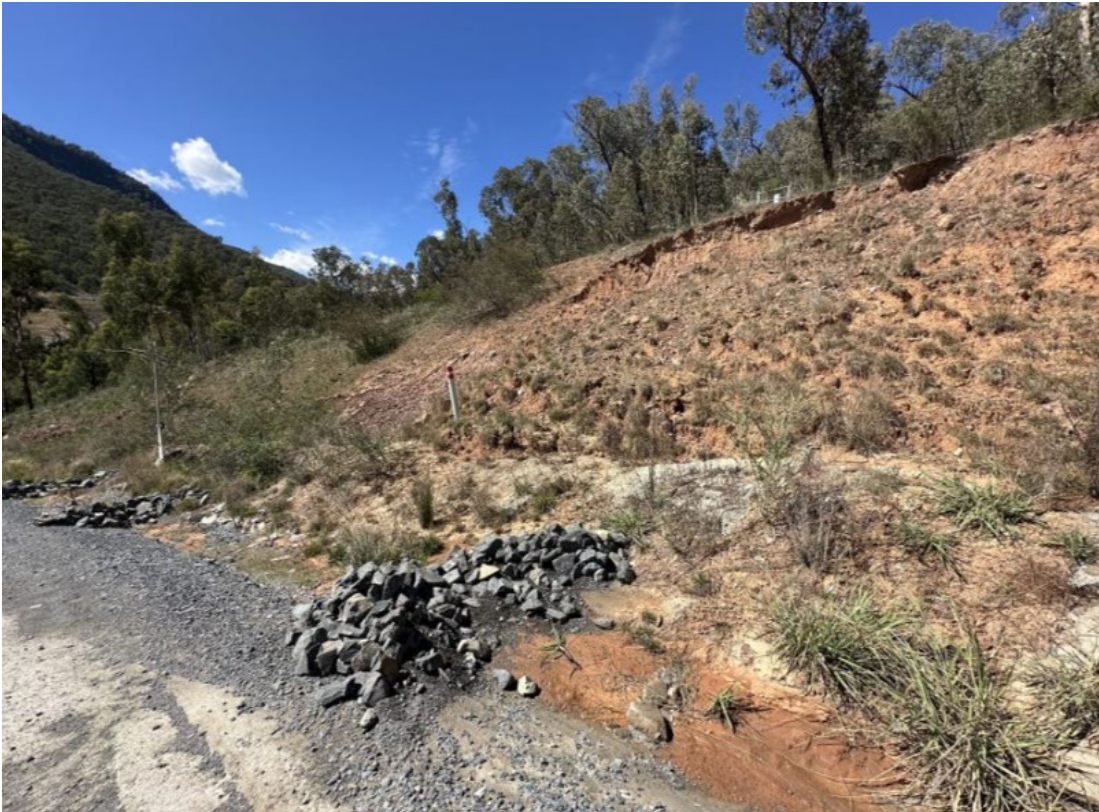
**Plate 43: Dirty water diversion with rock checks located on Track 8 (Inspection Date: 12/03/2025).**
