**Subject: Snowy 2.0 - Transmission Connection - Independent Environmental Audit #4**

# **Snowy 2.0 Transmission Connection Project**

Independent Environmental Audit Construction Audit 4

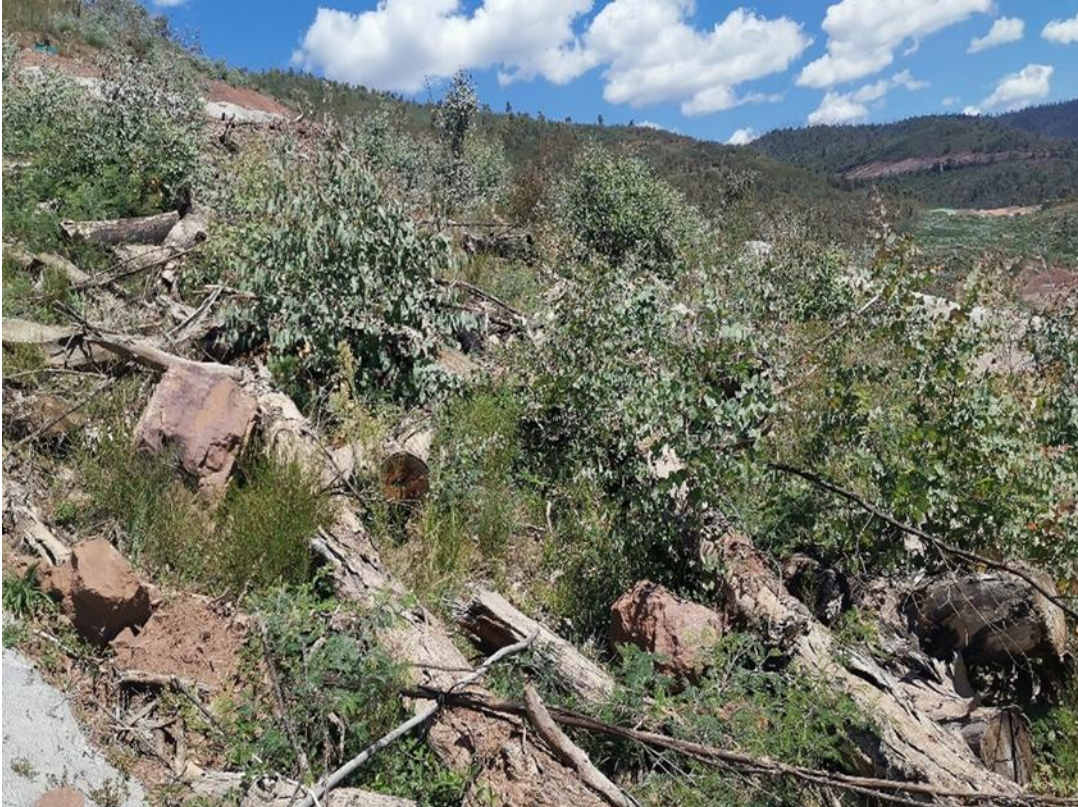
**Plate 2: Post partial clearing vegetation response - Project East near Pad 2**  
(Inspection date 10/09/2025)

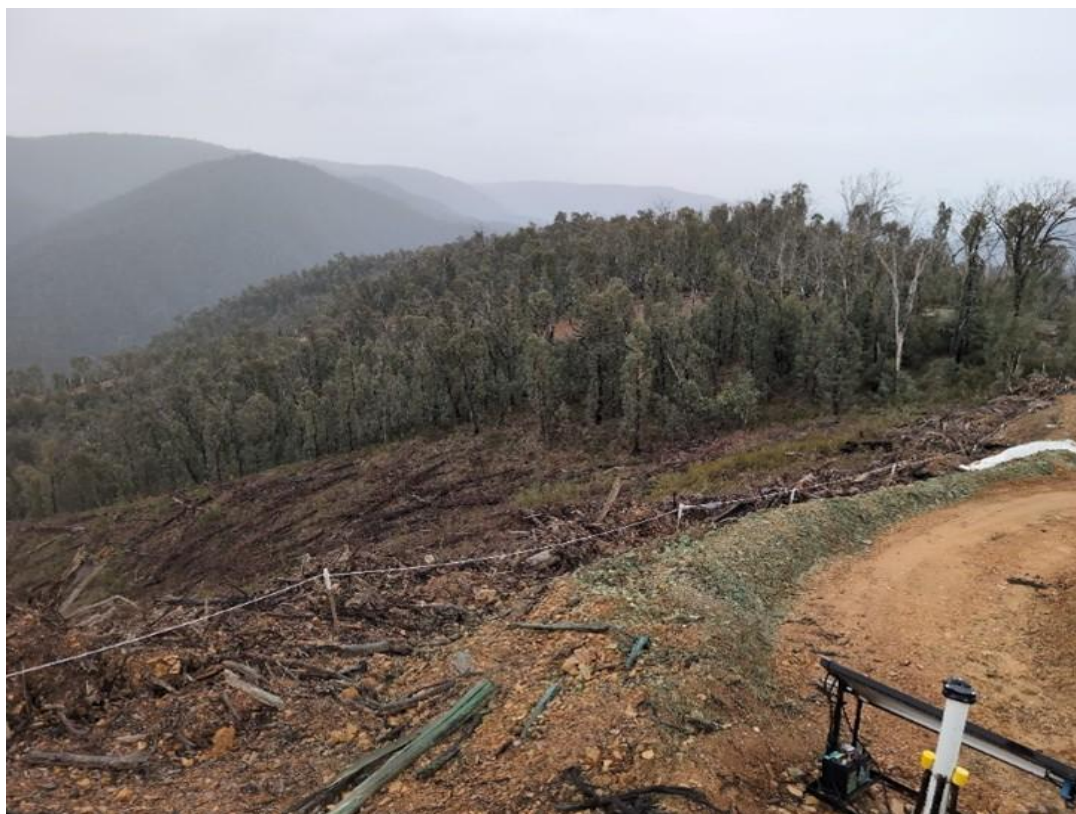
**Plate 3: Edge of total clearing area and partial (hand) clearing - Project East Pad 10**  
(Inspection date 10/09/2025)

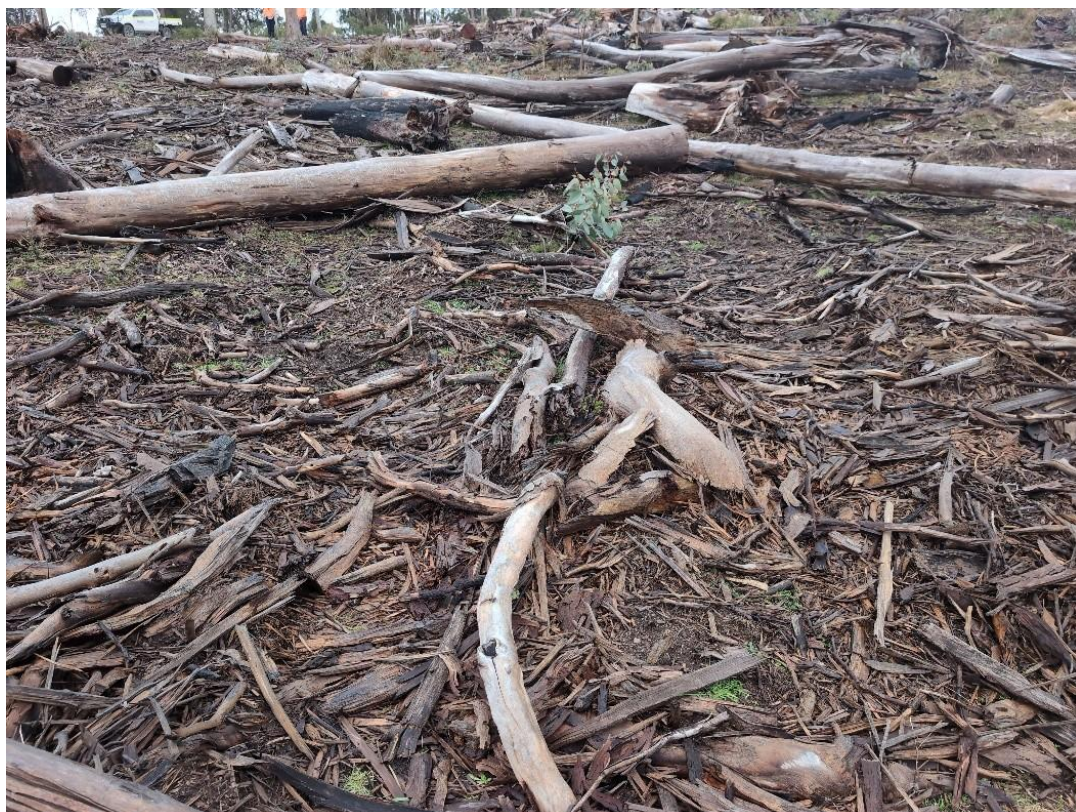
**Plate 4: Heavy mulch layer with minor regeneration response – Project West below Pad 18**  
(Inspection date 10/09/2025)

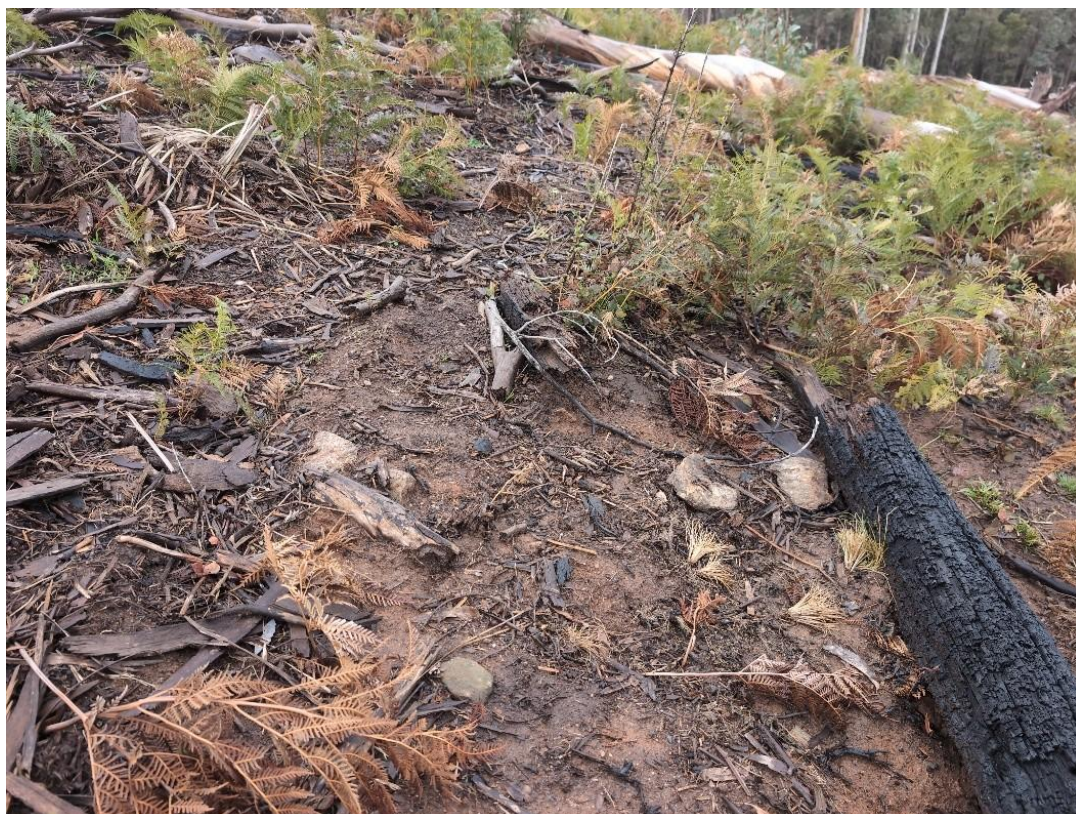
**Plate 5: Partial clearing (mechanical) exposed soils and patchy heavy mulch – Project West Pad 18 (Inspection date 10/09/2025)**

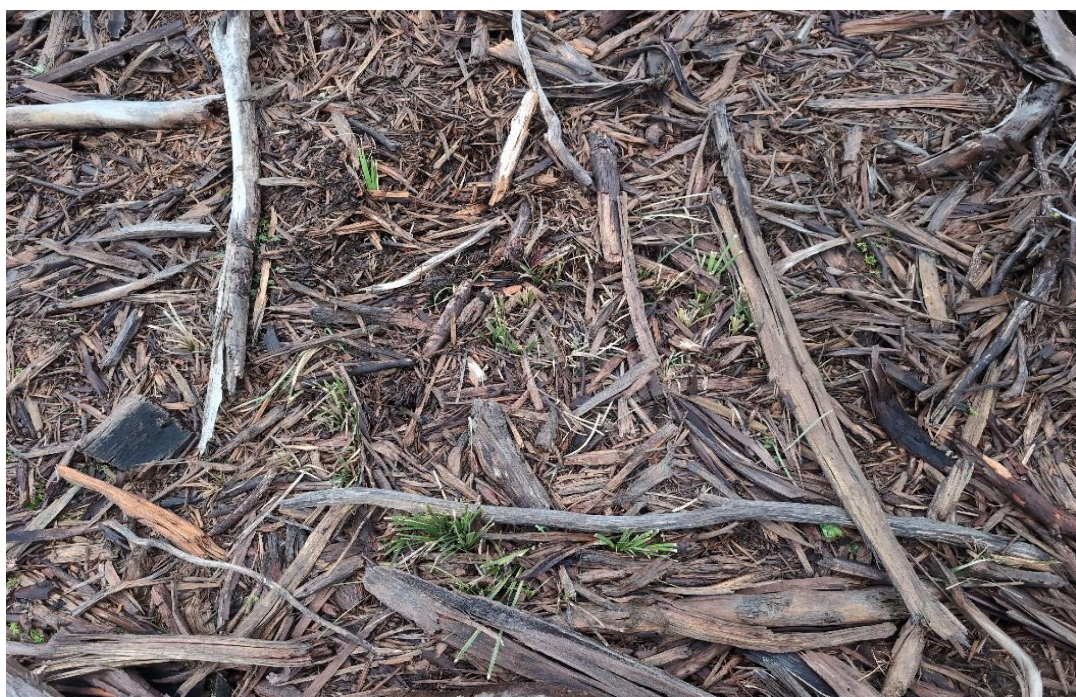
**Plate 6: Partial clearing (mechanical) heavy mulch and grazed ground layer – Project West Pad 19 (Inspection date 10/09/2025)**

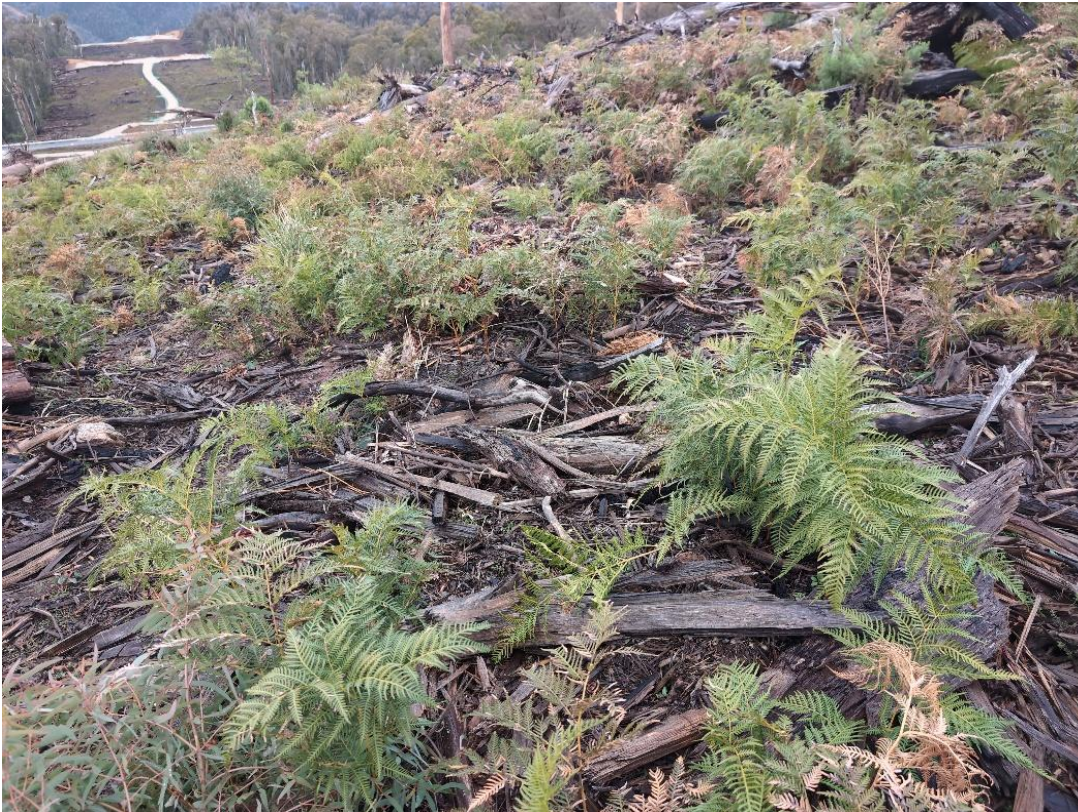
**Plate 7: Bracken fern with a scattered shrub and groundcover layer (Partial clearing) – Project West northeast of Pad 18 (Inspection date 10/09/2025)**

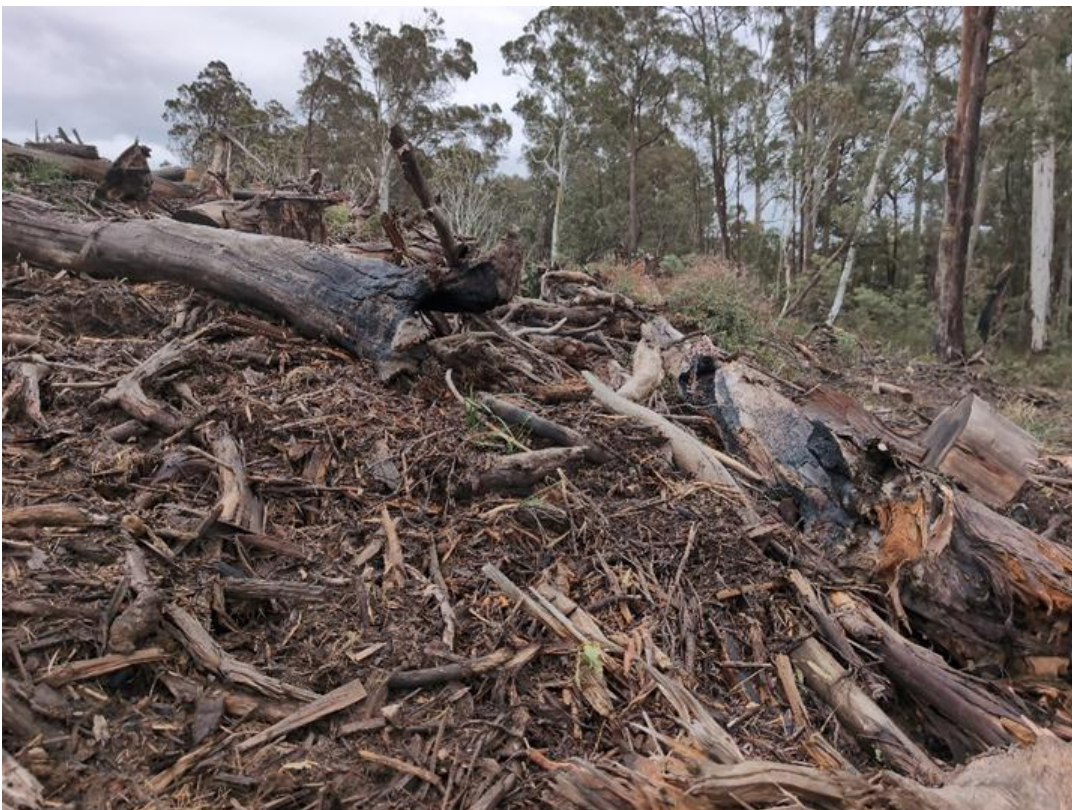
**Plate 8: Dense mulch cover lacking native groundcover. South east of Pad 19 – Project West (Inspection date 10/09/2025)**

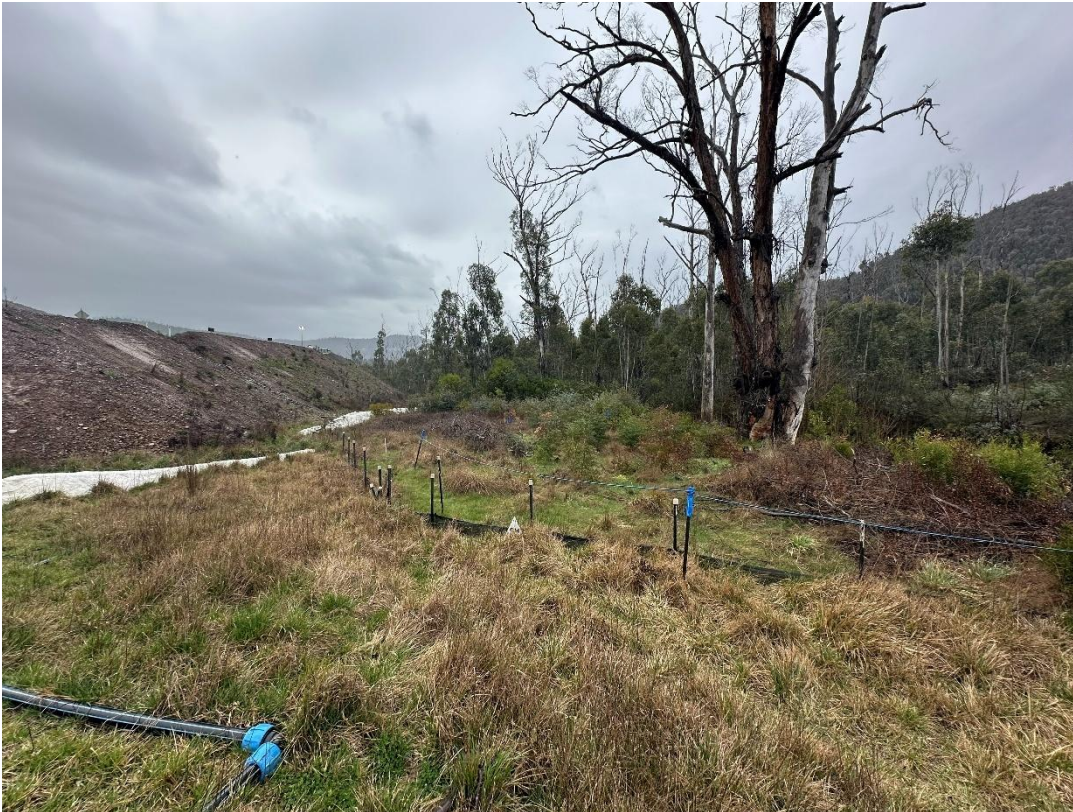
**Plate 9: Non- historical heritage items still demarcated by colour specific rope. Near Track 8 – Project West (Inspection date 10/09/2025)**

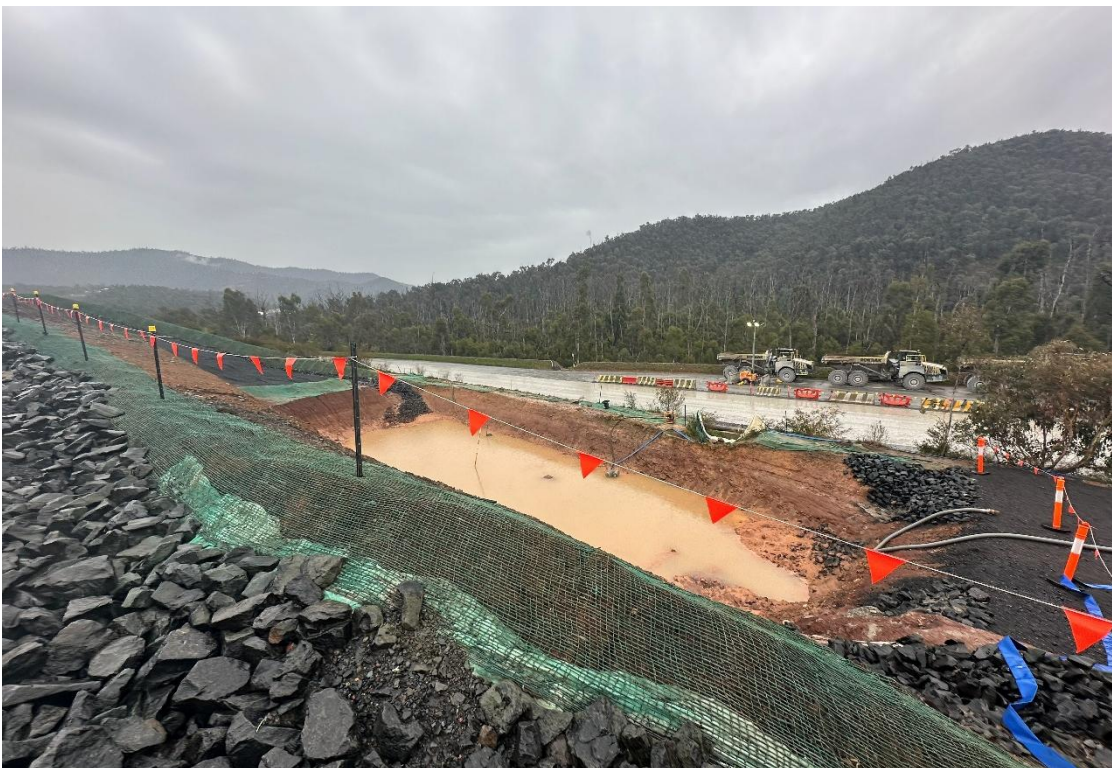
**Plate 10: Track 8 Sediment Basin (Inspection date 10/09/2025)**

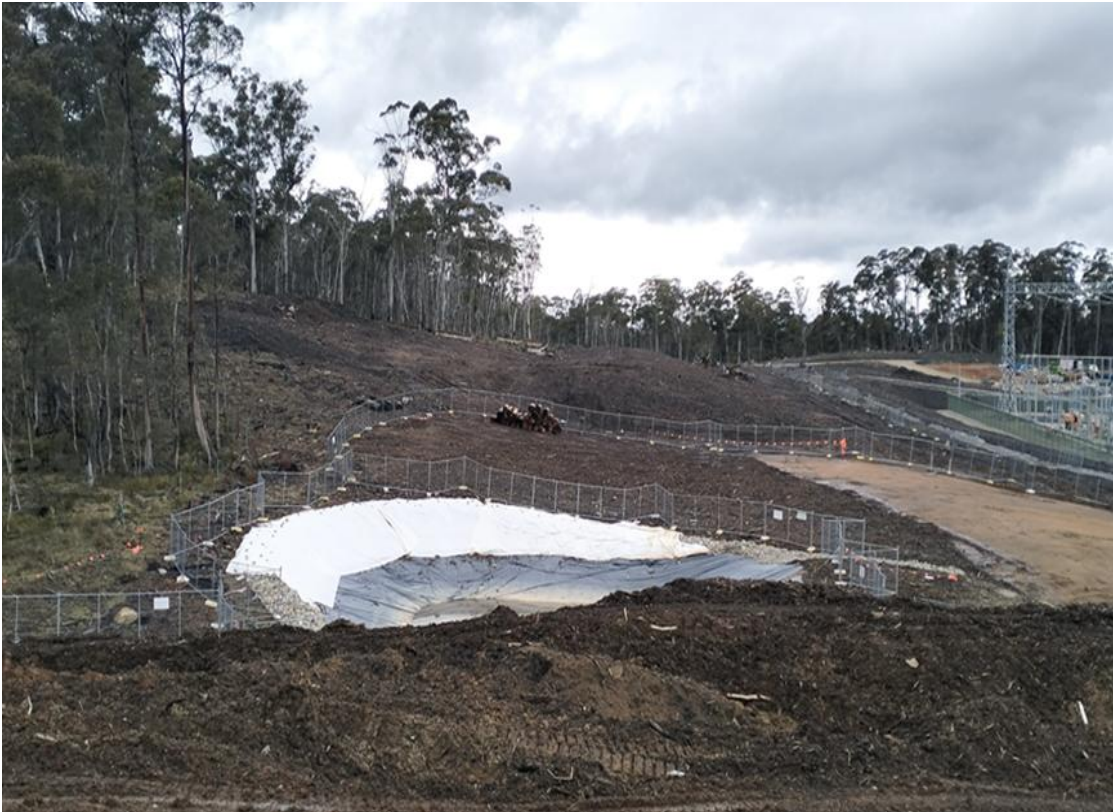
**Plate 11: 500 kV Substation Clean Water Basin – Substation Project Area**  
(Inspection date 10/09/2025)

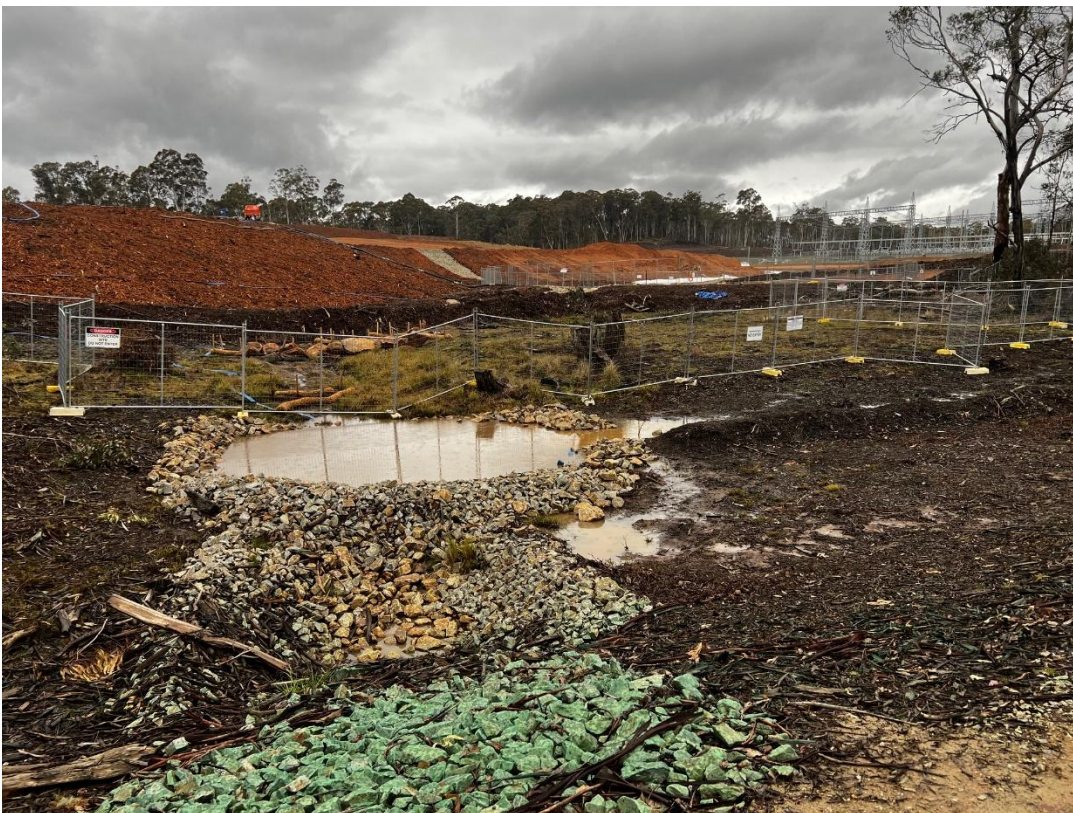
**Plate 12: Installed erosion and sediment controls around the “Duck Pond” looking towards the 500 kV substation sediment basin** (Inspection date 10/09/2025)

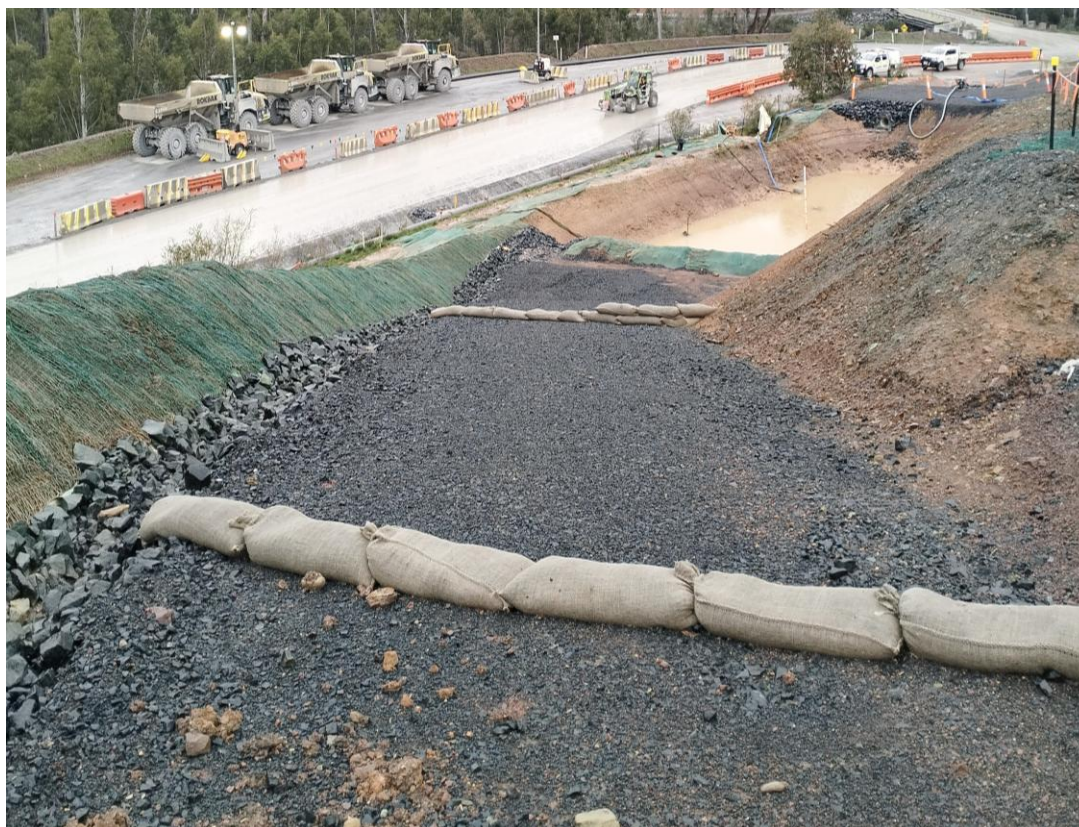
**Plate 13: Erosion and sediment controls leading to sediment basin along Track 8 – Project East (Inspection date 10/09/2025)**

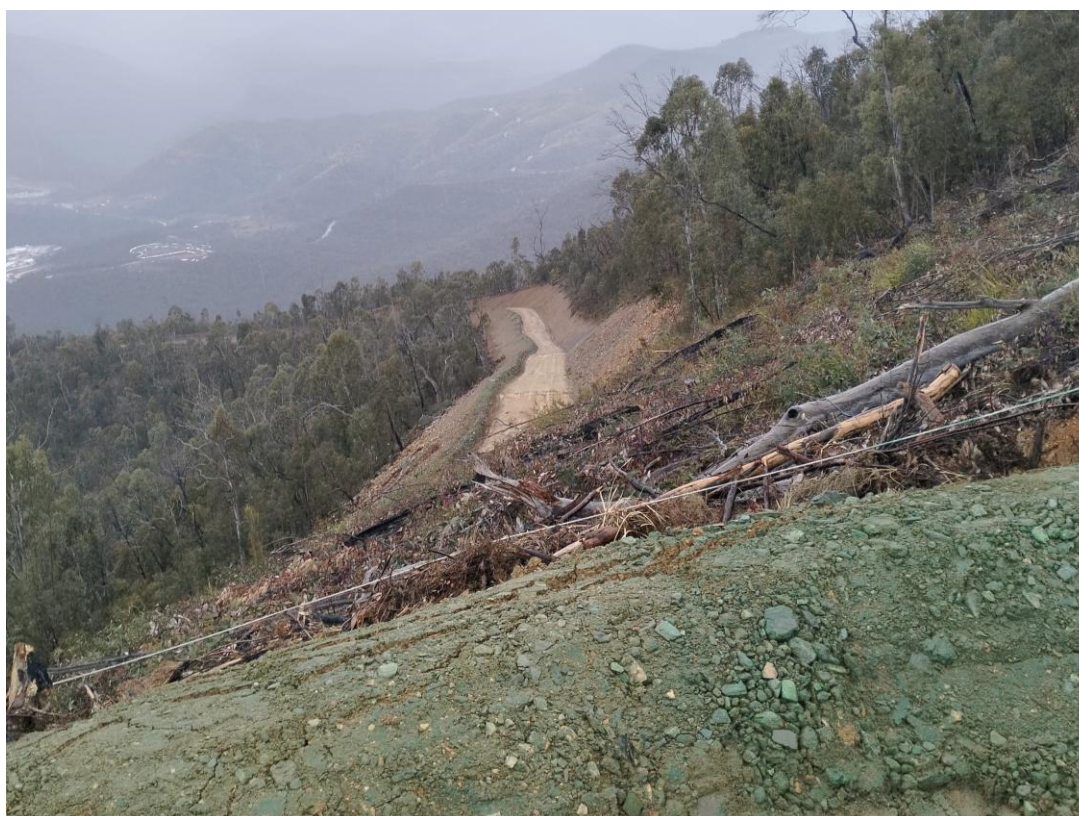
**Plate 14: Erosion and sediment controls and soil binder installed along Track 5 (as viewed from Pad 10) – Project East (Inspection date 10/09/2025)**

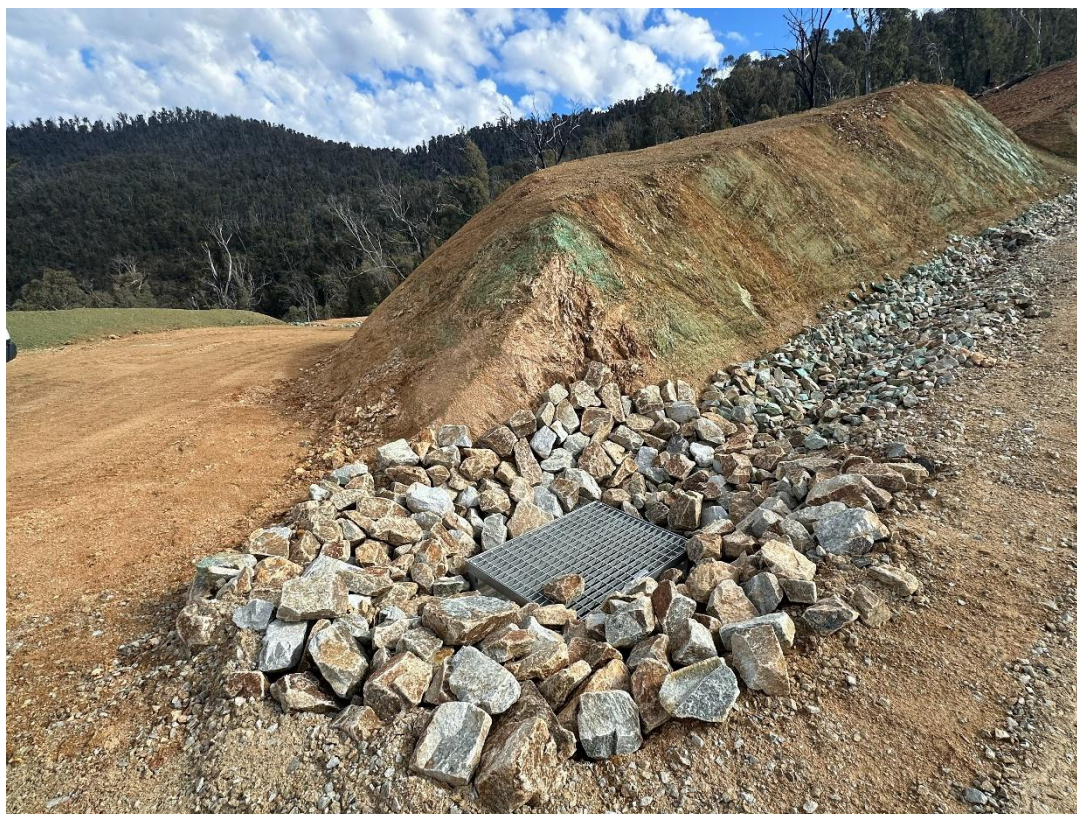
**Plate 15: Installed erosion and sediment controls on Track 2 (Inspection date 10/09/2025)**

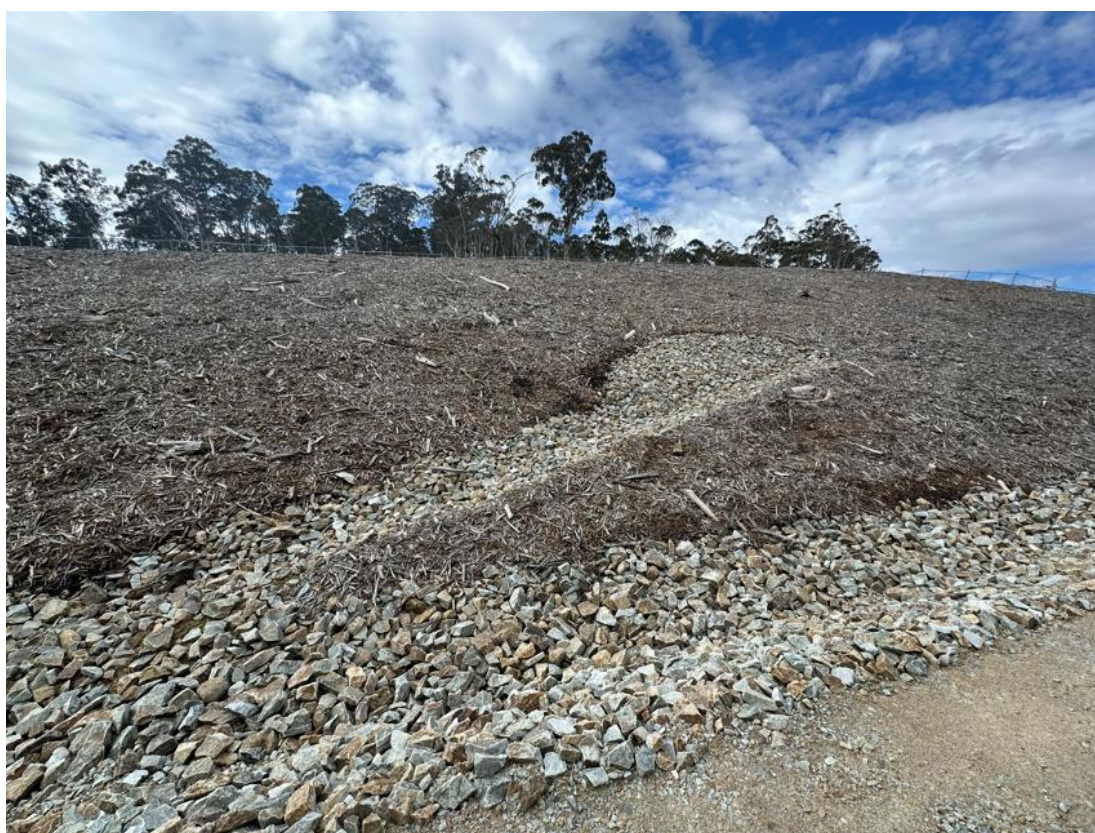
**Plate 16: Erosion and sediment controls installed to address water seepage issues and prevent soil loss at Maragle Switchyard – Project West (Inspection date 10/09/2025)**

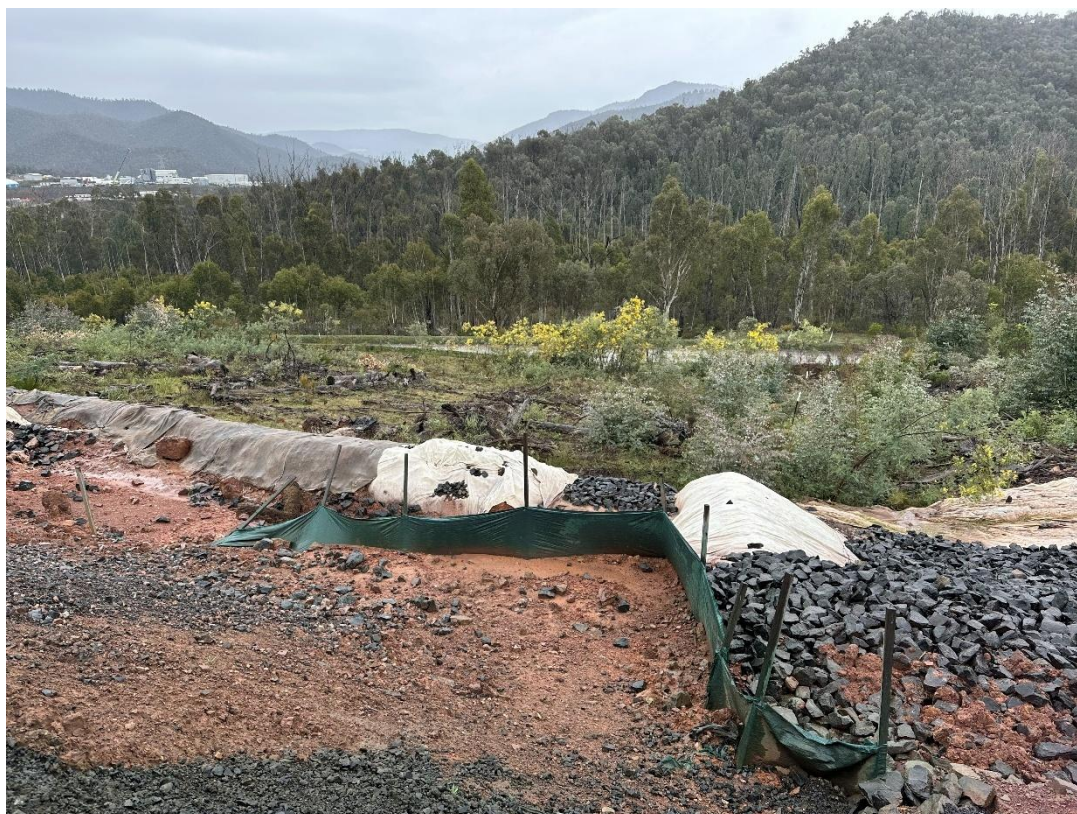
**Plate 17: Fallen sediment fence on Track 8 – Project East (Inspection date 10/09/2025)**

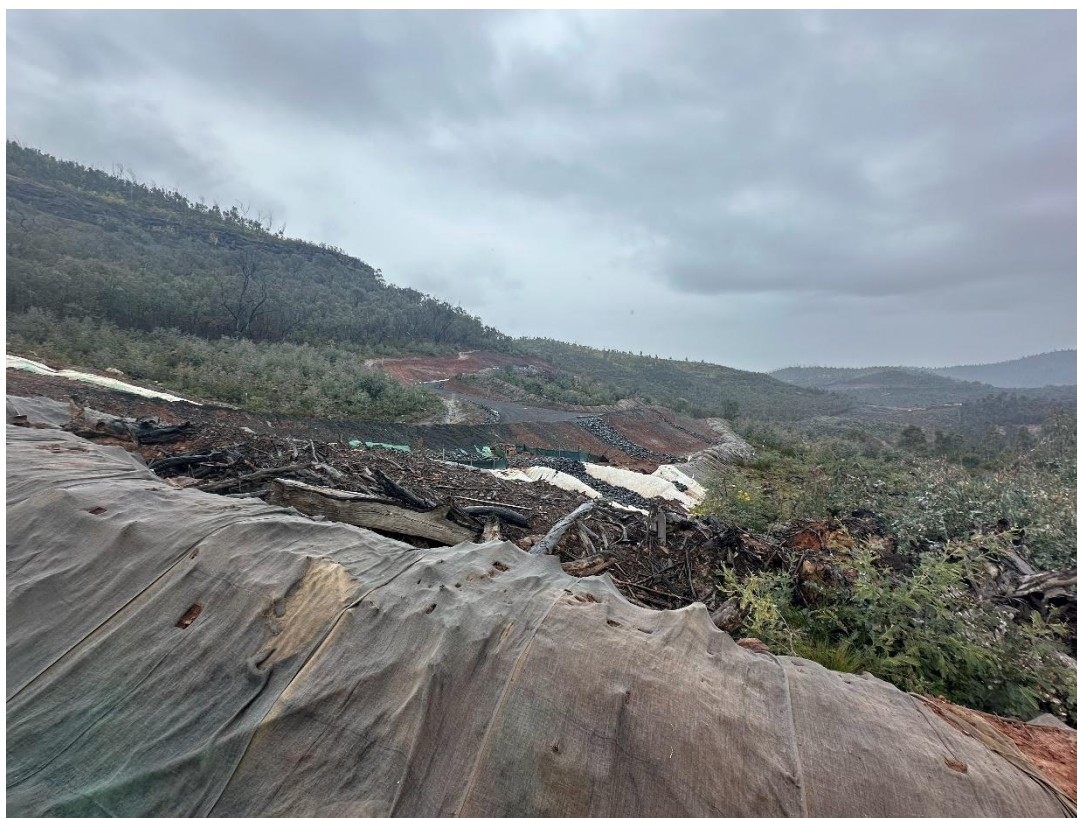
**Plate 18: Degraded geofabric on some of the batters along Track 8 – Project East (Inspection date 10/09/2025)**

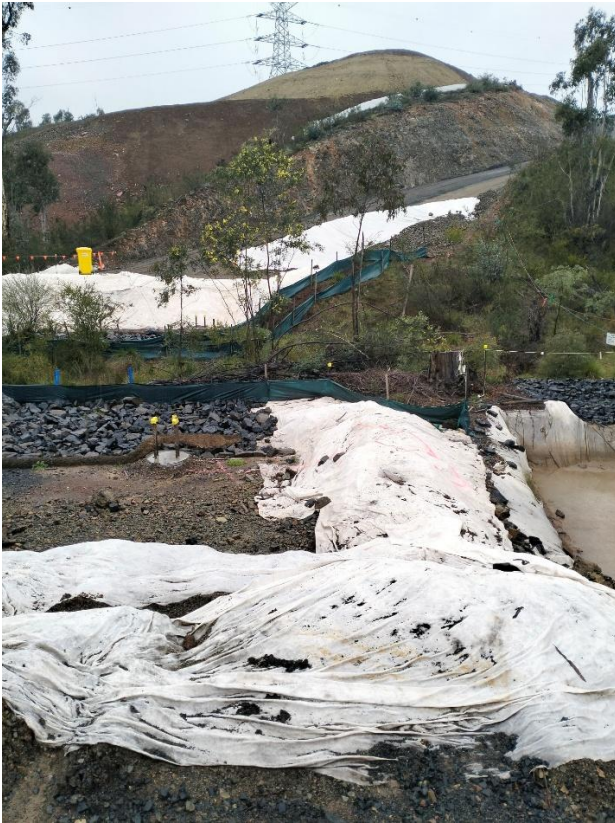
**Plate 19: Implementation of erosion and sediment controls around the temporary Sheep Station Creek Bridge – Project East (Inspection date 10/09/2025)**

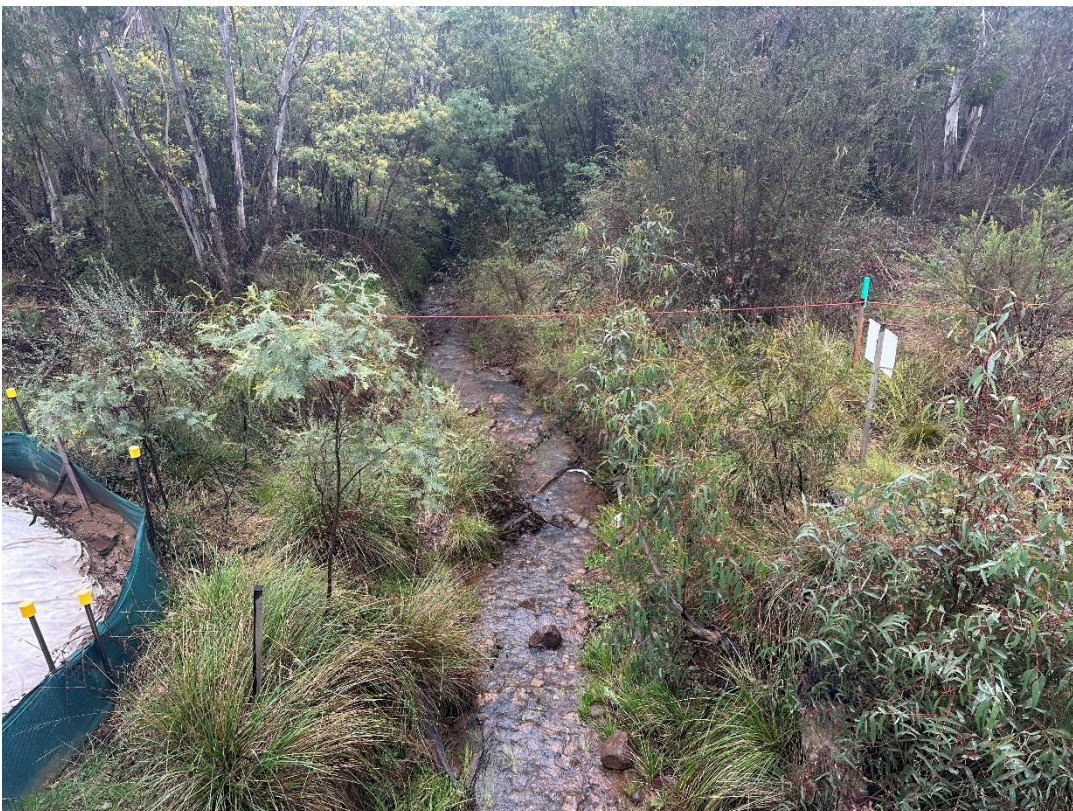
**Plate 20: Effectiveness of sediment fences around the temporary Sheep Station Creek Bridge – Project East (Inspection date 10/09/2025)**

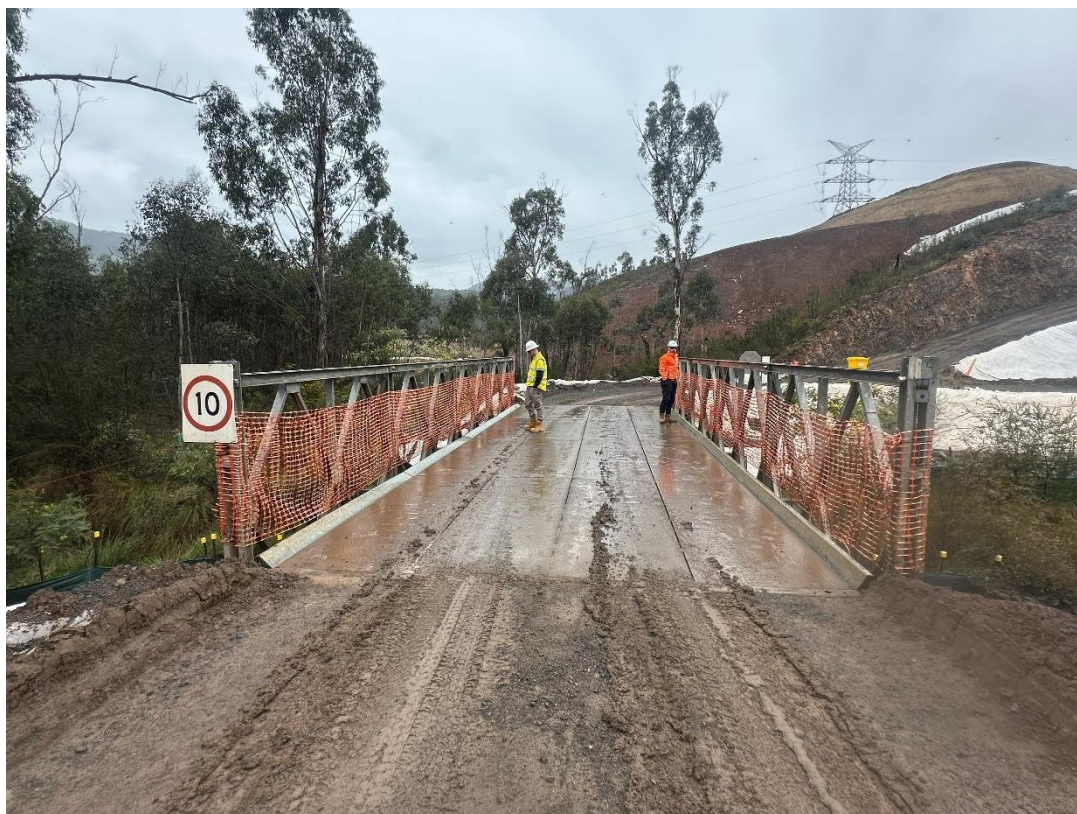
**Plate 21: Temporary Sheep Station Creek Bridge deck clear of sediment - Project East (Inspection date 10/09/2025)**

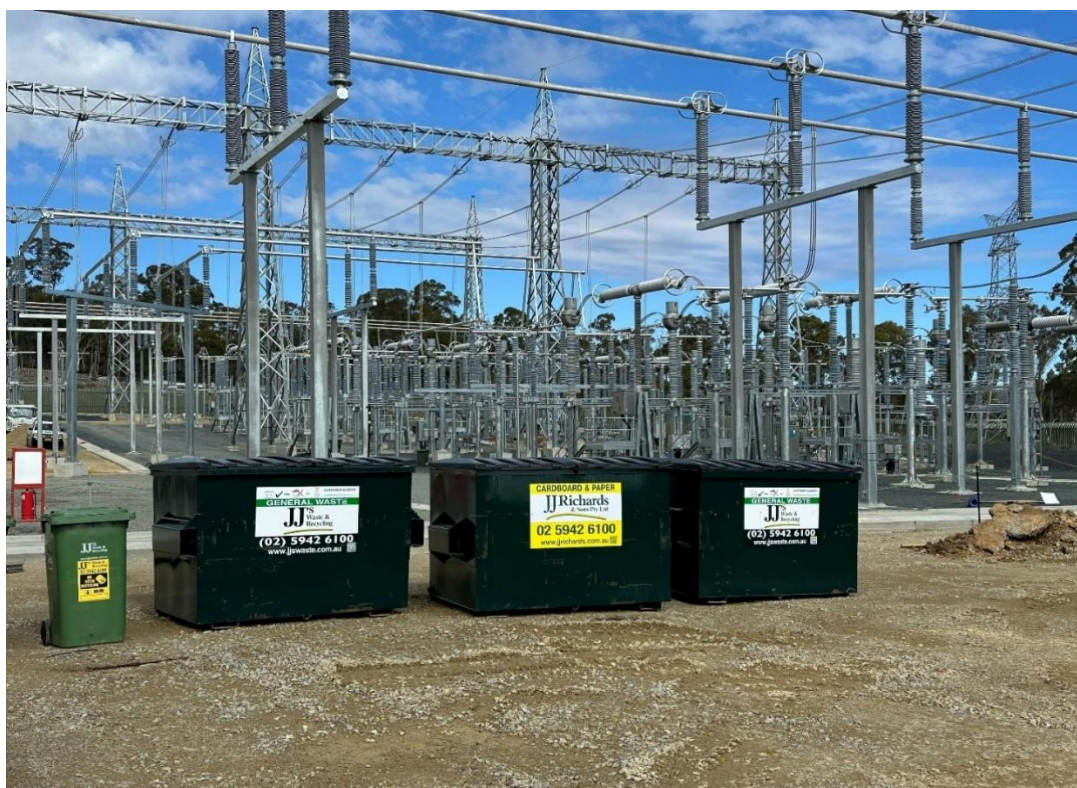
**Plate 22: Areas free of litter and waste appropriately sorted into designated bins- Maragle Project Construction Compound (Inspection date 09/09/2025)**

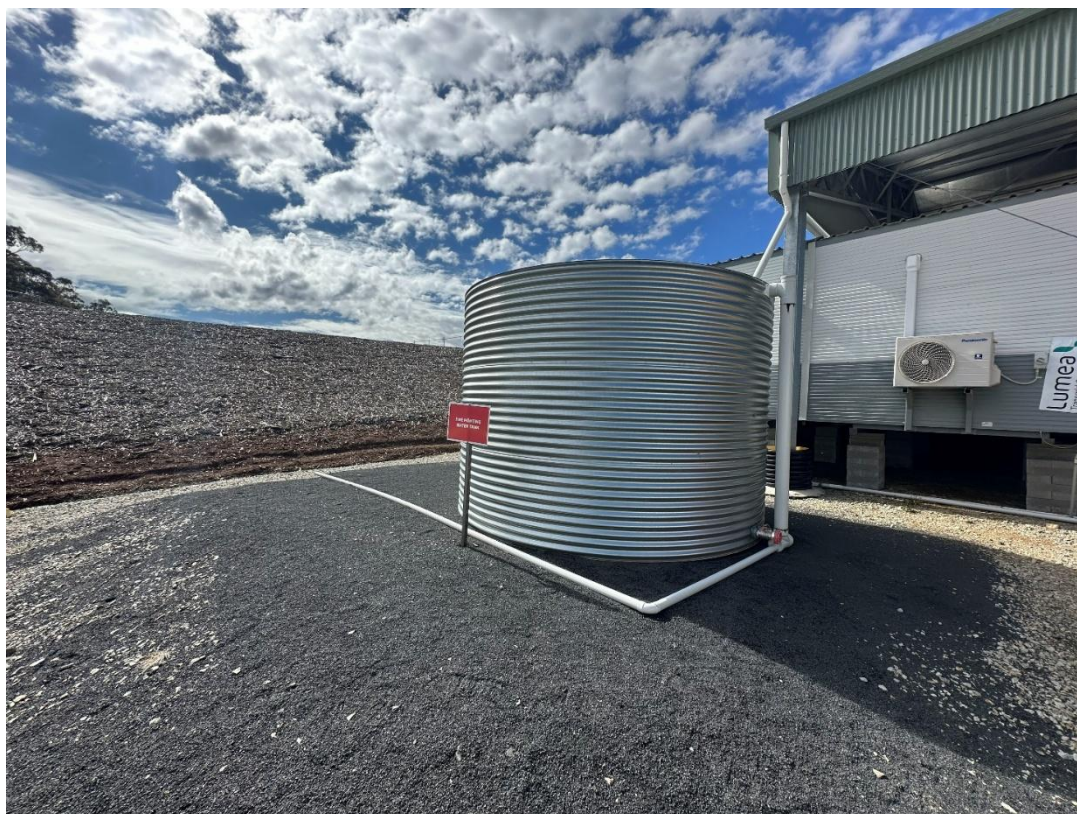
**Plate 23: Fire tank full and correctly signposted - Maragle Project Construction Compound**  
(Inspection date 09/09/2025)

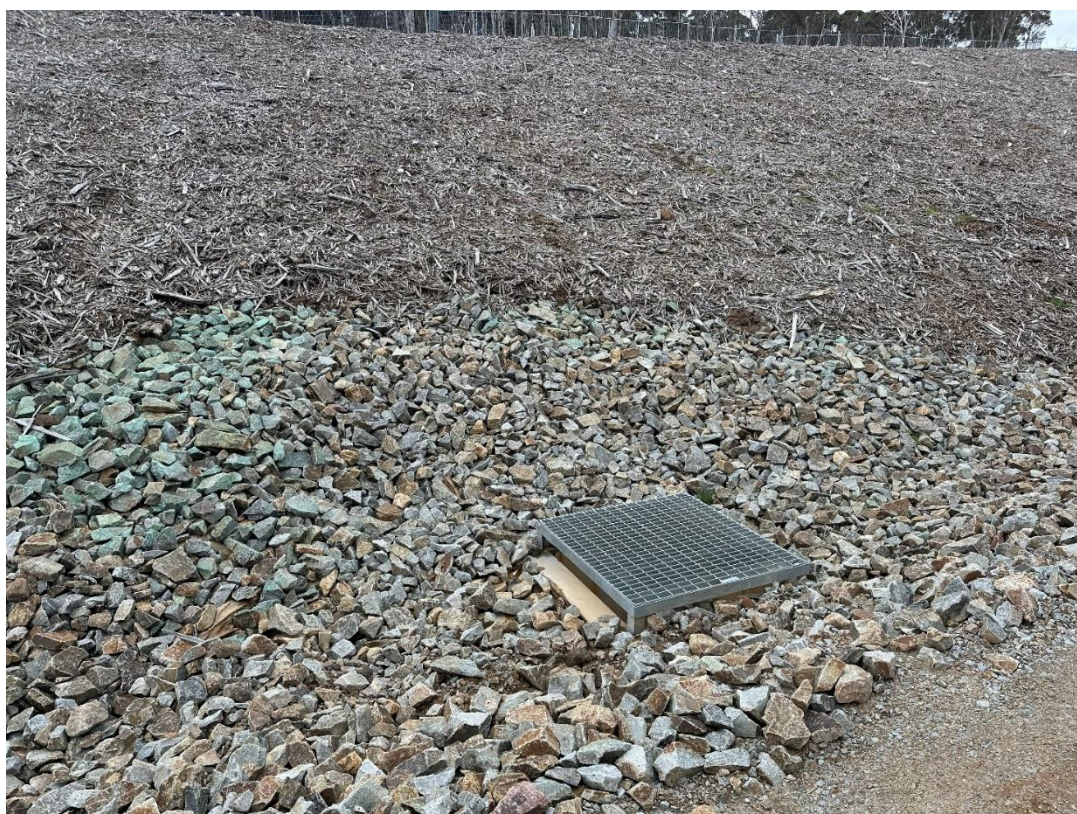
**Plate 24: Erosion and sediment controls well maintained and effective - Maragle Switchyard**  
(Inspection date 09/09/2025)

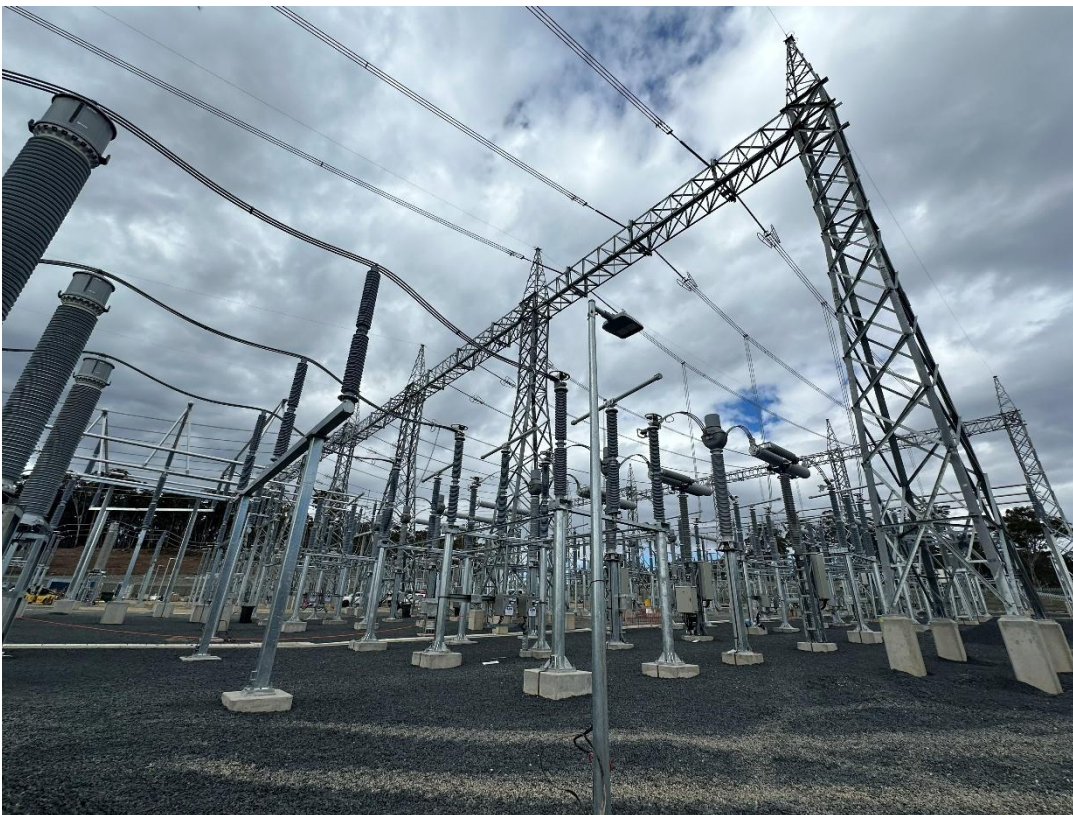
**Plate 26: Overview of Maragle Switchyard (Inspection date 09/09/2025)**

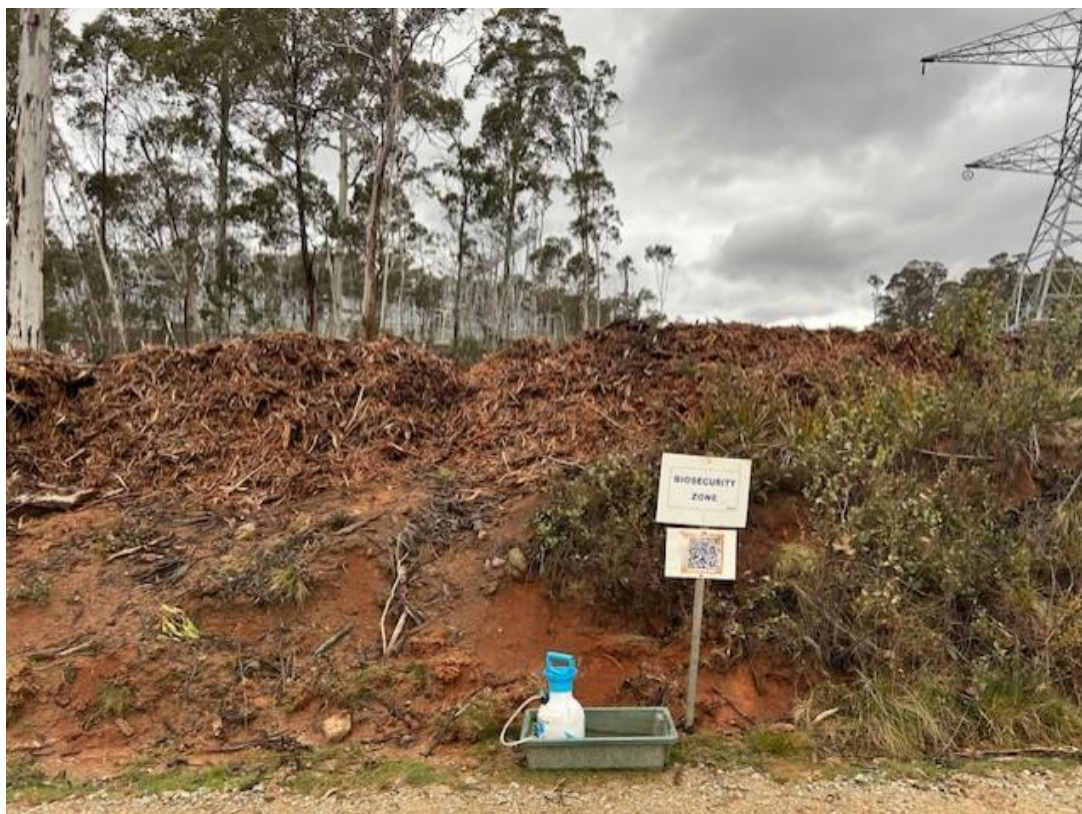
**Plate 27: Biosecurity signage for areas under active management for *Phytophthora* sp. Risk - Project West (Inspection date 10/09/2025)**

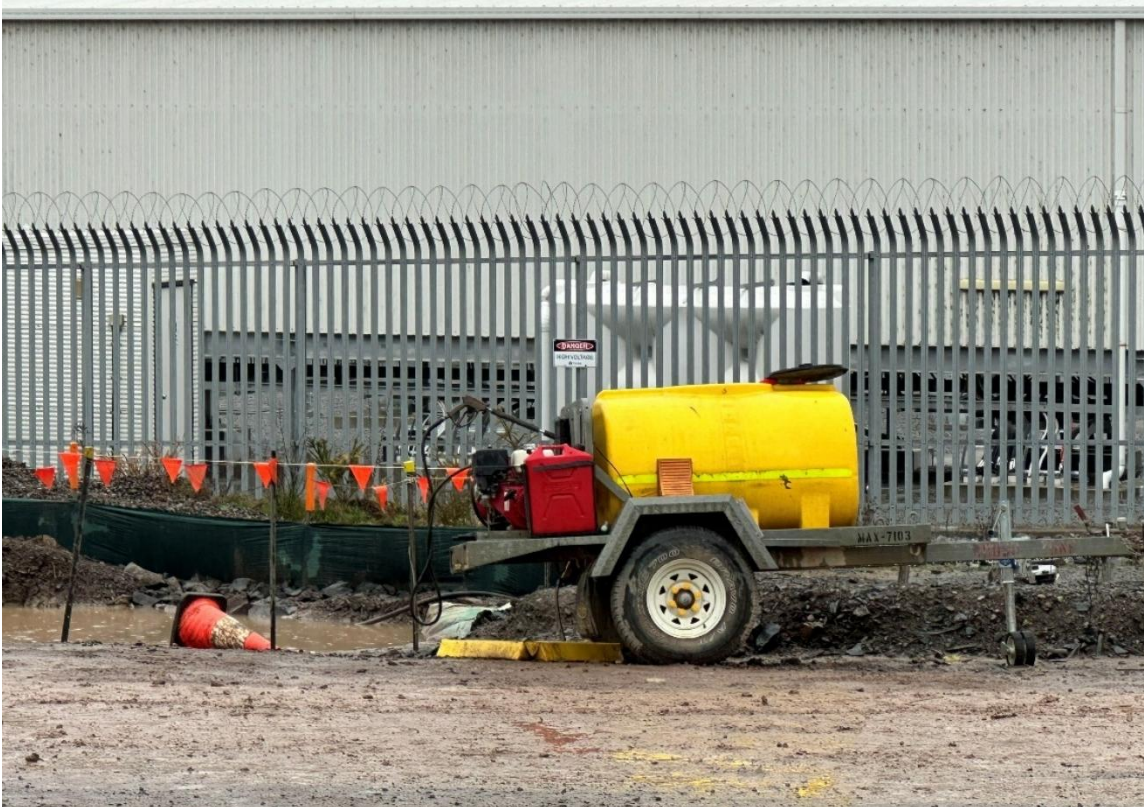
**Plate 29: Firefighting equipment was available – Lobs Hole Construction Compound (Inspection date 10/09/2025)**
