**Subject: Snowy 2.0 - Transmission Connection - Independent Environmental Audit #4**

# **Snowy 2.0 Transmission Connection Project**

Independent Environmental Audit Construction Audit 4

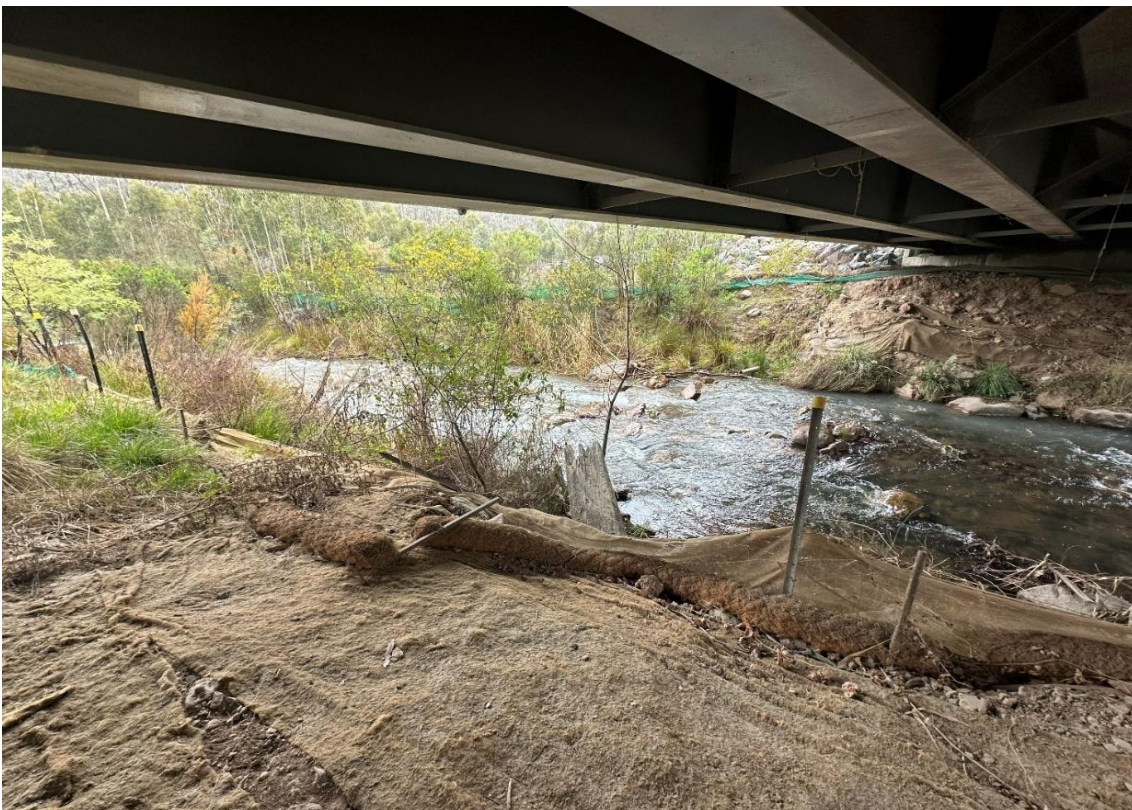
**Plate 30: Ineffective erosion and sediment controls located on edge of Wallace Creek - Project East (Inspection date 10/09/2025)**

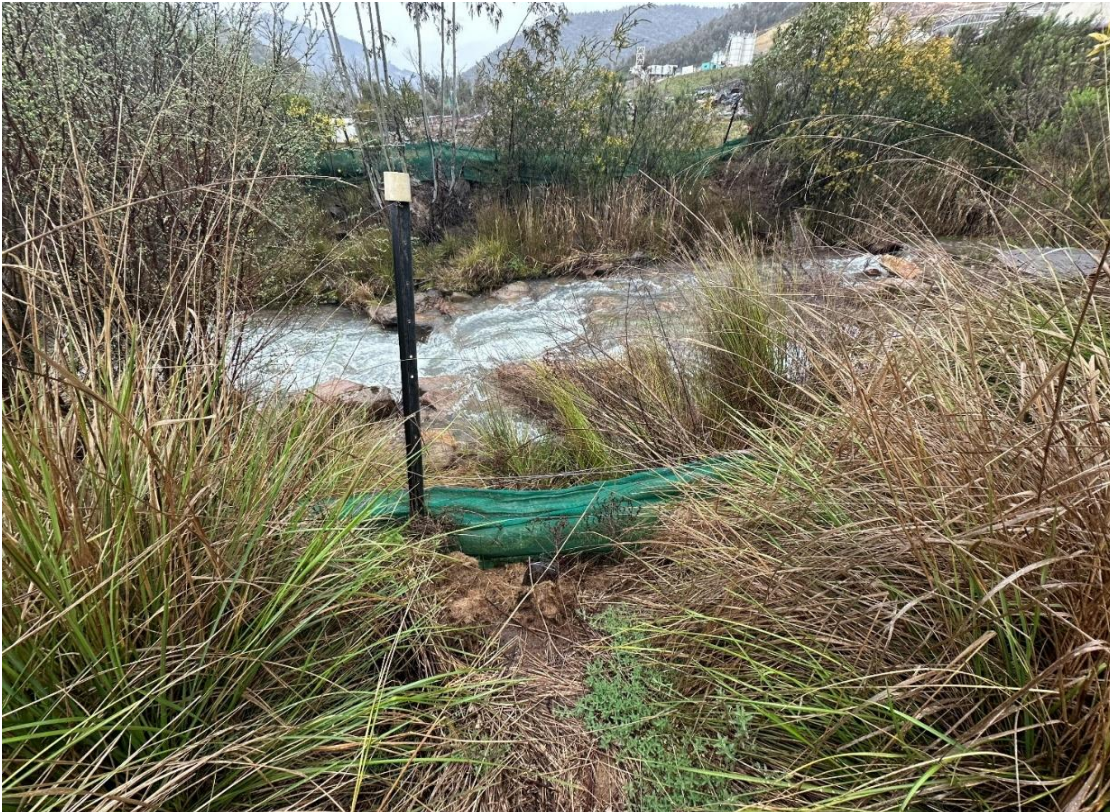
**Plate 31: Erosion and sediment controls located on edge of Wallace Creek. Sediment fences were observed not embedded – Project East (Inspection date 10/09/2025)**
